ПРОЦЕДУРНЫЕ ТРЕБОВАНИЯ,
УНИФИЦИРОВАННЫЕ ИНТЕРПРЕТАЦИИ
И РЕКОМЕНДАЦИИ
МЕЖДУНАРОДНОЙ АССОЦИАЦИИ
КЛАССИФИКАЦИОННЫХ ОБЩЕСТВ

GENERAL DRY CARGO SHIPS

Guidelines for
Surveys, Assessment and Repair
of Hull Structure

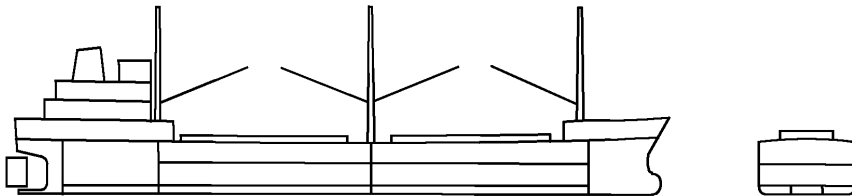
Figure 1 General view of a typical general dry cargo ship

Figure 1 shows a typical general arrangement of a general dry cargo ship with single tween deck.

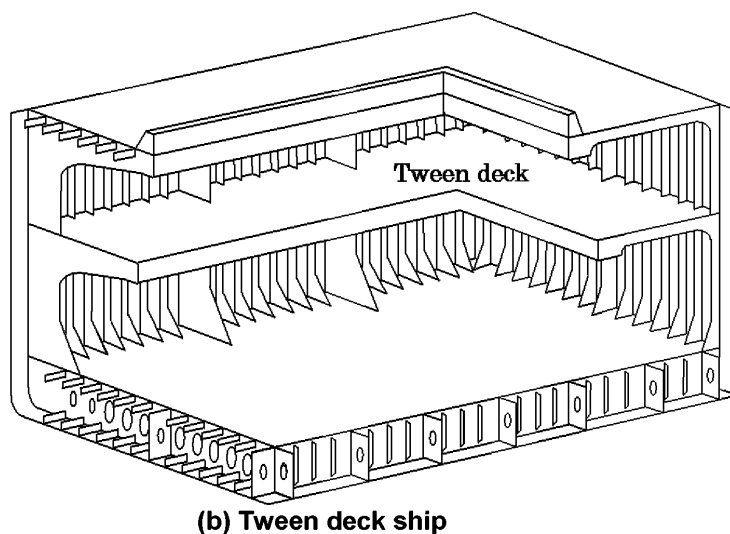
Figure 2 Cargo hold structural configurations for general dry cargo ships

Figures 2 (a) and (b) show cargo hold structural configurations for general dry cargo ships. As

many different cargoes are carried by general dry cargo ships, hull structures differ in accordance with their purpose. These guidelines intend to cover general dry cargo ships these ships.

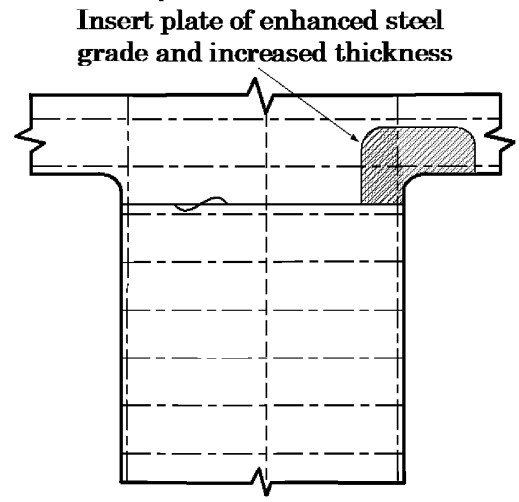
GENERAL DRY CARGO SHIPS		Guidelines for Surveys, Assessment and Repair of Hull Structure	
Part 1	Cargo hold region	Example No.	
Area 1	Upper deck structure	2	
Detail of damage		Fractures at main cargo hatch corner	
<p>Sketch of damage</p>

<p>Notes on possible cause of damage</p> <ol style="list-style-type: none"> 1. Stress concentration at hatch corners, i.e. radius of corner. 2. Welded attachment of shedder plate close to edge of hatch corner. 3. Wire rope groove. 		<p>Notes on repairs</p> <ol style="list-style-type: none"> 1. The corner plating in way of the fracture is to be cropped and renewed. If stress concentration is primary cause, insert plate should be of increased thickness, enhanced steel grade and/or improved geometry. Insert plate should be continued beyond the longitudinal and transverse extent of the hatch corner radius ellipse or parabola, and the butt welds to the adjacent deck plating should be located well clear of the butts in the hatch coaming. It is recommended that the edges of the insert plate and the butt welds connecting the insert plates to the surrounding deck plating be made smooth by grinding. In this respect caution should be taken to ensure that the micro grooves of the grinding are parallel to the plate edge. 2. If the cause of fracture is welded attachment of shedder plate, the deck connection should be left unwelded. 3. If the cause of the fracture is wire rope groove, replacement to the original design can be accepted.

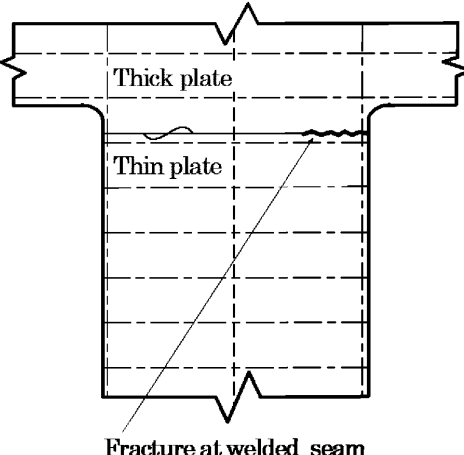
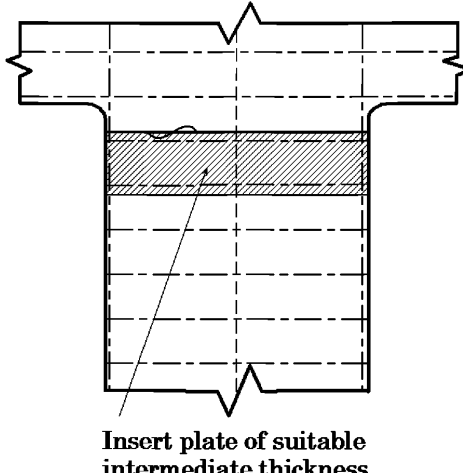
GENERAL DRY CARGO SHIPS		Guidelines for Surveys, Assessment and Repair of Hull Structure
Part 1	Cargo hold region	Example No.
Area 1	Upper deck structure	3-a
Detail of damage	Fracture of welded seam between thick plate and thin plate at cross deck	
Sketch of damage		Sketch of repair

<p>Thick plate</p> <p>Thin plate</p> <p>Fracture at welded seam</p>

<p>Insert plate of suitable intermediate thickness</p>
Notes on possible cause of damage <ol style="list-style-type: none"> 1. Stress concentration created by abrupt change in deck plating thickness. 2. In-plane bending in cross deck strip due to torsional (longitudinal) movements of ship sides. 3. Welded seam not clear of tangent point of hatch corner. 		Notes on repairs <ol style="list-style-type: none"> 1. Insert plate of intermediate thickness is recommended. 2. Smooth transition between plates (beveling) should be considered.

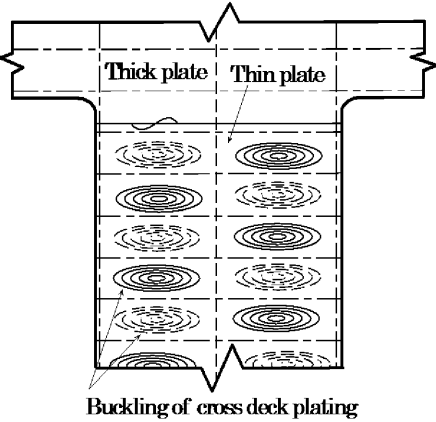
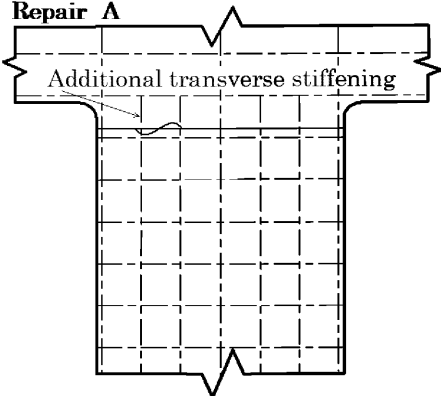
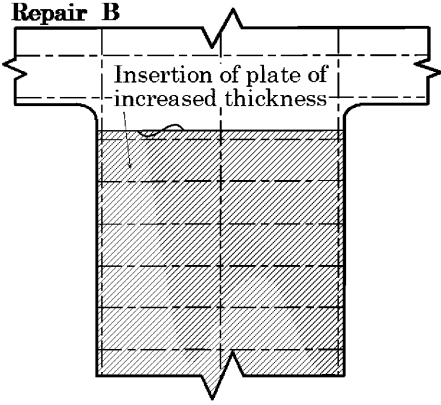
GENERAL DRY CARGO SHIPS		Guidelines for Surveys, Assessment and Repair of Hull Structure
Part 1	Cargo hold region	Example No.
Area 1	Upper deck structure	3-c
Detail of damage	Overall buckling of cross deck plating	
Sketch of damage	Sketch of repair

<p>Buckling of cross deck plating</p>	<p>Repair A</p>

<p>Additional transverse stiffening</p> <p>Repair B</p>

<p>Insertion of plate of increased thickness</p>	
Notes on possible cause of damage	Notes on repairs	
<ol style="list-style-type: none"> 1. Transverse compression of deck due to sea load. 2. Insufficient transverse stiffening. 	<ol style="list-style-type: none"> 1. Repair A Plating of original thickness in combination with additional transverse stiffening. 2. Repair B Insertion of plating of increased thickness.

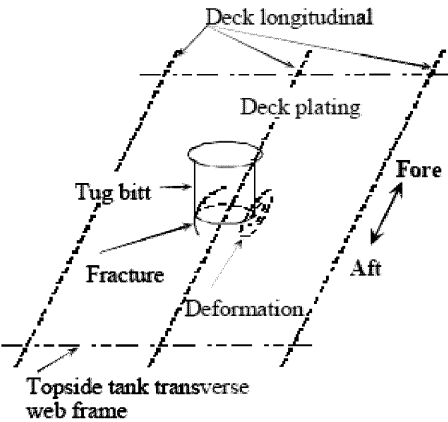
GENERAL DRY CARGO SHIPS		Guidelines for Surveys, Assessment and Repair of Hull Structure	
Part 1	Cargo hold region	Example No.	
Area 1	Upper deck structure	3-d	
Detail of damage		Deformed and fractured deck plating around tug bitt	
Sketch of damage		Sketch of repair

Notes on possible cause of damage		Notes on repairs	
1. <u>Insufficient strength.</u>		1. <u>Fractured/deformed deck plating should be cropped and part renewed.</u>	
		2. <u>Reinforcement by stiffeners should be considered.</u>

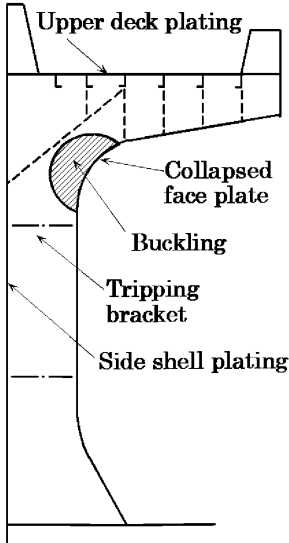
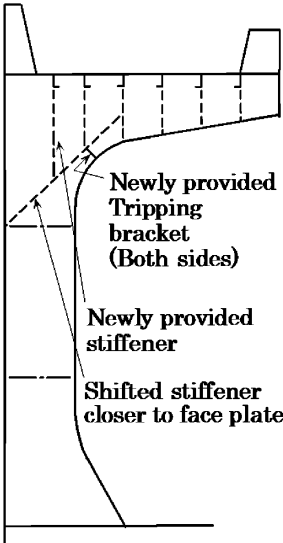
GENERAL DRY CARGO SHIPS		Guidelines for Surveys, Assessment and Repair of Hull Structure	
Part 1	Cargo hold region	Example No.	
Area 1	Upper deck structure	4	
Detail of damage		Buckling of web beam	
Sketch of damage

Notes on possible cause of damage <ol style="list-style-type: none"> 1. Overloading by green sea on deck or by excessive deck cargo. 2. Excessive corrosion. 3. Insufficient/improper web stiffening. 		Notes on repairs <ol style="list-style-type: none"> 1. Buckled part is to be cropped and renewed. 2. If corrosion is not the cause, renewal by thicker plate (web and/or face) and/or reinforcement by stiffener and tripping bracket should be considered.

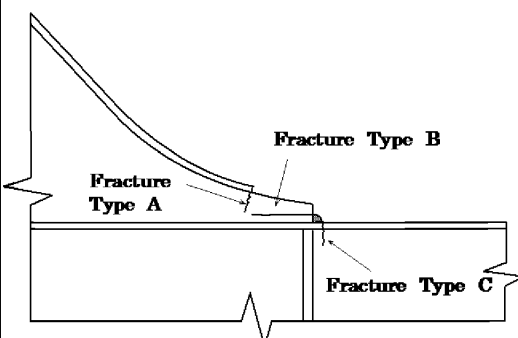
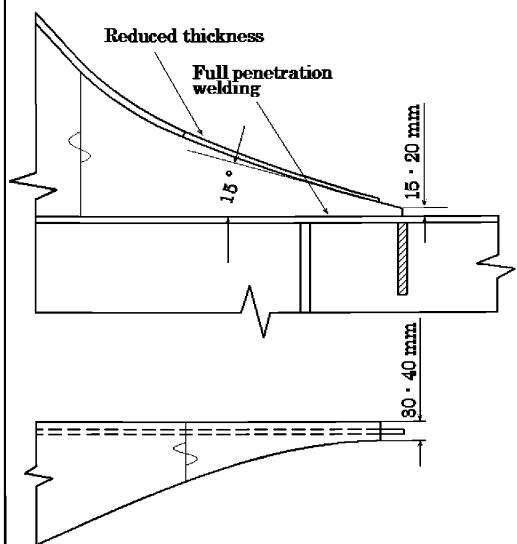
GENERAL DRY CARGO SHIPS		Guidelines for Surveys, Assessment and Repair of Hull Structure
Part 1	Cargo hold region	Example No.
Area 1	Upper deck structure	5-b
Detail of damage		Fractures in continuous longitudinal hatch coaming extension bracket
Sketch of damage

Notes on possible cause of damage <ol style="list-style-type: none"> 1. Flange force at the end of the flange too high due to insufficient tapering (Fracture Type A, propagating in the web). 2. Shear force in the web plate too high due to insufficient reduction of the web height at the end (Fracture Type B, propagating in the web at the undercut or HAZ of the fillet weld). Insufficient support of the extension bracket below the deck (Fracture Type C, starting from undercut or HAZ of the fillet weld and propagating in the deck plating). 		Notes on repairs <ol style="list-style-type: none"> 1. Extend the extension bracket as long as possible to arrange a gradual transition. 2. Reduce the web height at the end of the bracket; in case of high stress areas grind smooth the transition to the deck plating welding. 3. Reduce the cross sectional area of the flange at the end as far as possible. 4. Provide longitudinal structure in way of the web of the extension bracket to the next transverse structure or provide a new transverse structure.

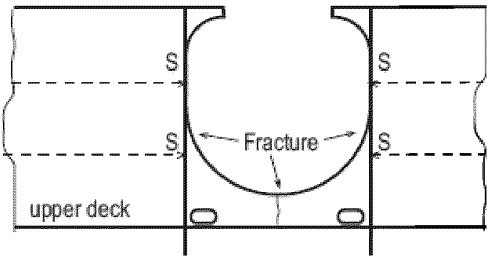
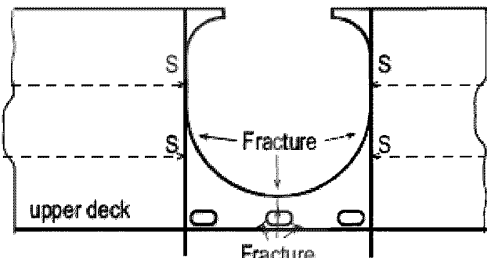
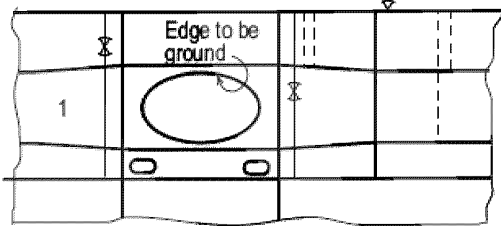
GENERAL DRY CARGO SHIPS		Guidelines for Surveys, Assessment and Repair of Hull Structure
Part 1	Cargo hold region	Example No.
Area 1	Upper deck structure	5-c
Detail of damage	Fracture in access hole of longitudinal hatch coaming	
Sketch of damage		Sketch of repair

Notes on possible cause of damage		Notes on repairs
<p>1. <u>Coincidence of maximum increased stress due to the reduction of the hatch coaming with the metallurgical notches due to the welding seams in web and flat bar located at the same position. Insufficient transverse stiffening.</u></p>		<p>1. <u>Hatch coaming to be continuous.</u> 2. <u>Access opening to be provided.</u> 3. <u>Drain holes to be elliptical and located above fillet weld to deck.</u> 4. <u>Hatch coaming stiffeners of same material as coaming.</u></p>

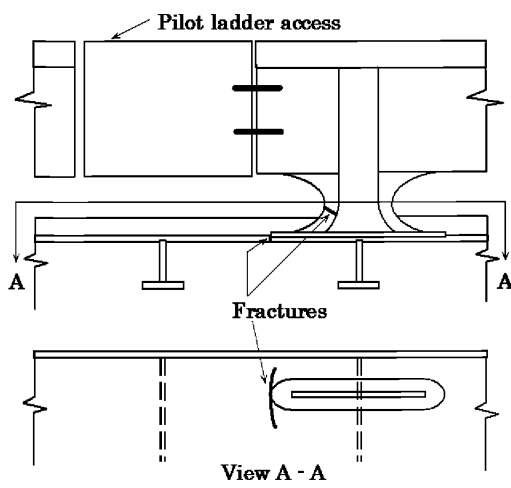
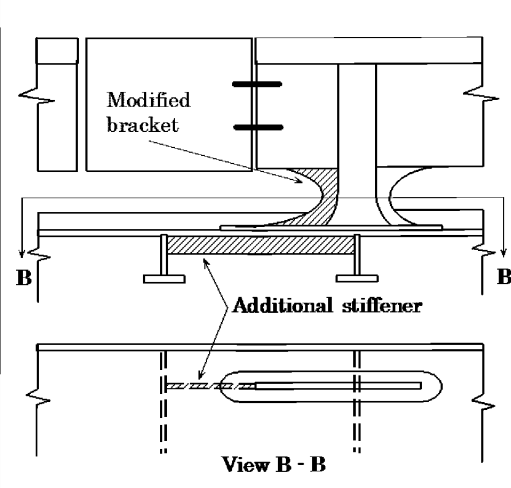
GENERAL DRY CARGO SHIPS		Guidelines for Surveys, Assessment and Repair of Hull Structure
Part 1	Cargo hold region	Example No.
Area 1	Upper deck structure	9
Detail of damage	Fracture in deck plating at the pilot ladder access of bulwarks	
Sketch of damage		Sketch of repair

Notes on possible cause of damage 1. Stress concentration at the termination of bulwarks.		Notes on repairs 1. Fractured deck plating should be cropped and part renewed. 2. Reduction of stress concentration should be considered. In the above figure gusset plate was replaced with soft type for the fracture in gusset plate and pad plate was increased. Additional stiffeners were provided for the fracture in deck plating.

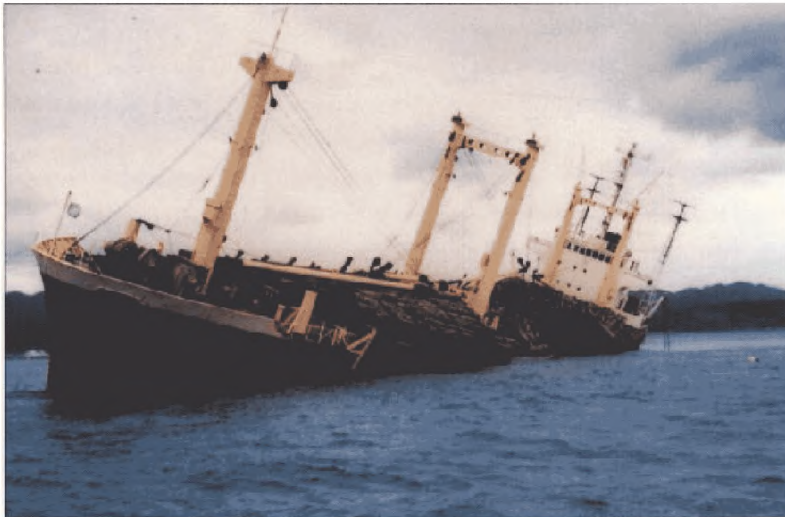
Photograph 2 Timber carrier listing due to ingress of water

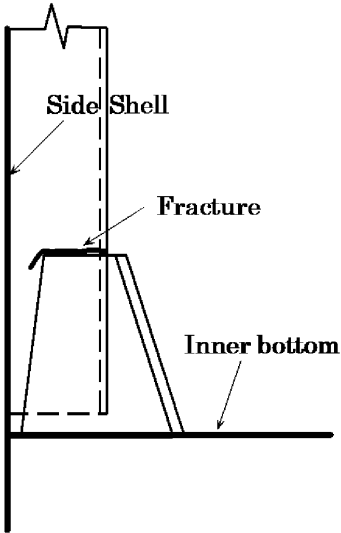
GENERAL DRY CARGO SHIPS		Guidelines for Surveys, Assessment and Repair of Hull Structure
Part 1	Cargo hold region	Example No.
Area 2	Side structure	1
Detail of damage	Fracture in side shell frame at lower bracket	
Sketch of damage

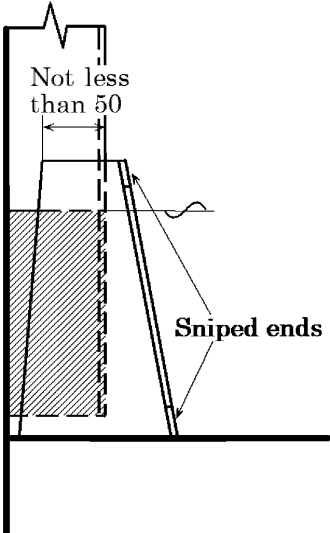
Sketch of repair

Notes on possible cause of damage	Notes on repairs	
1. This type of damage is caused due to stress concentration.	1. For small fractures, e. g. hairline fractures, the fracture can be veed-out, welded up, ground, examined by NDT for fractures, and rewelded. For larger/significant fractures consideration is 2. to be given to cropping and partly renewing/renewing the frame brackets. If renewing the brackets, end of frames can be sniped to soften them. If felt prudent, soft toes are to be incorporated 3. at the boundaries of the bracket to the inner bottom plating.

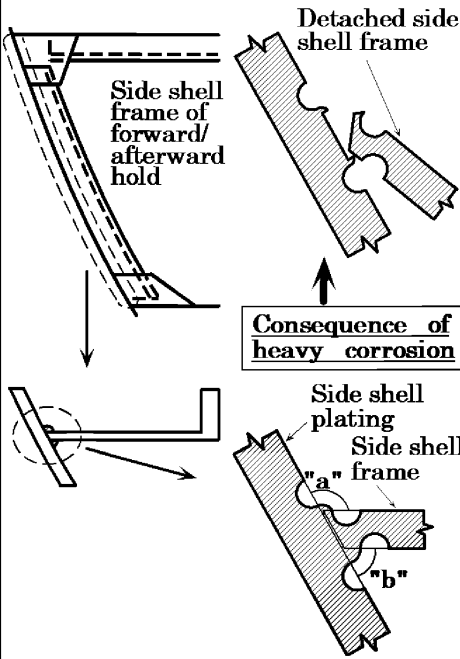
GENERAL DRY CARGO SHIPS		Guidelines for Surveys, Assessment and Repair of Hull Structure
Part 1	Cargo hold region	Example No.
Area 2	Side structure	3
Detail of damage	Adverse effect of corrosion on the frame of forward/afterward hold	
Sketch of damage

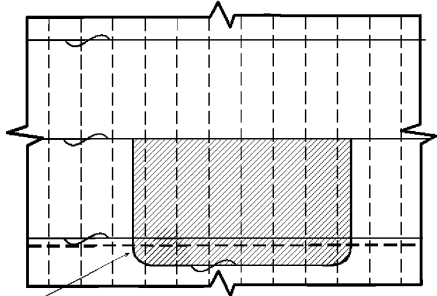
<ol style="list-style-type: none"> 1. Part renewal including side shell frames and inner bottom plating, as found necessary 2. Deep penetration welding at the connections of side shell frames to side shell plating
Notes on possible cause of damage 1. Heavy corrosion (grooving) of side shell frame along side shell plating and difference of throat thickness "a" from "b". (Since original throat thickness of "a" is usually smaller than that of "b", if same welding procedure is applied, the same corrosion has a more severe effect on "a", and may cause collapse and/or detachment of side shell frame.)		Notes on repairs 1. Sketch of repair applies when damage extends over several frames. 2. Isolated fractures may be repaired by veeing-out and rewelding. 3. Isolated cases of grooving may be repaired by build up of welding.

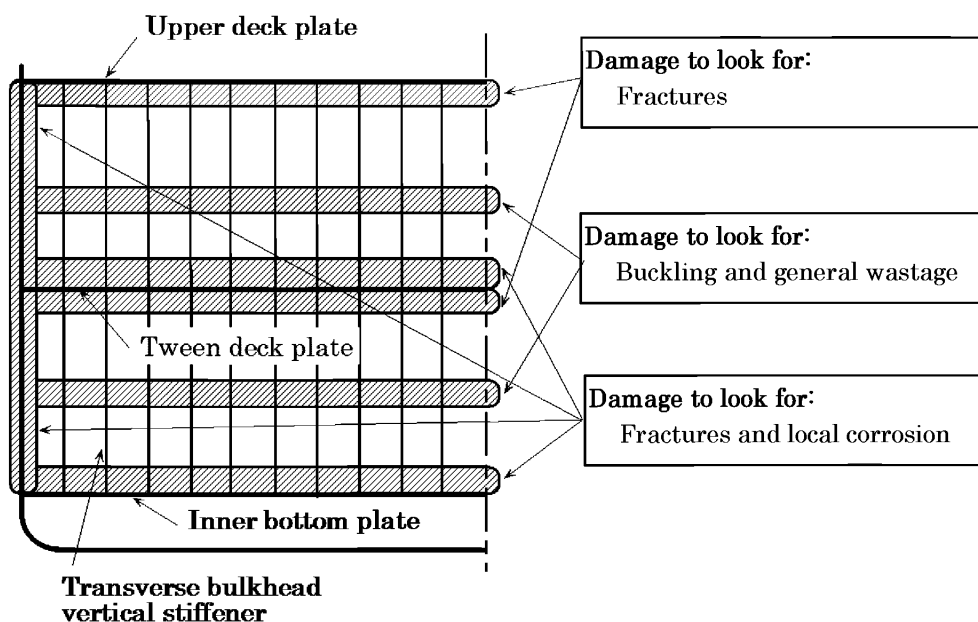
Figure 1 Transverse bulkhead - potential problem areas

- The structure may sometimes appear to be in good condition when it is in fact excessively corroded. In view of this, appropriate access arrangements as indicated in **Chapter 4 Survey planning, preparation and execution** of the Guidelines guidelines, should be provided to enable a proper close-up inspection and thickness measurement (See **Figure 1**).

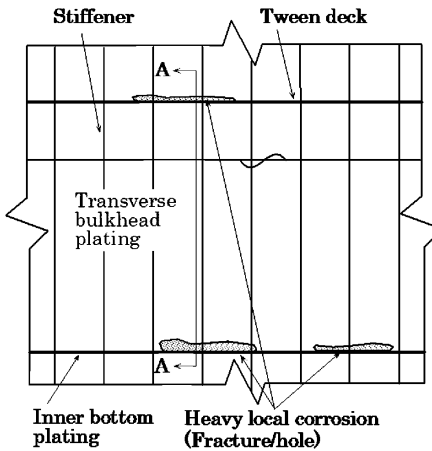
GENERAL DRY CARGO SHIPS		Guidelines for Surveys, Assessment and Repair of Hull Structure	
Part 1	Cargo hold region	Example No.	
Area 3	Transverse bulkhead structure	1	
Detail of damage		Corrosion along inner bottom or tween deck plating	
Sketch of damage

<p>Stiffener</p> <p>Tween deck</p> <p>A</p> <p>Transverse bulkhead plating</p> <p>Inner bottom plating</p> <p>Heavy local corrosion (Fracture/hole)</p> <p>Note: Regarding "View A-A", refer to Example 2 of Area 2 of this part</p>		Sketch of repair

- 2.1.1 Heavy wastage along the boundaries at ship's sides and at transverse bulkheads may occur as a result of seawater accumulated from wet cargo due to poor drainage. Such damages are related to those suffered at the lower end of side structures and transverse bulkhead structures (See **Area 2, Example 2** and **Area 3, Example 1**).

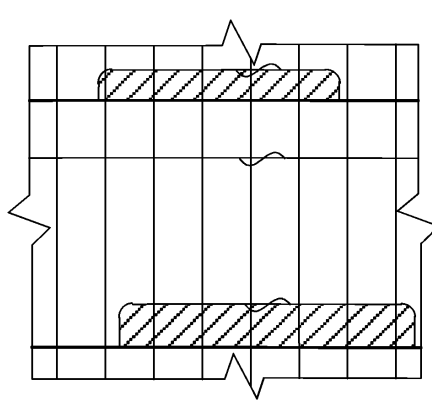
Notes on possible cause of damage <ol style="list-style-type: none"> 1. Heavy corrosion including grooving along inner bottom plating or tween deck due to poor drainage. 		Notes on repairs <ol style="list-style-type: none"> 1. The extent of the renewal should be determined carefully. If the renewal plate (original thickness) is welded to thin plate (corroded plate), it may cause stress concentration and cause fracture. 2. Protective coating should be applied.

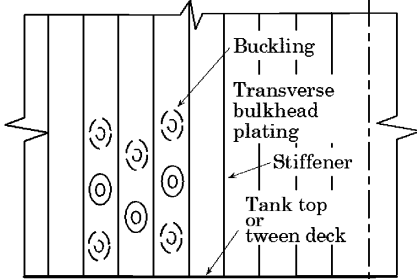
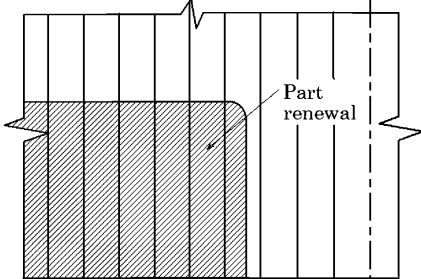
GENERAL DRY CARGO SHIPS		Guidelines for Surveys, Assessment and Repair of Hull Structure	
Part 1	Cargo hold region	Example No.	
Area 3	Transverse bulkhead structure	2	
Detail of damage		Shear Buckling in transverse bulkhead	
Sketch of damage		Sketch of repair

Notes on possible cause of damage		Notes on repairs	
1. Heavy general corrosion.		1. The extent of the renewal should be determined carefully. If the renewal plating (original thickness) is welded to thin plating (corroded plating), it may cause stress concentration and fracture. 2. Protective coating should be applied.

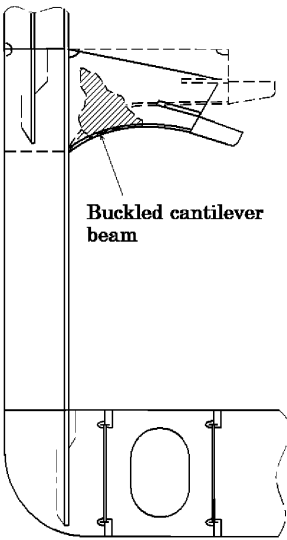
GENERAL DRY CARGO SHIPS		Guidelines for Surveys, Assessment and Repair of Hull Structure	
Part 1	Cargo hold region	Example No.	
Area 4	Tween deck structure	1	
Detail of damage		Sagging of deck panel/buckling of cantilever beam	
Sketch of damage

<p>Buckled cantilever beam</p>		Sketch of repair <div style="display: flex; justify-content: space-around;"> <div style="text-align: center;"> <p>Repair A</p>

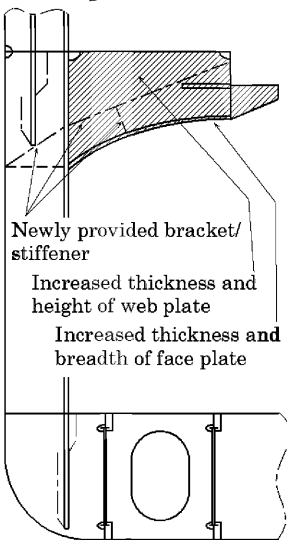
<p>Newly provided bracket/stiffener</p> <p>Increased thickness and height of web plate</p> <p>Increased thickness and breadth of face plate</p> </div> <div style="text-align: center;"> <p>Repair B</p>

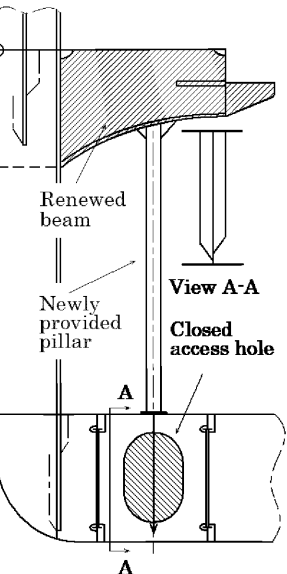
<p>Renewed beam</p> <p>Newly provided pillar</p> <p>View A-A</p> <p>Closed access hole</p> </div> </div>	
Notes on possible cause of damage 1. Poor design, overloading and/or excessive inertia force caused in heavy weather.		Notes on repairs 1. The affected structures are to be cropped and renewed. 2. Repair A: Reinforcement should be considered by increased scantlings of beam and/or additional stiffeners. 3. Repair B: Pillars may be provided for reinforcement subject to the approval of the owner. In such a case, reinforcement of the floor under the pillar should be considered. (In the above example, access hole was closed.)

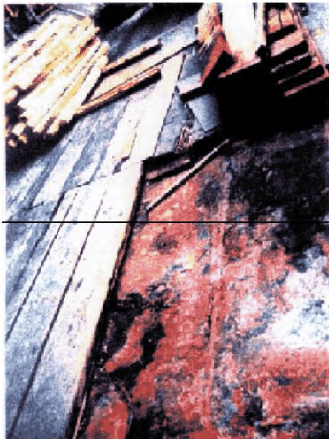
Photograph 1
Fractured inner bottom plating due to heavy corrosion on both sides

- 2.1.2 When the tank top plating has been covered with dunnage or ceiling the plating may have suffered heavy corrosion, due to high humidity, and lack of proper maintenance (See **Photograph 1**).

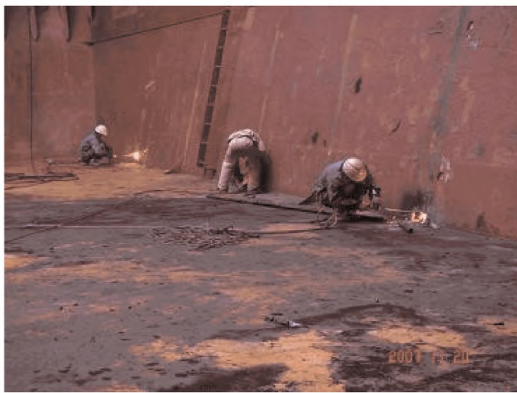
Photograph 1 Heavy corrosion affecting inner bottom plating

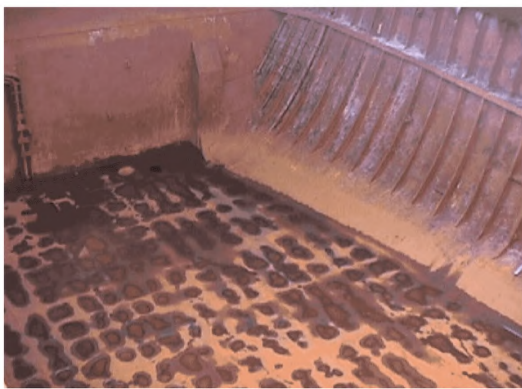
Photograph 2 Damaged inner bottom plating

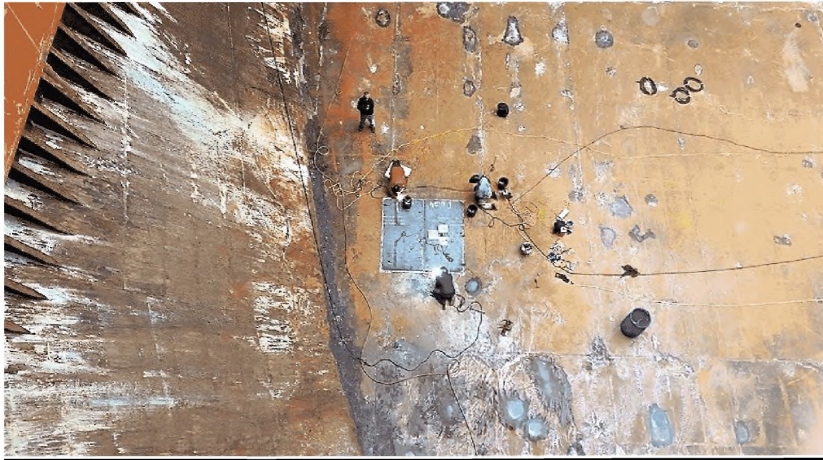
Photograph 3 Repairs of damaged inner bottom plating

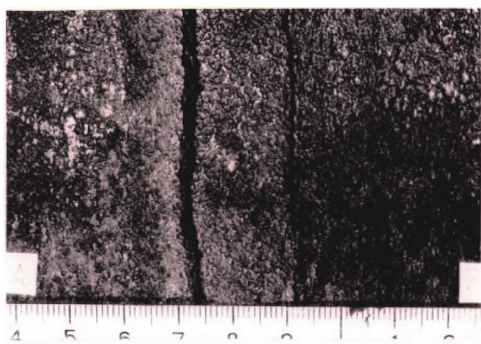
Photograph 24
Grooving corrosion of welding of bottom plating

- 4.1.1 Hull structure below the water line can usually be inspected only when the ship is dry-docked. Therefore, the structure should be inspected carefully, taking into account the period until the next scheduled dry-docking. The level of wastage of the bottom plating may have to be established by means of thickness measurements.
- 4.1.2 Severe grooving along welding of bottom plating is often found (See **Photographs 24** and **35**). This grooving can be accelerated by poor maintenance of the protective coating and/or sacrificial anodes fitted to the bottom plating.
- 4.1.3 Bottom or “docking” plugs should be carefully examined for excessive corrosion along the edge of the weld connecting the plug to the bottom plating.

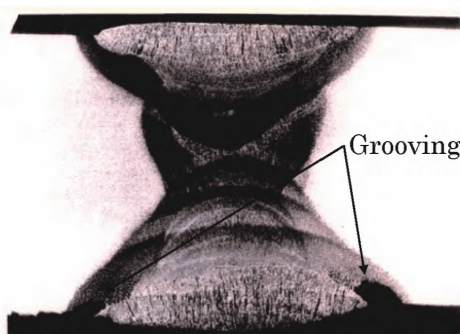
Photograph 35
Section of the grooving shown in Photograph 24

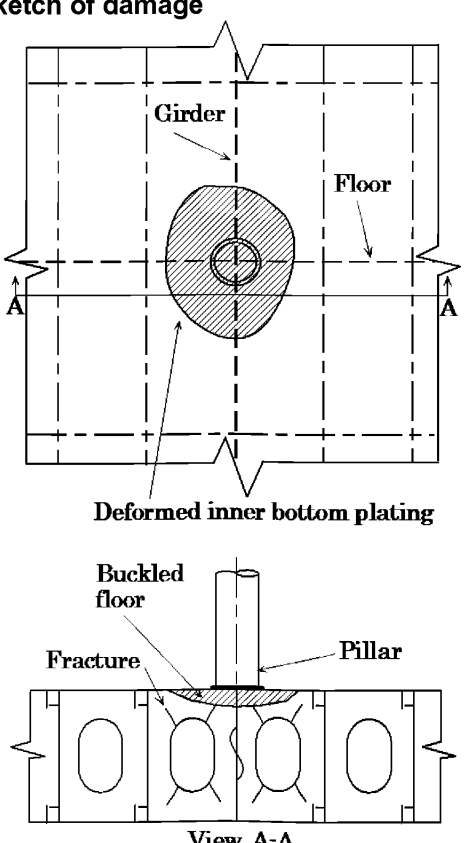
GENERAL DRY CARGO SHIPS		Guidelines for Surveys, Assessment and Repair of Hull Structure
Part 1	Cargo hold region	Example No.
Area 5	Double bottom structure	2
Detail of damage	Dented inner bottom plating and buckled/fractured floor under pillar	
<p>Sketch of damage</p>

<p>View A-A</p>		<p>Sketch of repair</p>

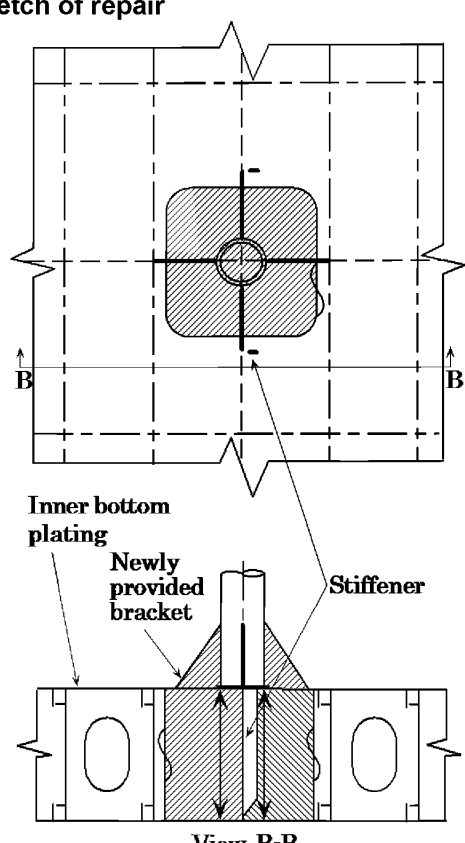
<p>View B-B</p>
<p>Notes on possible cause of damage</p> <ol style="list-style-type: none"> 1. Inadequate arrangement and/or reinforcement of access holes. 2. Excessive deck-loading on tween deck. 		<p>Notes on repairs</p> <ol style="list-style-type: none"> 1. Dented inner bottom plating is to be cropped and part renewed. 2. The fractured floor is to be cropped and part renewed. 3. Access holes should be closed by insert plates. 4. Stiffener on floor/girder and/or brackets should be considered. (Fitting of brackets in the hold is subject to the agreement of the owner.)

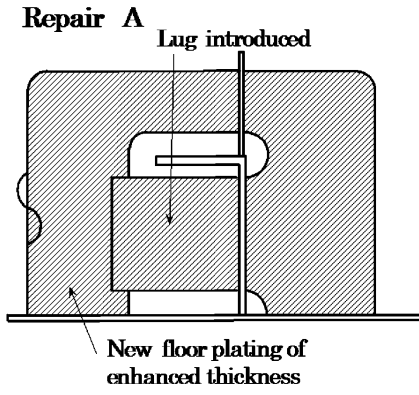
<p>Note: same type of damage may occur at similar connections to inner bottom</p>	
Sketch of repair	<p>Repair A</p>

Notes on possible cause of damage	<p>1. Damage can be caused by general levels of corrosion and presence of stress concentration associated with the presence of a cut-out.</p>	
Notes on repairs	<p>1. If fractures are significant then crop and part renew the floor plating otherwise the fracture can be veed-out and welded provided the plating is not generally corroded.</p> <p>Repair B is to be incorporated if the lug proves to be ineffective.</p> <p>2.</p>

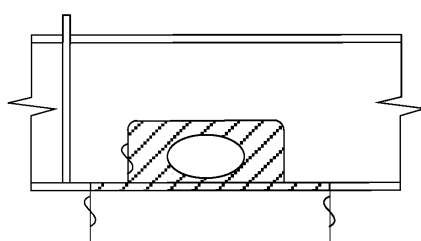
<p>The sketch shows a cross-sectional view of the double bottom structure. The fractured plating at the corner of the drain hole is shaded with diagonal lines, indicating it has been cropped and replaced with new plating. The drain hole is shown as a semi-circular opening in the bottom shell plating.</p>

Notes on possible cause of damage		Notes on repairs	
<ol style="list-style-type: none"> 1. Stress concentration and/or corrosion due to stress concentration at the corner of drain hole/air hole. 		<ol style="list-style-type: none"> 1. Fractured plating should be cropped and part renewed. 2. If fatigue life is to be improved, change of drain hole/air hole shape is to be considered.

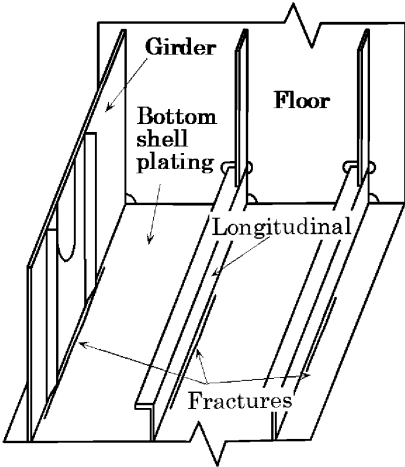
GENERAL DRY CARGO SHIPS		Guidelines for Surveys, Assessment and Repair of Hull Structure
Part 1	Cargo hold region	Example No.
Area 5	Double bottom structure	6
Detail of damage	Fracture in bottom shell plating along side girder and/or bottom longitudinal	
Sketch of damage

Notes on possible cause of damage	Notes on repairs	
1. Vibration.	<ol style="list-style-type: none"> 1. Fractured bottom shell plating should be cropped and renewed. 2. Natural frequency of the panel should be changed, e.g. reinforcement by additional stiffener/bracket.

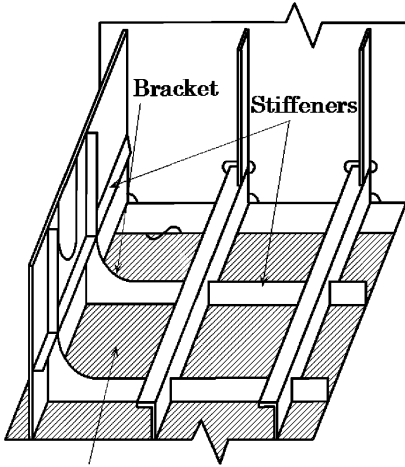
Sketch of repair

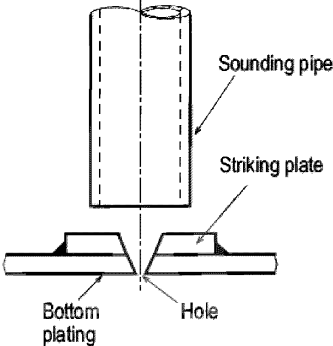
GENERAL DRY CARGO SHIPS		Guidelines for Surveys, Assessment and Repair of Hull Structure	
Part 1	Cargo hold region	Example No.	
Area 5	Double bottom structure	9	
Detail of damage		Corrosion in bottom plating below sounding pipe	
Sketch of damage		Sketch of repair

<p>Sounding pipe</p> <p>Striking plate</p> <p>Bottom plating</p> <p>Hole</p>		<p>Repair A</p>

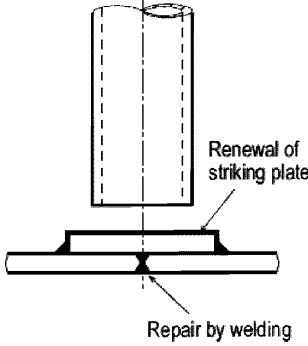
<p>Renewal of striking plate</p> <p>Repair by welding</p> <p>Repair B</p>

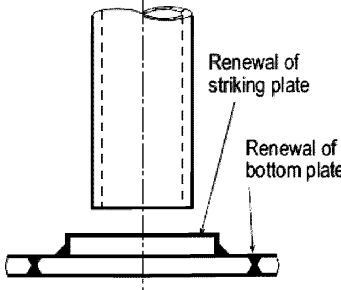
<p>Renewal of striking plate</p> <p>Renewal of bottom plate</p>	
Notes on possible cause of damage		Notes on repairs	
<ol style="list-style-type: none"> Accelerated corrosion of striking plate by the striking of the weight of the sounding tape. 		<ol style="list-style-type: none"> Corroded bottom plating should be welded or partly cropped and renewed if considered necessary. Corroded striking plate should be renewed.

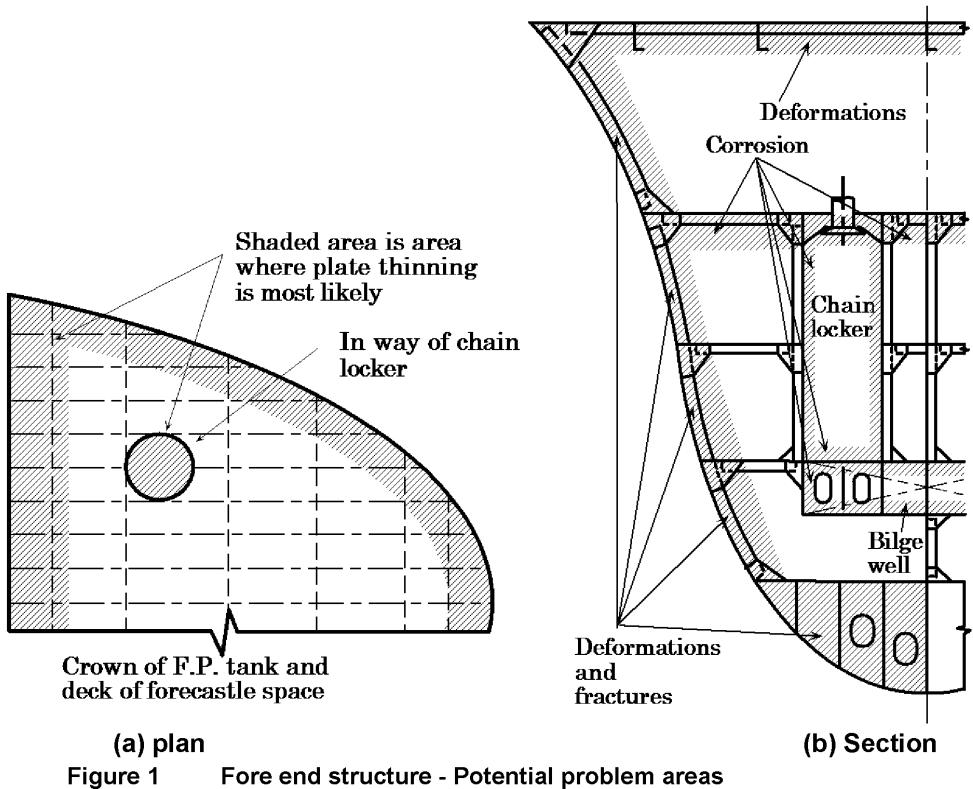
- 2.1.1 Wastage (and possible subsequent fractures) is more likely to show initially in locations as indicated in **Figure 1**. A close-up inspection should be carried out. In addition, a representative selection of thickness measurements should be taken with particular attention being given to locations such as chain lockers.
- 2.1.2 Structure in chain lockers is liable to have heavy corrosion because of mechanical damage to the protective coating by anchor chains. In some ships, e.g. relatively small ships, side shell plating may form boundaries of the chain lockers. Consequently, heavy corrosion may result in a hole in the side shell plating.

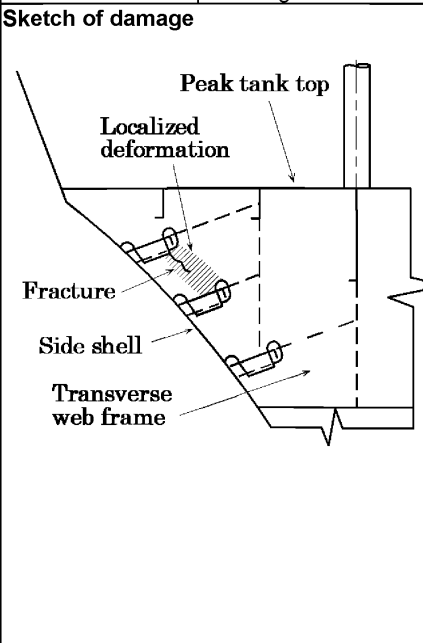
GENERAL DRY CARGO SHIPS		Guidelines for Surveys, Assessment and Repair of Hull Structure	
Part 2	Fore and aft end regions		Example No.
Area 1	Fore end structure		1
Detail of damage	Fracture and deformation of bow transverse web in way of cut-outs for side longitudinals		
Sketch of damage

Notes on possible cause of damage	Notes on repairs		
<ol style="list-style-type: none"> 1. Localized material wastage in way of coating failure at cut-outs and sharp edges due to working of the structure. 2. Dynamic seaway loading in way of bow flare. 	<ol style="list-style-type: none"> 1. Sufficient panel strength to be provided to absorb the dynamic loads enhanced by bow flare shape.

3.3.1 In the case of fractures caused by sea-loads the structure should be cropped and renewed. Increased thickness of plating and/or design modification to reduce stress concentrations should be considered (See **Examples 1, 2 and 6**).

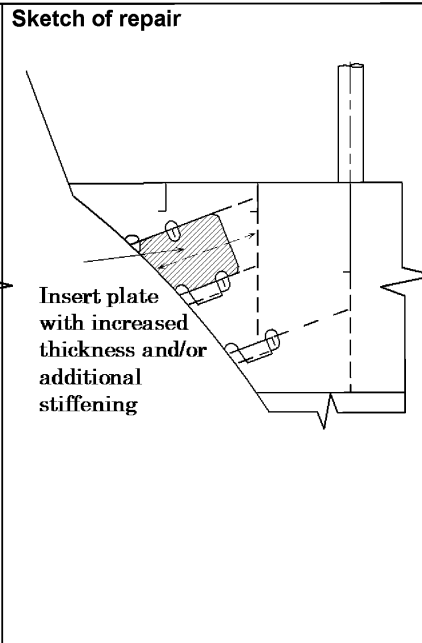
Sketch of repair

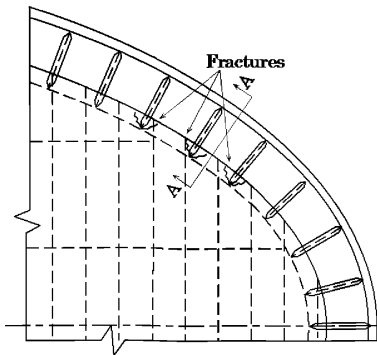
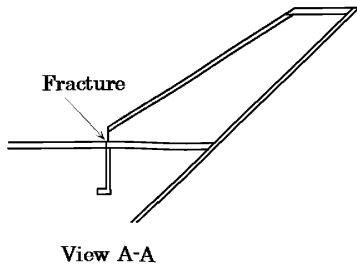
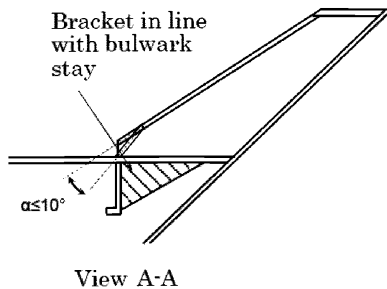
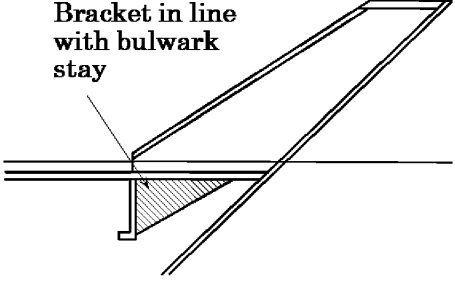
Detail of damage	Fracture in forecastle deck plating at bulwark
-------------------------	--

Sketch of damage	Sketch of repair
-------------------------	-------------------------

<p>Bracket in line with bulwark stay</p>

<p>View A-A</p>
<p>Notes on possible cause of damage</p> <ol style="list-style-type: none"> 1. Bow flare effect in heavy weather. 2. Stress concentration due to poor design. 	<p>Notes on repairs</p> <ol style="list-style-type: none"> 1. Fractured deck plating should be cropped and renewed. 2. Bracket in line with the bulwark stay to be fitted to reduce stress concentration. 3. <u>The lower end of the bulwark bracket flange to be reshaped in order to avoid the sniper end.</u>

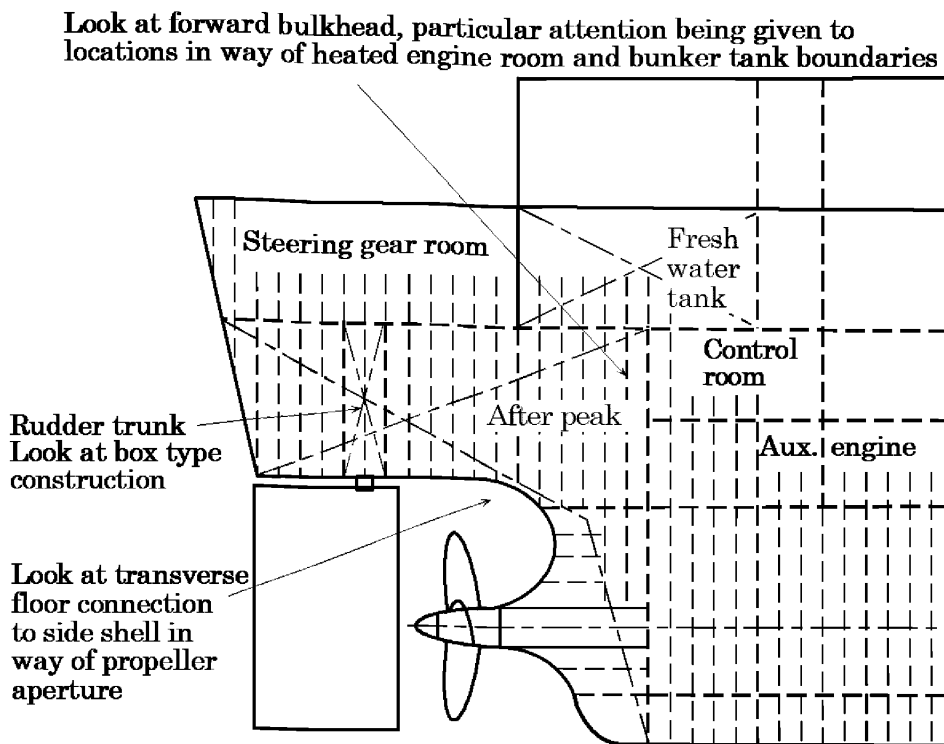
Figure 1 Aft end structure - Potential problem areas

- 2.1.1 Wastage (and possible subsequent fractures) is more likely to show initially in locations as indicated in **Figure 1**. A close-up inspection should be carried out. In addition, a representative selection of thickness measurements should be taken with particular attention being given to locations such as bunker tank boundaries and spaces adjacent to heated engine rooms.

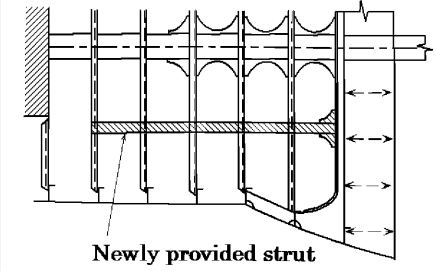
<p>View A - A</p>		Sketch of repair

<p>Newly provided strut</p>	
Notes on possible cause of damage 1. Vibration.		Notes on repairs 1. The fractured plating should be cropped and renewed. 2. Natural frequency of the panel should be changed, e.g. reinforcement by additional strut.

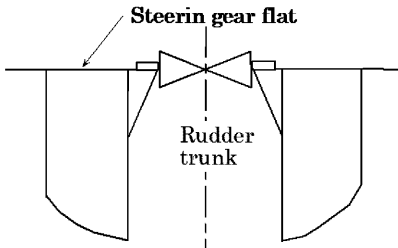
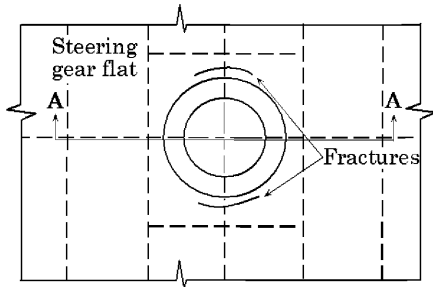
Detail of damage	Fractures in flat where rudder carrier is installed in steering gear room
-------------------------	--

Sketch of damage

View A - A

- 3.3.1 Repairs of main engines and propeller excited vibration damage should be made by returning the structure to its original condition. In order to prevent recurrence of the damage the cause of the vibration should be ascertained and additional reinforcements provided as found necessary (See **Examples 1 and 2**).
- 3.3.2 Fractured structure which supports the rudder carrier is to be cropped and renewed, and may have to be reinforced (See **Example 3**).

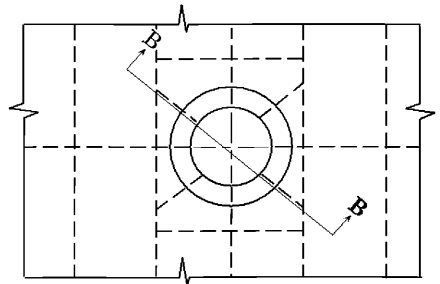
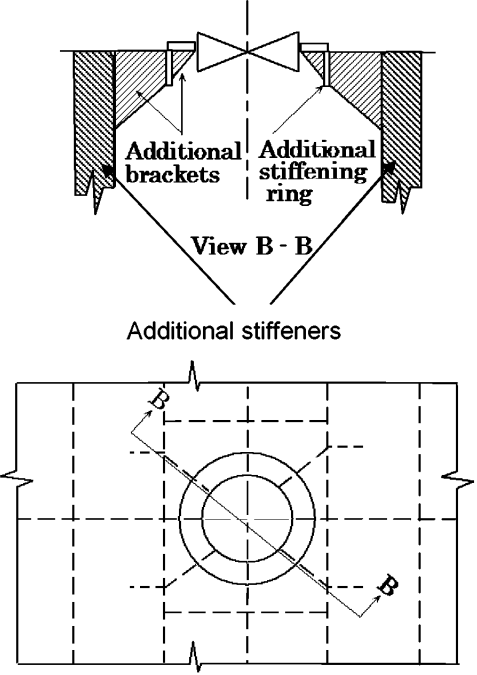
Sketch of repair

View B - B

<p>Additional brackets Additional stiffening ring</p> <p>View B - B</p> <p>Additional stiffeners</p>
<p>Notes on possible cause of damage</p> <ol style="list-style-type: none"> 1. Inadequate design. 	<p>Notes on repairs</p> <ol style="list-style-type: none"> 1. Fractured plating should be cropped and renewed. 2. Additional brackets, <u>stiffeners</u> and stiffening ring should be fitted for reinforcement.

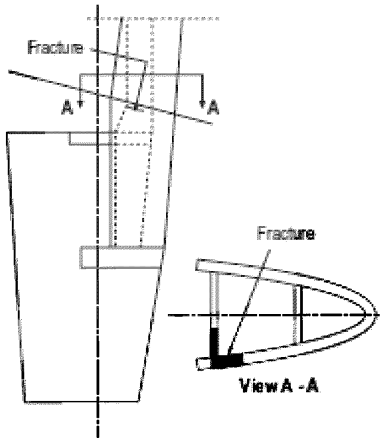
GENERAL DRY CARGO SHIPS		Guidelines for Surveys, Assessment and Repair of Hull Structure	
Part 2	Fore and aft end regions	Example No.	
Area 2	Aft end structure	3-c	
Detail of damage		Stern frame, rudder arrangement and propeller shaft support	
<p>Sketch of damage</p>

<p>Notes on possible cause of damage</p> <ol style="list-style-type: none"> 1. Insufficient strength due to poor design. 		<p>Notes on repairs</p> <ol style="list-style-type: none"> 1. Fractured plating to be veed-out and re-welded. 2. Fractured plating to be cropped and renewed if considered necessary. 3. Reinforcement should be considered if deemed necessary.

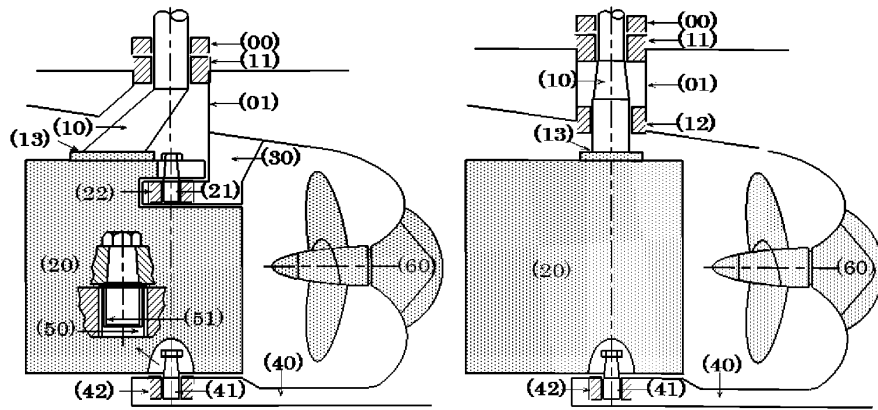
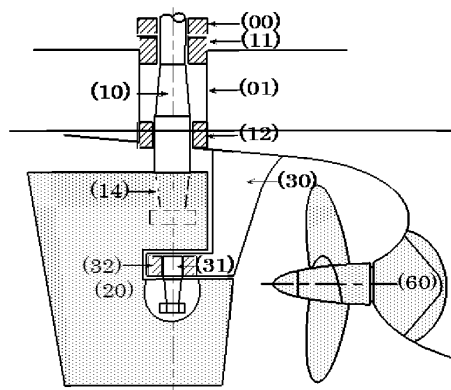
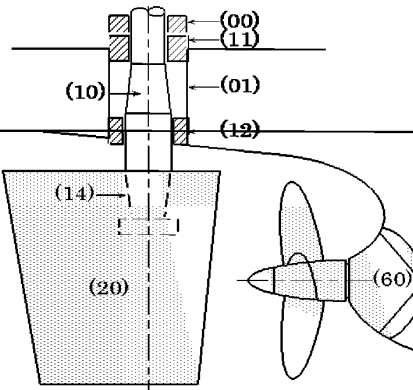
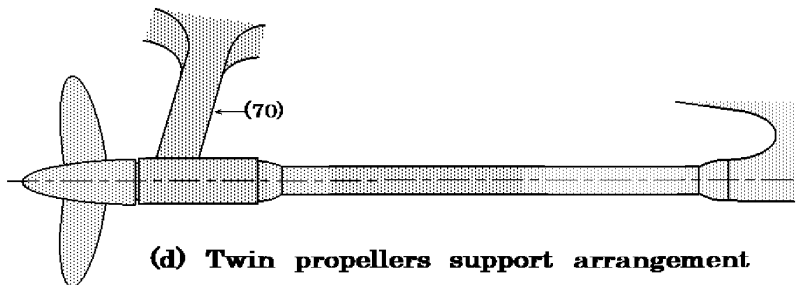
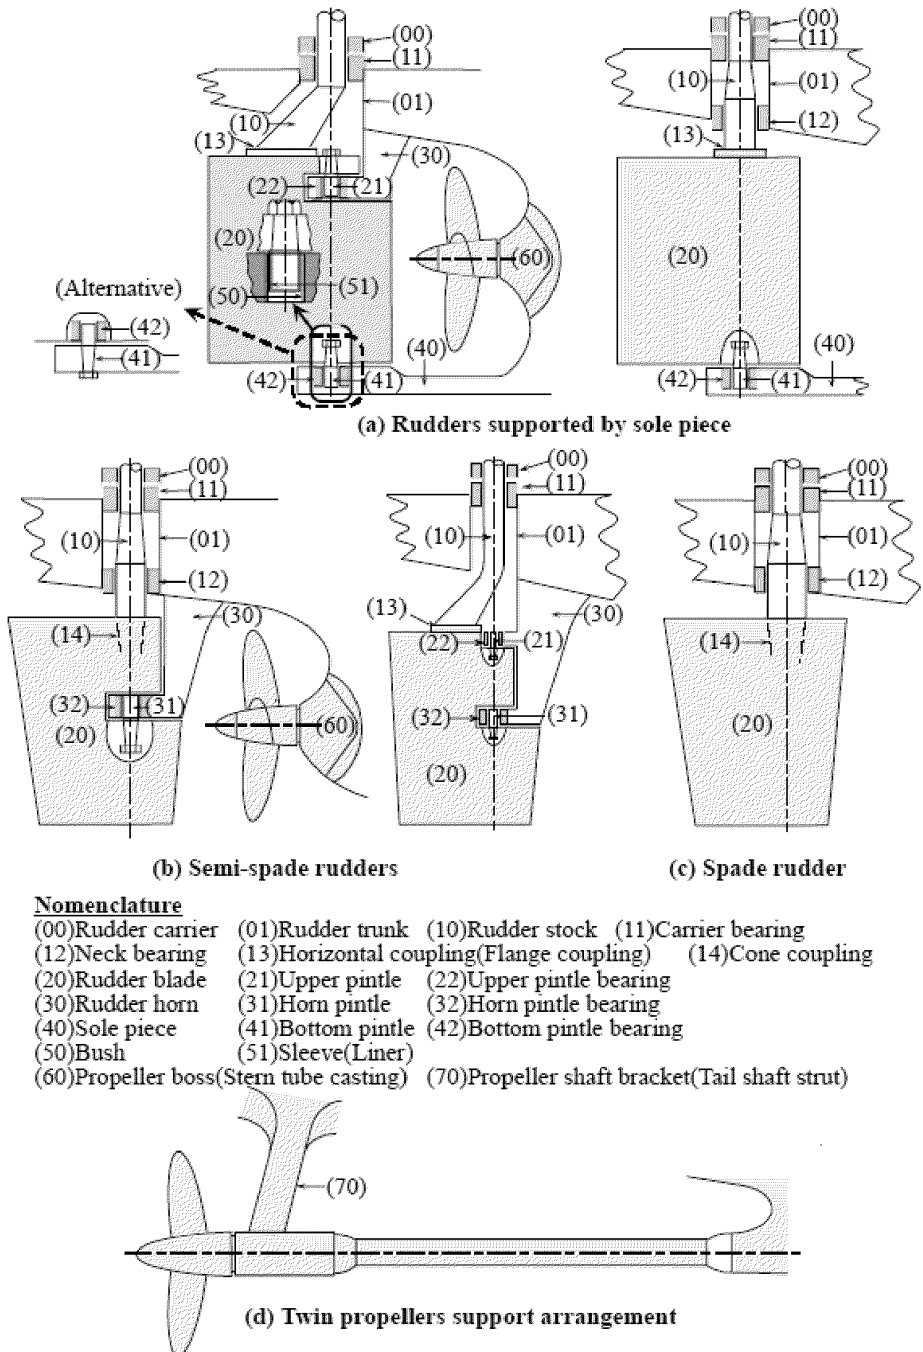
(a) Rudders supported by sole piece

- (00) Rudder carrier
- (01) Rudder trunk
- (10) Rudder stock
- (11) Carrier bearing
- (12) Neck bearing
- (13) Horizontal coupling (Flange coupling)
- (14) Cone coupling
- (20) Rudder blade
- (21) Upper pintle
- (22) Upper pintle bearing
- (30) Rudder horn
- (31) Horn pintle
- (32) Horn pintle bearing
- (40) Sole piece
- (41) Bottom pintle
- (42) Bottom pintle bearing
- (50) Bush
- (51) Sleeve (Liner)
- (60) Propeller boss (Stern tube casting)
- (70) Propeller shaft bracket (Tail shaft strut)

(b) Semi-spade rudder (or Mariner rudder)

(c) Spade rudder

(d) Twin propellers support arrangement

Figures and/or Photographs - Area 3	
No.	Title
Figure 1	Nomenclature for stern frame, rudder arrangement and propeller shaft support
Figure 2	Potential problem areas
Photograph 1	Fractured rudder due to corrosion in rudder plating
Figure 3	Rudder stock repair by welding
Diagram 1	Preheating temperature
