ПРОЦЕДУРНЫЕ ТРЕБОВАНИЯ,
УНИФИЦИРОВАННЫЕ ИНТЕРПРЕТАЦИИ
И РЕКОМЕНДАЦИИ
МЕЖДУНАРОДНОЙ АССОЦИАЦИИ
КЛАССИФИКАЦИОННЫХ ОБЩЕСТВ

GENERAL DRY CARGO SHIPS

Guidelines for
Surveys, Assessment and Repair
of Hull Structure

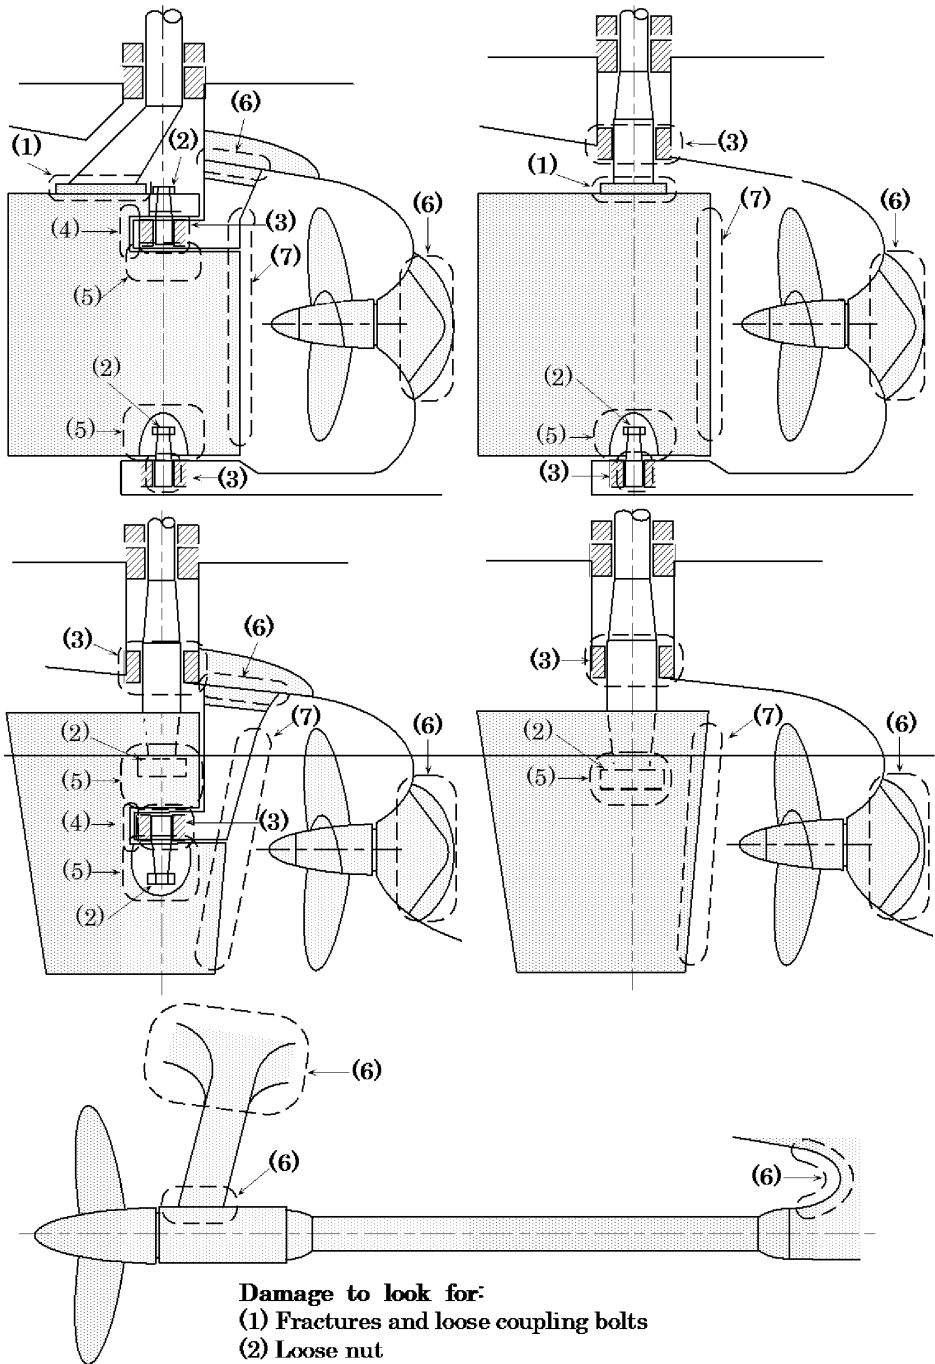
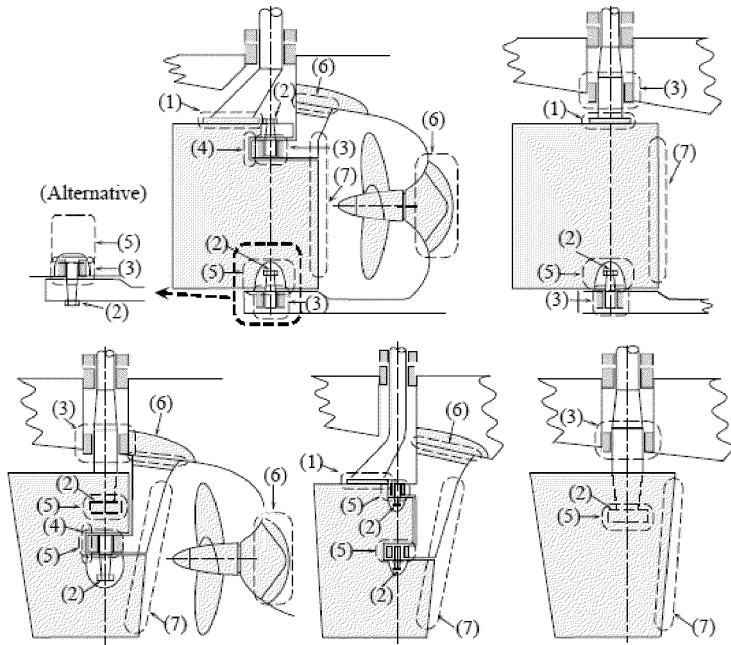
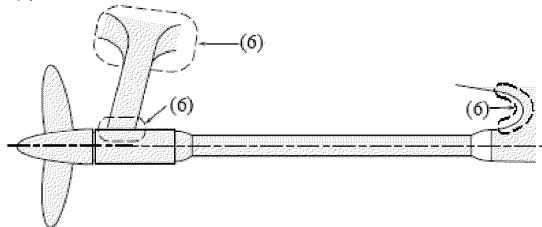
Figure 2 Potential problem areas

Damage to look for:

- (1) Fractures and loose coupling bolts
- (2) Loose nut
- (3) Wear (excessive bearing clearance)
- (4) Fractures in way of pintle cutout
- (5) Fractures in way of removable access plate
- (6) Fractures
- (7) Erosion

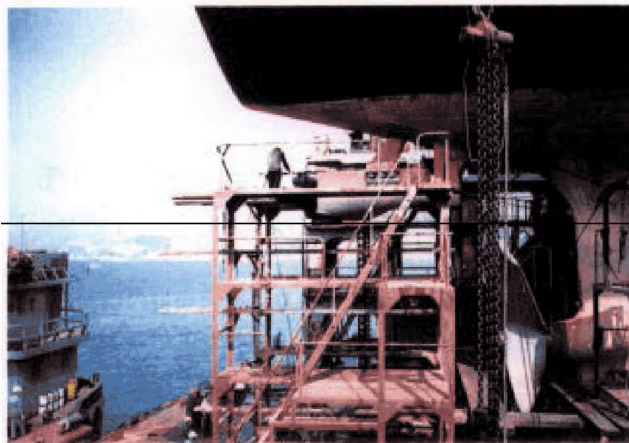
Photograph 1
Fractured rudder due to corrosion in rudder plating

Corrosion/erosion (such as deep pitting corrosion) should be looked for in rudder/rudder horn, especially in welds. In extreme cases the corrosion /erosion may cause a large fracture as shown in **Photograph 1**.

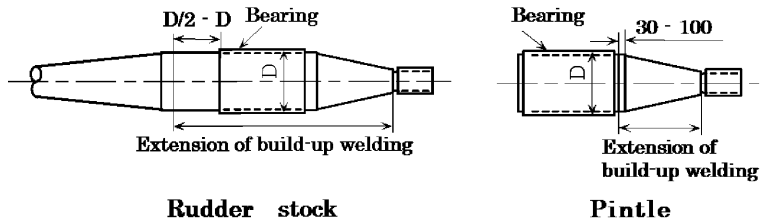
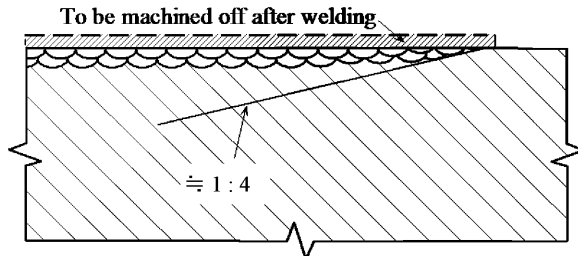
Figure 3 Rudder stock repair by welding

Rudder stocks and/or pintles may be repaired by welding replacing wasted material by similar weld material. After removal of the wasted area (corrosion, scratches, etc.) by machining and/or grinding the build-up welding has to be carried out by an automatic spiral welding according to an approved welding procedure. The welding has to be extended over the area of large bending moments (rudder stocks). In special cases post weld heat treatment has to be carried out according to the requirements of the Classification Society. After final machining, a sufficient number of layers of welding material have to remain on the rudder stock/pintle. A summary of the most important steps and conditions of this repair is shown in the **Figure 3**.

- Removal of the wasted area by machining and/or grinding, non-destructive examination for fractures (magnetic particle inspection preferred)
- Build-up welding by automatic spiral welding (turning device) according to an approved welding procedure (weld process, preheating, welding consumables, etc.)
- Extension of build-up welding over the area of **large bending moments (shafts)** according to the sketch

- Sufficient number of weld layers to compensate removed material, at least one layer in excess (heat treatment of the remaining layer)
- Transition at the end of the build-up welding according to the following sketch

- Post weld heat treatment if required in special cases (never for stainless steel cladding on ordinary steel)
- Final machining, at least two layers of welding material have to remain on the rudder stock (See the above sketch)
- Non-destructive fracture examination

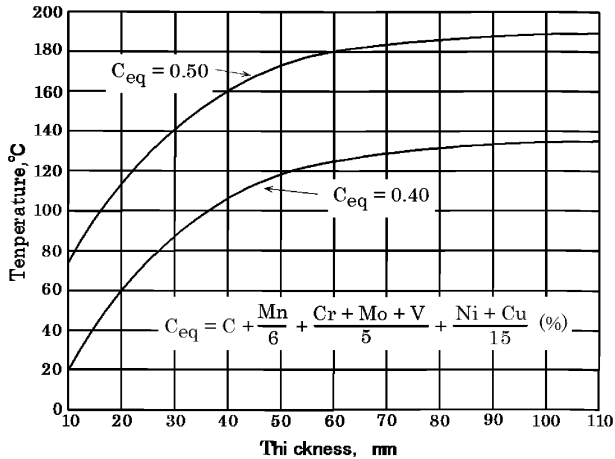
Diagram 1 Preheating temperature

- 3.2.4 For the fractures at the connection between plating and cast pieces adequate pre-heating is necessary. The pre-heating temperature is to be determined taking into account the following parameters:
- chemical composition (carbon equivalent C_{eq})
 - thickness of the structure
 - hydrogen content in the welding consumables
 - heat input
- 3.2.5 As a guide, the preheating temperature can be obtained from **Diagram 1** using the plate thickness and carbon equivalent of the thicker structure.
- 3.2.6 All welding repairs are to be carried out using qualified/approved welding procedures.

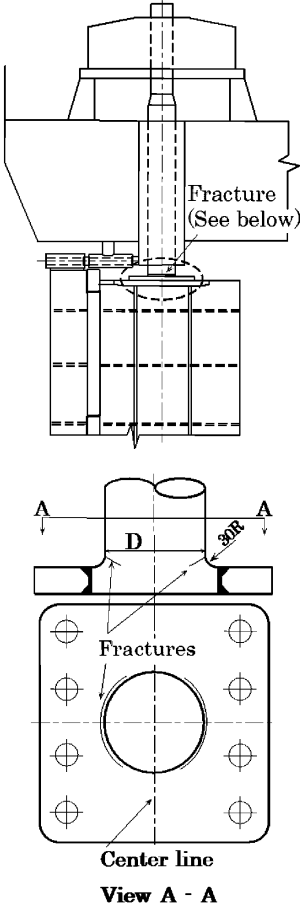
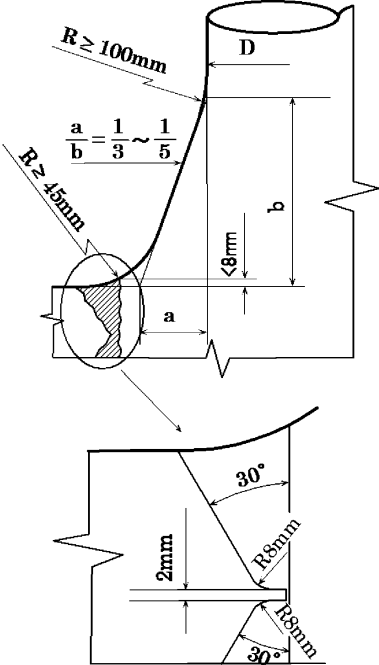
GENERAL DRY CARGO SHIPS		Guidelines for Surveys, Assessment and Repair of Hull Structure	
Part 2	Fore and aft end regions	Example No.	
Area 3	Stern frame, rudder arrangement and propeller shaft support	1	
Detail of damage		Fracture in rudder stock	
Sketch of damage		Sketch of repair

Notes on possible cause of damage		Notes on repairs	
1. Inadequate design for stress concentration in rudder stock.		1. Modification of detail design of rudder stock to reduce the stress concentration.

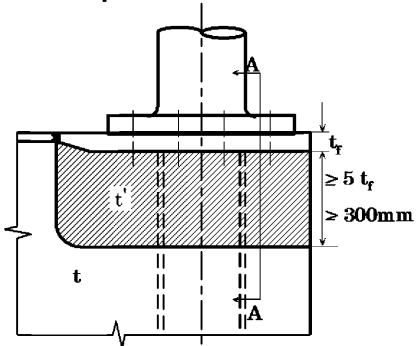
GENERAL DRY CARGO SHIPS		Guidelines for Surveys, Assessment and Repair of Hull Structure
Part 2	Fore and aft end regions	Example No.
Area 3	Stern frame, rudder arrangement and propeller shaft support	2
Detail of damage		Fracture in connection of palm plate to rudder blade
Sketch of damage		Sketch of repair

<p style="text-align: center;">View A - A</p>

<p>Full penetration weld</p> <p>Backing bar fully welded before closing</p> <p>t = plate thickness, mm t_r = actual flange thickness, mm $t' = \frac{t_r}{3} + 5$, mm, where $t_r < 50$mm $t' = 3 \sqrt{t_r}$, mm, where $t_r \geq 50$mm</p>
Notes on possible cause of damage		Notes on repairs

1. Inadequate connection between palm plate and rudder blade plating (insufficient plating thickness and/or insufficient fillet weld).		1. Modification of detail design of the connection by increasing the plate thickness and full penetration welding.

- 2.2.4 Fractures should be looked for at the transition radius between rudder stock and horizontal coupling (palm) plate, and the connection between horizontal coupling plate and rudder blade in case of horizontal coupling. Typical fractures are shown in **Examples 1 and 2**. Fatigue fractures should be looked for at the palm plate itself in case of loosened or lost coupling bolts.

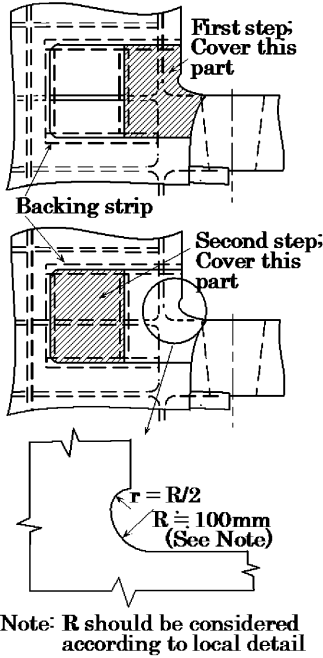
GENERAL DRY CARGO SHIPS		Guidelines for Surveys, Assessment and Repair of Hull Structure
Part 2	Fore and aft end regions	Example No.
Area 3	Stern frame, rudder arrangement and propeller shaft support	4
Detail of damage	Fracture in rudder plating of semi-spade rudder extending beyond the vertical web	
<p>Sketch of damage</p>

<p>Sketch of repair</p>

<p>Notes on possible cause of damage</p> <ol style="list-style-type: none"> 1. Stress concentration due to inadequate local design and/or fabrication notches in way of the butt weld between cast piece and plating. 		<p>Notes on repairs</p> <ol style="list-style-type: none"> 1. Fractured plating is to be cut-out. 2. Internal structures are to be checked. 3. Cut-out is to be closed by an insert plating according to the sketch (welding only from one side is demonstrated). 4. Modification of the radius. 5. In case of a new cast piece, connection with the plating is to be shifted outside the high stress area.

In case of longer fatigue fractures starting in the lower and/or upper corners of the pintle recess of semi-spade rudders that propagate over a longer distance into the plating, thorough check of the internal structures has to be carried out. The fractured parts of the plating and internal structures, if necessary, have to be replaced by insert plates. A proper welding connection between the insert plate and the internal stiffening structure is very important (See **Examples 4 and 5**).

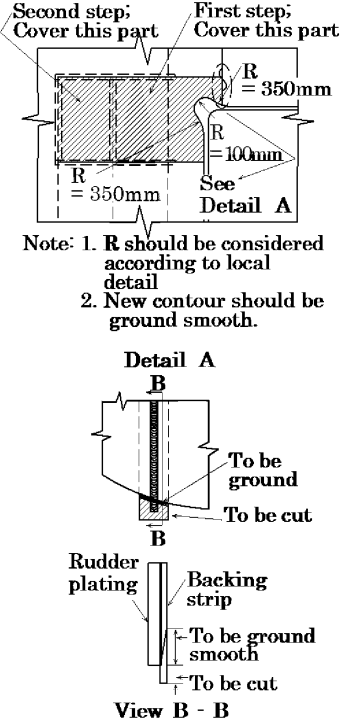
GENERAL DRY CARGO SHIPS		Guidelines for Surveys, Assessment and Repair of Hull Structure
Part 2	Fore and aft end regions	Example No.
Area 3	Stern frame, rudder arrangement and propeller shaft support	5
Detail of damage Fracture in rudder plating of semi-spade rudder in way of pintle cutout		
Sketch of damage		Sketch of repair

<p>Note: 1. R should be considered according to local detail 2. New contour should be ground smooth.</p>
Notes on possible cause of damage		Notes on repairs
<ol style="list-style-type: none"> Inadequate design for stress concentration in way of pintle bearing (Fracture A). Imperfection in welding seam (Fracture B). 		<ol style="list-style-type: none"> Fractured part to be cropped off. Repair by two insert plates of modified, stress releasing contour. For the vertical seam no backing strip is used 100mm off contour, welding from both sides, to be ground after welding. Variant (See Detail A): Repair as mentioned under 2 with the use of backing strip for the complete complete vertical seam. After welding backing strip partly removed by grinding.

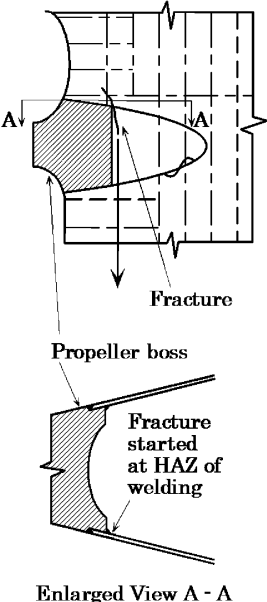
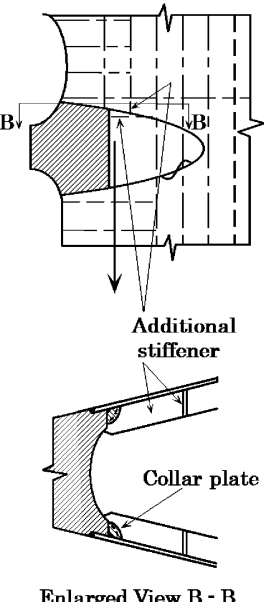
GENERAL DRY CARGO SHIPS		Guidelines for Surveys, Assessment and Repair of Hull Structure
Part 2	Fore and aft end regions	Example No.
Area 3	Stern frame, rudder arrangement and propeller shaft support	6
Detail of damage		Fracture in side shell plating at the connection to propeller boss
Sketch of damage		Sketch of repair

<p>Fracture</p> <p>Propeller boss</p> <p>Fracture started at HAZ of welding</p> <p>Enlarged View A - A</p>

<p>Additional stiffener</p> <p>Collar plate</p> <p>Enlarged View B - B</p>
Notes on possible cause of damage		Notes on repairs
1. Fatigue fracture due to vibration.		1. Fractured side shell plating is to be cropped and part renewed. 2. Additional stiffeners are to be provided. 3. Collar plate is to be provided.

Repair examples for propeller boss and stern tube are shown in **Examples 6** and **7**. Regarding the welding reference is made to **3.1.2**, **3.2.4** and **3.2.5**.

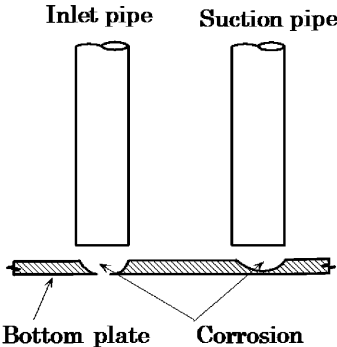
GENERAL DRY CARGO SHIPS		Guidelines for Surveys, Assessment and Repair of Hull Structure	
Part 3	Machinery and accommodation spaces	Example No.	
Area 1	Engine room structure	3	
Detail of damage	Corrosion in bottom plating under inlet/suction/pipe in way of bilge storage tank in engine room		
Sketch of damage	Sketch of repair

<p>Inlet pipe Suction pipe</p> <p>Bottom plate Corrosion</p>

Notes on possible cause of damage	Notes on repairs		
<ol style="list-style-type: none"> 1. Heavy corrosion of bottom plating under the inlet/suction pipe. 	<ol style="list-style-type: none"> 1. Corroded bottom plate is to be cropped and part renewed. Thicker plate is preferable. 2. Replacement of pipe end by enlarged conical opening (similar to suction head in ballast tank) is preferable.

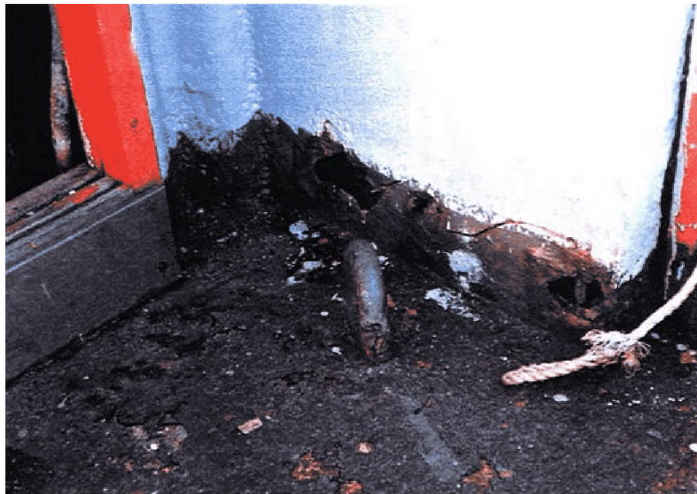
Photograph 1 Corroded accommodation house structure

The main damage is corrosion which may cause serious problems since the structure is relatively thin. Serious corrosion may be found in exposed deck plating and its adjoining accommodation house structure where water is liable to collect (See **Photograph 1**). Corrosion is also found in accommodation bulkheads where fittings such as doors, side scuttles, ventilators, etc. are fitted and proper maintenance of the area is relatively difficult. Deterioration of the bulkheads including fittings may impair the integrity of weathertightness.

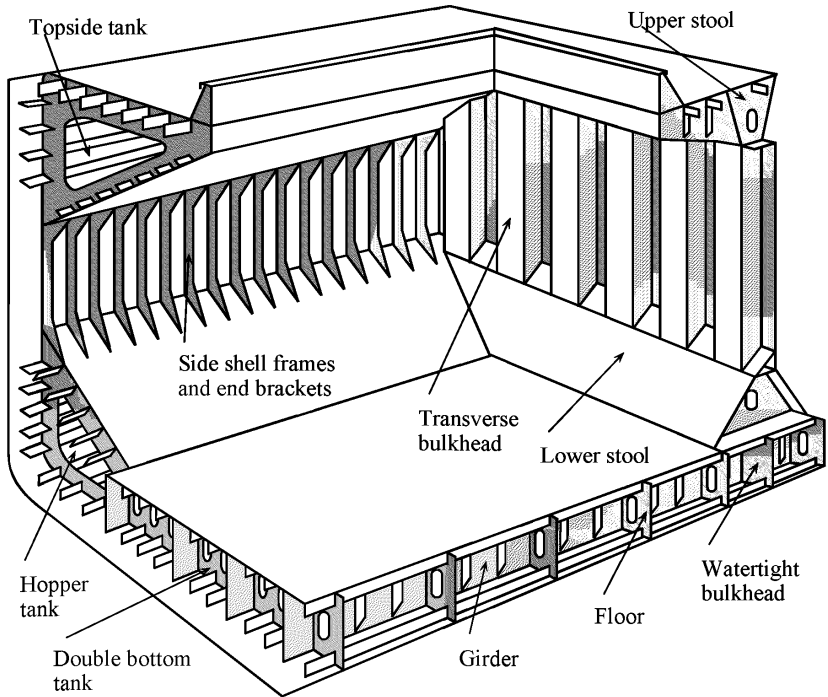
Figure 2 Typical cargo hold configuration for a single skin bulk carrier

Figure 2 shows a typical cargo hold structural arrangement in way of cargo hold region.

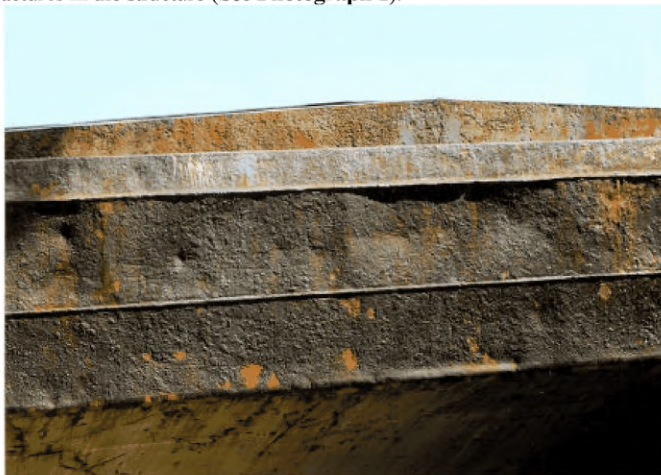
Photograph 1 Heavy corrosion of hatch coaming and topside tank plating vertical strake

- 3.1.1** The level of wastage of under-deck stiffeners/structure in cross deck may have to be established by means of thickness measurements. The combined effect of the marine environment and the high humidity atmosphere within cargo hold s will give rise to a high corrosion rate.
- 3.1.2** Severe corrosion of the hatch coaming plating inside cargo hold and topside tank plating vertical strake may occur due to difficult access for the maintenance of the protective coating. This may lead to fractures in the structure (See **Photograph 1**).

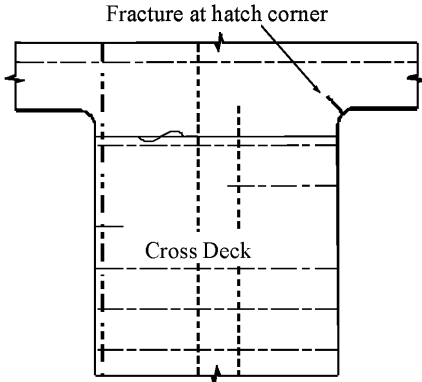
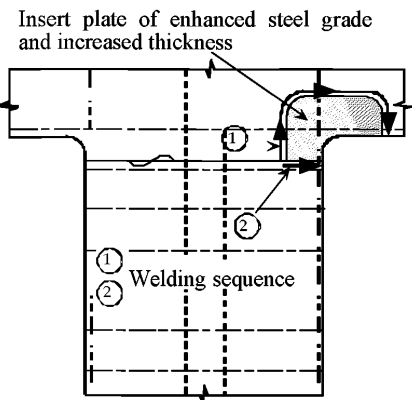
BULK CARRIERS		Guidelines for Surveys, Assessment and Repair of Hull Structure	
Part 1	Cargo hold region	Example No.	
Area 1	Deck structure	1	
Detail of damage		Fractures at main cargo hatch corner	
Sketch of damage		Sketch of repair

<p>Fracture at hatch corner</p> <p>Cross Deck</p>

<p>Insert plate of enhanced steel grade and increased thickness</p> <p>① ② Welding sequence</p>	
Notes on possible cause of damage		Notes on repairs	
<ol style="list-style-type: none"> 1. Stress concentration at hatch corners, i.e. radius of corner. 2. Welded attachment of shedder plate close to edge of hatch corner. 3. Wire rope groove. 		<ol style="list-style-type: none"> 1. The corner plating in way of the fracture is to be cropped and renewed. If stress concentration is primary cause, insert plate should be increased thickness, enhanced steel grade and/or improved geometry. Insert plate should be continued beyond the longitudinal and transverse extent of the hatch corner radius ellipse or parabola, and the butt welds to the adjacent deck plating should be located well clear of the butts in the hatch coaming. It is recommended that the edges of the insert plate and the butt welds connecting the insert plates to the surrounding deck plating be made smooth by grinding. In this respect caution should be taken to ensure that the micro grooves of the grinding are parallel to the plate edge. 2. If the cause of fracture is welded attachment of shedder plate, the deck connection should be left unwelded. 3. If the cause of the fracture is wire rope groove, replacement to the original design can be accepted.

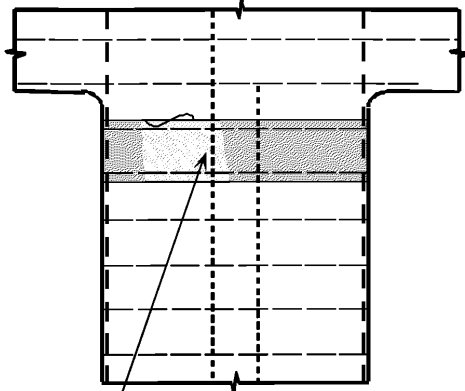
<p>The sketch shows the same cross-section as the damage sketch. A shaded rectangular area is inserted between the thick and thin plates, bridging the gap where the seam was. An arrow points from the text 'Insert plate of suitable intermediate thickness' to this shaded area.</p>

<p>Notes on possible cause of damage</p> <ol style="list-style-type: none"> 1. Stress concentration created by abrupt change in deck plating thickness. 2. In-plane bending in cross deck strip due to torsional (longitudinal) movements of ship sides. 3. Welded seam not clear of tangent point of hatch corner. 		<p>Notes on repairs</p> <ol style="list-style-type: none"> 1. Insert plate of intermediate thickness is recommended. 2. Smooth transition between plates (beveling) should be considered.

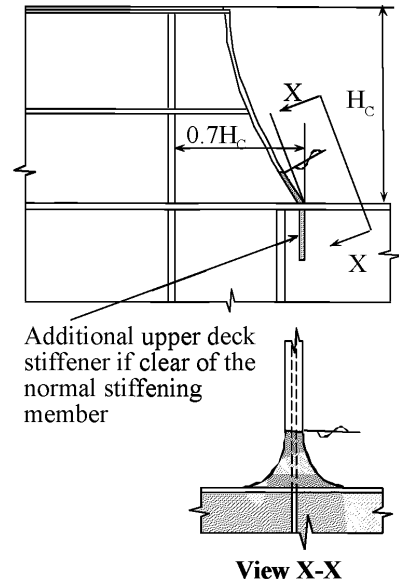
<p>View X-X</p>	
<p>Notes on possible cause of damage</p> <ol style="list-style-type: none"> 1. This damage is caused by stress concentrations attributed to the design of the bracket. 		<p>Notes on repairs</p> <ol style="list-style-type: none"> 1. The design of the bracket can be altered as shown above, however, it is to be ensured that an additional under deck stiffener is provided at the toe of the termination bracket, where the toe is clear of the normal stiffening member. 2. Full penetration weld for a distance of $0.15 H_C$ from toe of side coaming termination bracket and for connection of athwartship gusset bracket to deck. 3. The fracture in deck plating to be veed-out and rewelded or deck plating cropped and part renewed as appropriate, using low hydrogen electrodes for welding.

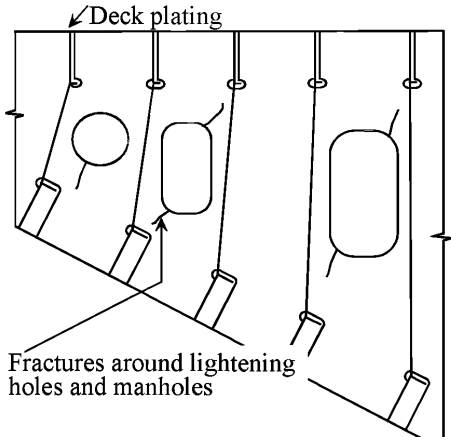
BULK CARRIERS		Guidelines for Surveys, Assessment and Repair of Hull Structure	
Part 1	Cargo hold region	Example No. 1	
Area 2	Topside tank structure	1	
Detail of damage		Fractures around unstiffened lightening holes and manholes in wash bulkhead	
Sketch of damage		Sketch of repair

<p>Deck plating</p> <p>Fractures around lightening holes and manholes</p>

<p>Repair B</p> <p>New face plates around holes</p>	
Notes on possible cause of damage		Notes on repairs	
<ol style="list-style-type: none"> General levels of corrosion and presence of stress concentration. 		<ol style="list-style-type: none"> Corroded/fractured plate should be cropped and renewed with plating of enhanced thickness. Reinforcement should be considered.

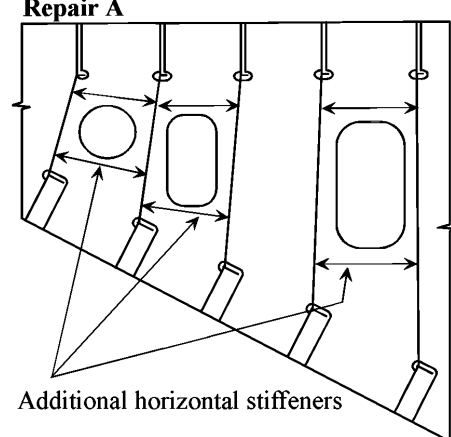
<p>Repair A</p> <p>Additional horizontal stiffeners</p>

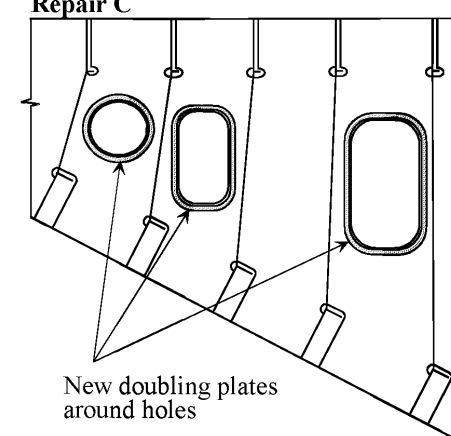
<p>Repair C</p> <p>New doubling plates around holes</p>

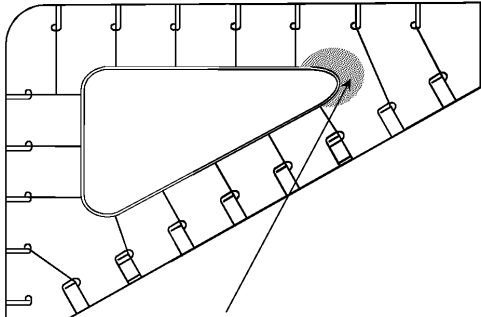
BULK CARRIERS		Guidelines for Surveys, Assessment and Repair of Hull Structure	
Part 1	Cargo hold region	Example No.	
Area 2	Topside tank structure	2-b	
Detail of damage		Thinning and subsequent buckling of web plating in the vicinity of the radii of the opening	
Sketch of damage		Sketch of repair

<p>Areas of excessive corrosion, and subsequent buckling and/or fracture</p>

<p>Enlarged radius of the opening</p>	
Notes on possible cause of damage		Notes on repairs	
<ol style="list-style-type: none"> 1. Corrosion caused by stress concentration at the corner due to insufficient radius for the opening. 		<ol style="list-style-type: none"> 1. Corroded/buckled plating is to be cropped and parts renewed with plating of increased thickness and additional stiffeners are preferable to minimize deflection. 2. An attempt should be made to improve the design of the radius if felt necessary.

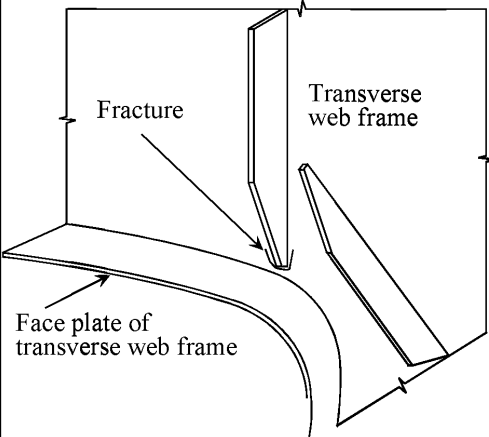
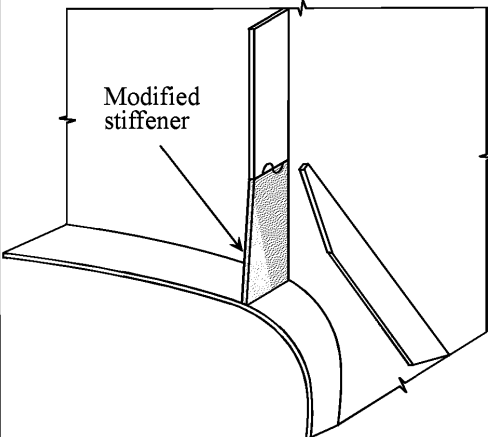
BULK CARRIERS		Guidelines for Surveys, Assessment and Repair of Hull Structure	
Part 1	Cargo hold region	Example No.	
Area 2	Topside tank structure	3	
Detail of damage		Fractures in transverse web at sniped end of stiffener	
Sketch of damage		Sketch of repair

Notes on possible cause of damage		Notes on repairs	
<ol style="list-style-type: none"> 1. Stress concentration. 		<ol style="list-style-type: none"> 1. Fracture can be veed-out and welded provided the plating is not generally corroded. If necessary, fractured plating should be cropped and renewed. 2. Excessive stress concentration at the end of stiffener should be avoided.

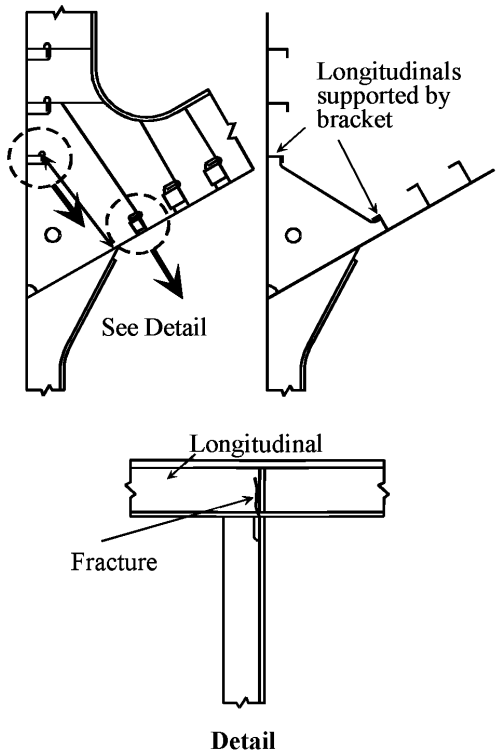
BULK CARRIERS		Guidelines for Surveys, Assessment and Repair of Hull Structure	
Part 1	Cargo hold region	Example No.	
Area 2	Topside tank structure	6	
Detail of damage		Fractures in the lowest longitudinal at transverse web frame	
<p>Sketch of damage</p>

<p>The sketch consists of three diagrams. The top-left diagram shows a cross-section of a hull structure with a longitudinal beam and a bracket. A dashed circle highlights a fracture at the junction, with arrows pointing to it and the text 'See Detail'. The top-middle diagram shows a similar structure with the text 'Longitudinals supported by bracket' and an arrow pointing to the bracket. The top-right diagram shows a similar structure with the text 'Increased bracket' and an arrow pointing to a larger bracket. The bottom diagram is a 'Detail' showing a cross-section of a longitudinal beam with a vertical fracture line through its center, labeled 'Fracture'.</p>

<p>Notes on possible cause of damage</p> <p>1. Insufficient scantling for torsional rigidity (The lowest longitudinal is usually supported by bracket(s) as shown in the above and smaller scantling may be adopted. However, the lowest longitudinal undergoes torsion from side shell frame through bracket(s) and may suffer fracture.)</p>		<p>Notes on repairs</p> <p>1. Fractured part to be cropped and renewed. 2. Size of bracket should be increased</p>

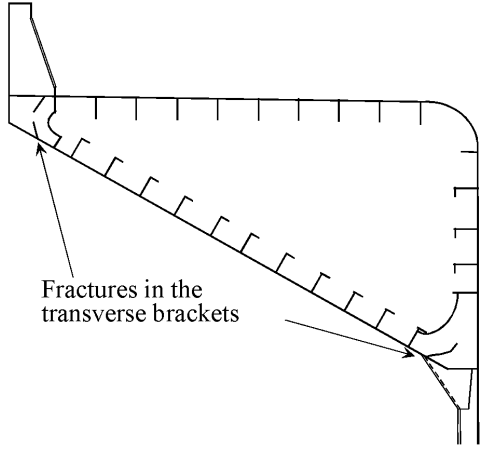
BULK CARRIERS		Guidelines for Surveys, Assessment and Repair of Hull Structure	
Part 1	Cargo hold region	Example No.	
Area 2	Topside tank structure	7-a	
Detail of damage Fractures in transverse brackets			
Sketch of damage		Sketch of repair

<p>Fractures in the transverse brackets</p>

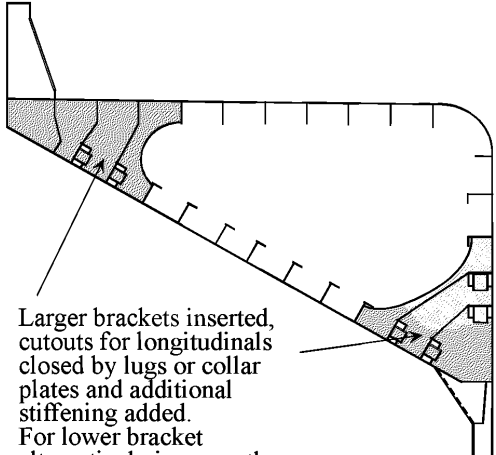
<p>Larger brackets inserted, cutouts for longitudinals closed by lugs or collar plates and additional stiffening added. For lower bracket alternatively increase the thickness</p>	
Notes on possible cause of damage		Notes on repairs	
<ol style="list-style-type: none"> 1. General levels of corrosion and presence of stress concentrations. 2. Misalignment of the brackets with adjoining structure, e.g. side shell frame brackets and/or coaming brackets. 3. High shear stresses due to insufficient bracket size. 4. Inadvertent overloading. 		<ol style="list-style-type: none"> 1. If the damage is caused by misalignment with the side shell frame brackets or the hatch coaming brackets the misalignment is to be rectified and the replacement by larger brackets incorporated only if considered necessary.

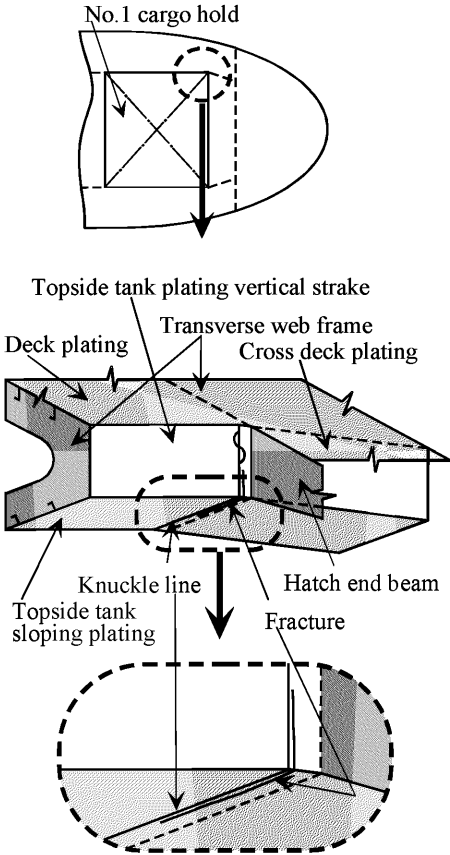
BULK CARRIERS		Guidelines for Surveys, Assessment and Repair of Hull Structure	
Part 1	Cargo hold region	Example No.	
Area 2	Topside tank structure	9	
Detail of damage		Fractures in sloping plating at knuckle	
Sketch of damage		Sketch of repair

<p>No. 1 cargo hold</p> <p>Topside tank plating vertical strake</p> <p>Deck plating</p> <p>Transverse web frame</p> <p>Cross deck plating</p> <p>Knuckle line</p> <p>Hatch end beam</p> <p>Topside tank sloping plating</p> <p>Fracture</p>

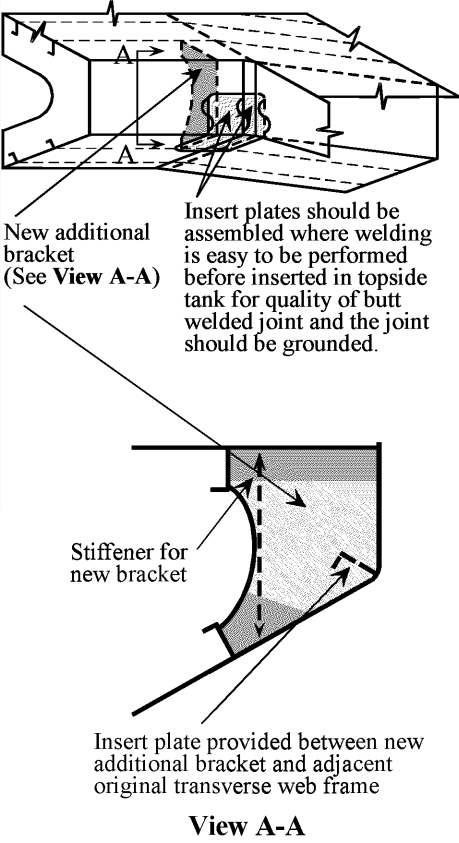
<p>New additional bracket (See View A-A)</p> <p>Insert plates should be assembled where welding is easy to be performed before inserted in topside tank for quality of butt welded joint and the joint should be grounded.</p> <p>Stiffener for new bracket</p> <p>Insert plate provided between new additional bracket and adjacent original transverse web frame</p> <p>View A-A</p>	
Notes on possible cause of damage		Notes on repairs

<ol style="list-style-type: none"> 1. Insufficient strength. 2. Additional stress induced by knuckle. 		<ol style="list-style-type: none"> 1. Knuckle part should be reinforced appropriately.

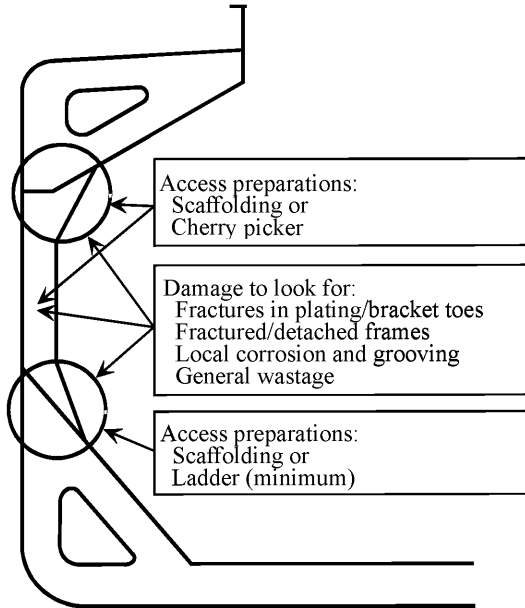
Figure 1
Side shell frame - Potential problem areas

- 1.6** A summary of potential problem areas is shown in **Figures 1 - 4**. Examples of failure and damaged ship side structure are illustrated in **Photographs 1- 2**.

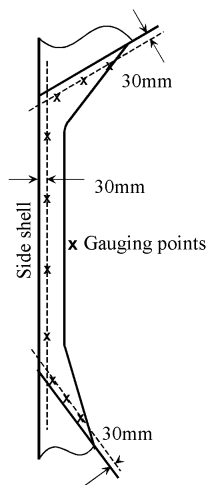
Figure 3
Representative gauging locations on the side shell frame - Potential problem areas

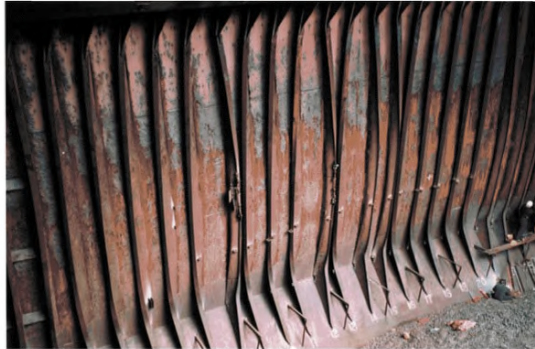
Photograph 1 Collapsed side shell frames (See Example 4)

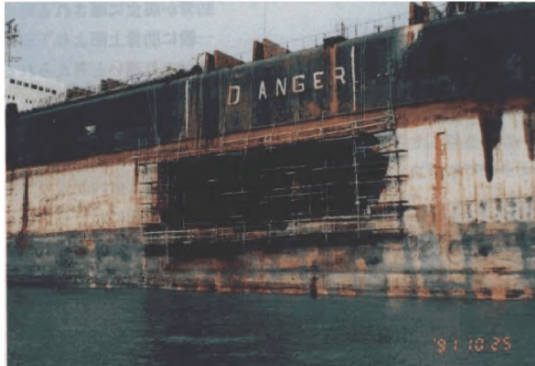
Photograph 2 Missing side shell structure (See Examples 4 and 5)

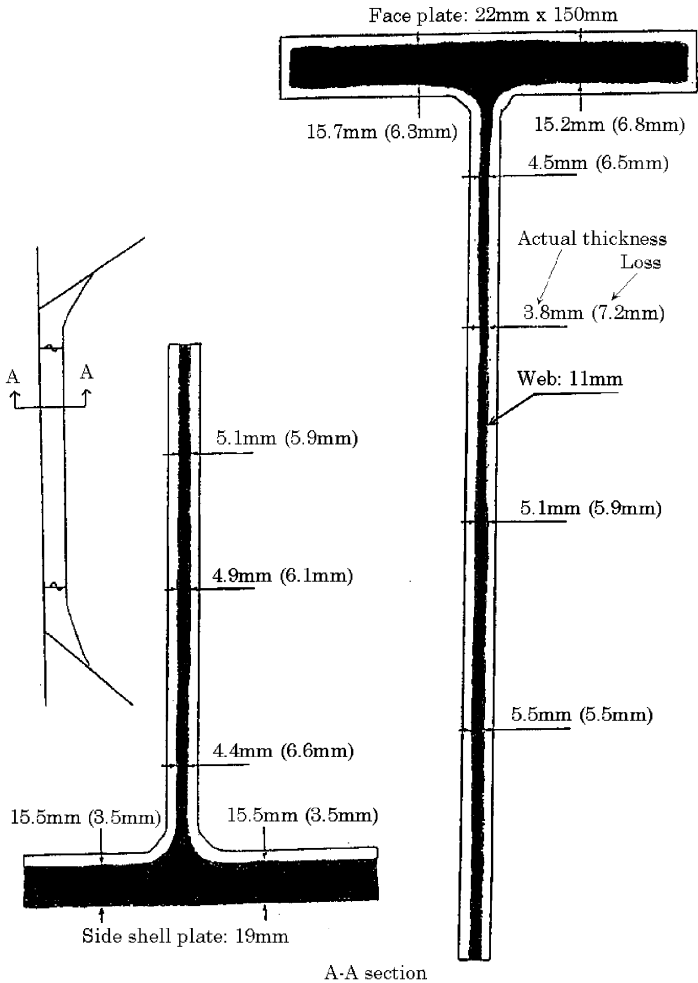
Figure 5 Uniform corrosion of side shell frame

- 2.1.1 Attention is drawn to the fact that side shell frames may be significantly weakened by loss of thickness although diminution and deformations may not be apparent. Inspection should be made after the removal of any scale or rust deposit. Thickness measurements may be necessary, particularly if the corrosion is smooth and uniform, to determine the condition of the structure (See **Figure 5**).

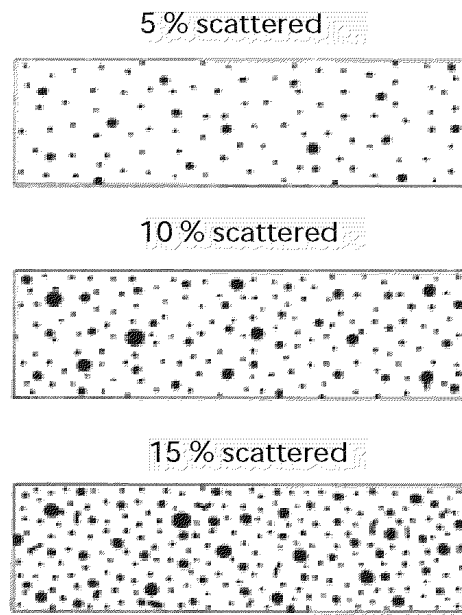
Figure 6 Pitting intensity diagrams (from 5% to 15% intensity)

- 4.1.2 If pitting intensity is lower than 15% in area (see **Figure 6**), pitting greater than $\frac{1}{4}$ of the original thickness can be welded flush with the original surface. If deep pits are clustered together or remaining thickness is less than 6 mm, the plate should be renewed by plate inserting instead of repairing by welding.

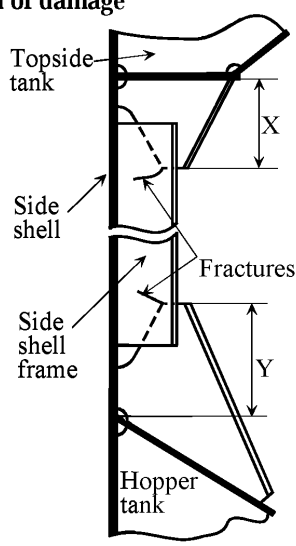
BULK CARRIERS		Guidelines for Surveys, Assessment and Repair of Hull Structure	
Part 1	Cargo hold region	Example No.	
Area 3	Cargo hold side structure	1-b	
Detail of damage		Fractures in side shell frame at bracket's toe	
<p>Sketch of damage</p>

<p>Separate bracket configuration</p>		<p>Sketch of repair</p>

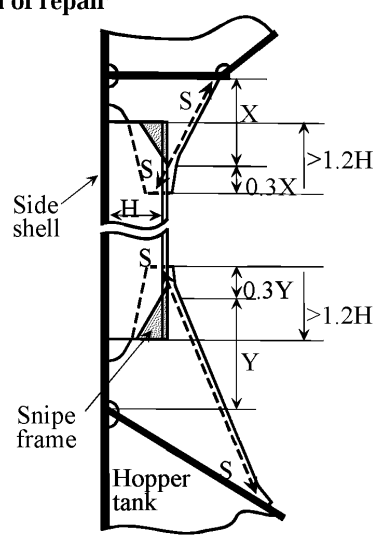
<p>S=Snipped end</p>	
<p>Notes on possible cause of damage</p> <ol style="list-style-type: none"> 1. This type of damage is caused due to stress concentration. 		<p>Notes on repairs</p> <ol style="list-style-type: none"> 1. For small fractures, e. g. hairline fractures, the fracture can be veed-out, welded up, ground, examined by NDT for fractures, and rewelded. 2. For larger/significant fractures consideration is to be given to cropping and partly renewing/ renewing the frame brackets. If renewing the brackets, end of frames can be snipped to soften them. 3. If felt prudent, soft toes are to be incorporated at the boundaries of the bracket to the hopper plating. 4. Attention to be given to the structure in wing tanks in way of the extended bracket arm. i.e. reinforcement provided in line with the bracket.

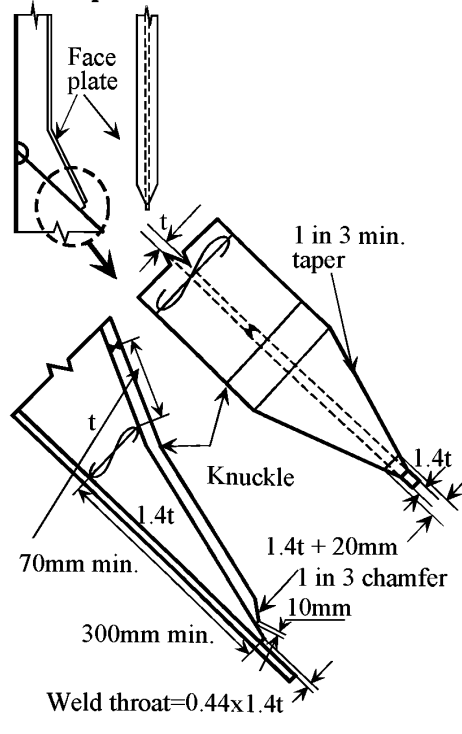
<p>Sketch of repair</p>

<p>Notes on possible cause of damage</p> <ol style="list-style-type: none"> This type of damage is caused due to stress concentration. 		<p>Notes on repairs</p> <ol style="list-style-type: none"> Repair is to incorporate a design similar to the one shown on the sketch and in addition:- <ol style="list-style-type: none"> The arm of the bracket along the hopper/ topside plating should be increased by altering the angle of the bracket face plate. A face plate taper of 1 in 3 should be arranged. The local thickness of the bracket web plating over the length of the new face plate taper should be increased by about 40% above that originally fitted. The face plate thickness should be chamfered 1 in 3 to a thickness at its extremity. Welding of the new bracket toe should be based on a weld factor of 0.44 applied to the increased thickness. Attention to be given to the structure in wing tanks in way of the extended bracket arm. i.e. reinforcement provided in line with the bracket.

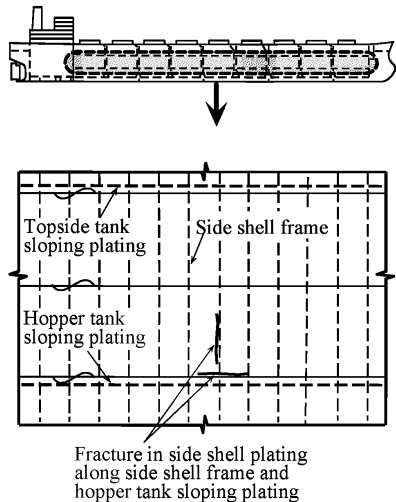
BULK CARRIERS		Guidelines for Surveys, Assessment and Repair of Hull Structure
Part 1	Cargo hold region	Example No.
Area 3	Cargo hold side structure	3
Detail of damage	Fractures in side shell frame/lower bracket and side shell plating near hopper	
Sketch of damage		Sketch of repair

<p>Topside tank sloping plating</p> <p>Side shell frame</p> <p>Hopper tank sloping plating</p> <p>Fracture in side shell plating along side shell frame and hopper tank sloping plating</p>

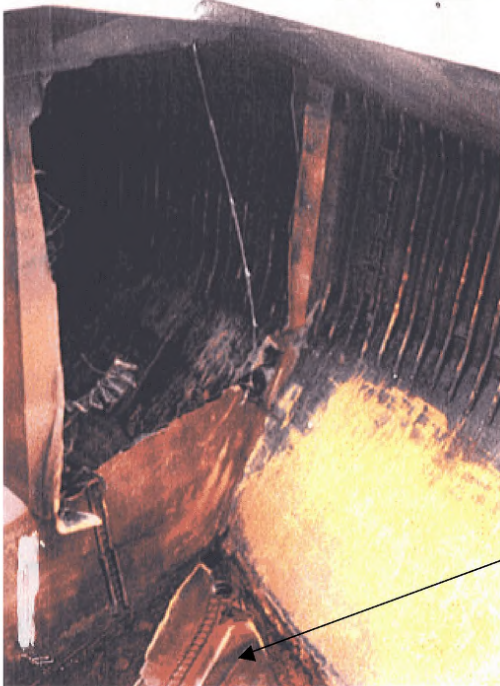
Photograph 1
Collapsed and detached transverse bulkhead

Collapsed and detached transverse bulkhead on the tank top

- 1.4 Dry cargo holds, not designed as ballast holds, may sometimes be partially filled with water ballast in order to achieve a satisfactory air draught at the loading/discharging berths.
The filling is restricted to a level that corresponds to the dry cargo hold scantlings, in particular the transverse bulkheads scantlings, and must only be carried out in port. In no case should these cargo holds be partially filled during voyage to save time at the berth. Such filling at sea may cause sloshing resulting in catastrophic failure such as indicated in **Photograph 1**.

- 1.5 Heavy corrosion may lead to collapse of the structure under extreme load, such as indicated in **Photograph 1** if it is not rectified properly.
- 1.6 A summary of potential problem areas is shown in **Figure 1**. It is emphasised that appropriate access arrangement as indicated in **Chapter 4 Survey planning, preparation and execution** of the guidelines, should be provided to enable a proper close-up inspection and thickness measurement as necessary.

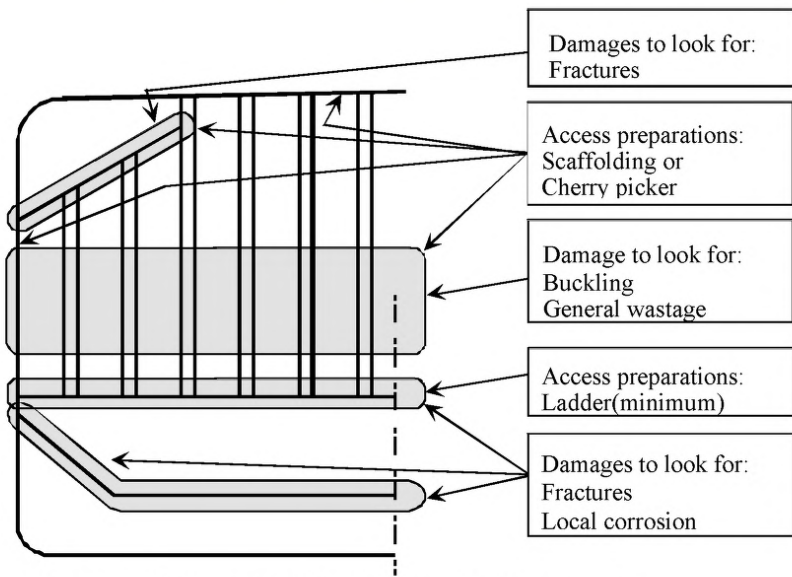
Figure 1 Transverse bulkhead - Potential problem areas

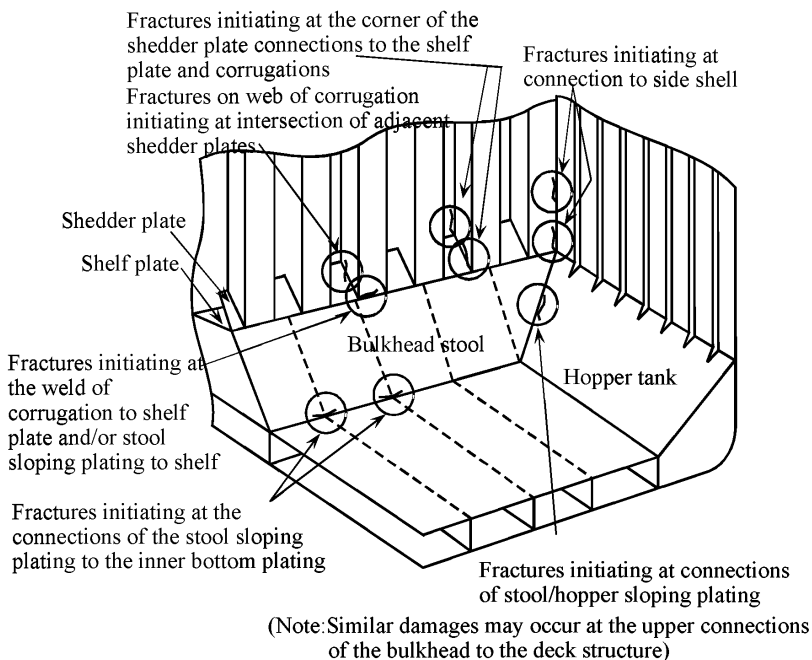
Figure 2 Typical fracturing at the connection of transverse bulkhead structure

2.3.1 Fractures usually occur at the boundaries of corrugations and bulkhead stools particularly in way of shelf plates, shedder plates, deck, inner bottom, etc. (See **Figure 2**).

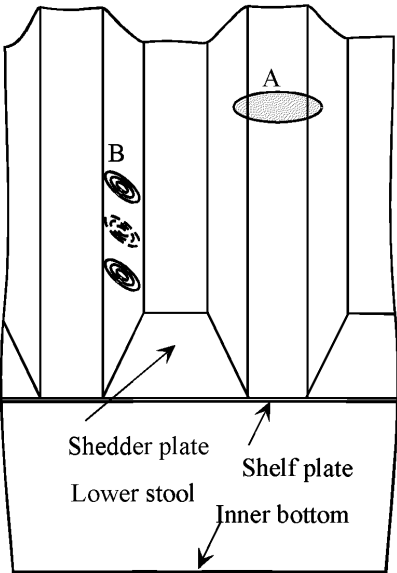
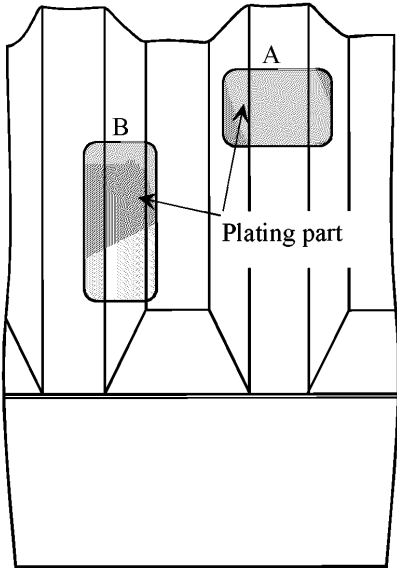
BULK CARRIERS		Guidelines for Surveys, Assessment and Repair of Hull Structure	
Part 1	Cargo hold region	Example No.	
Area 4	Transverse bulkhead and associated structure in cargo hold	3	
Detail of damage		Indentation and buckling of vertical corrugation	
Sketch of damage		Sketch of repair

Notes on possible cause of damage		Notes on repairs	
<ol style="list-style-type: none"> 1. Damages by mechanical abuse during cargo handling e.g. grab damage. 2. Damage resulting from thickness reduction by corrosion. 3. Buckling caused by bending or shear, see locations A and B respectively above, with a minimum reduction in thickness could be caused by underdesign or overloading. If this cause is suspected, the Classification Society concerned shall be contacted before proceeding with repairs. 		<ol style="list-style-type: none"> 1. Damage by mechanical abuse If the indentation/buckling is local and of a minor nature, the plating can be faired in place. If the deformation is more pronounced and/or in association with a generalized reduction in thickness the plating is to be cropped and renewed, as shown at locations A and B above. 2. Damage resulting from corrosion In this case thickness measurements are to be taken at mid-span and top and bottom of corrugations, and corrugations renewed or part renewed as necessary. Particular attention is to be given to the fit and alignment at corners of flanged corrugations when being partly renewed.

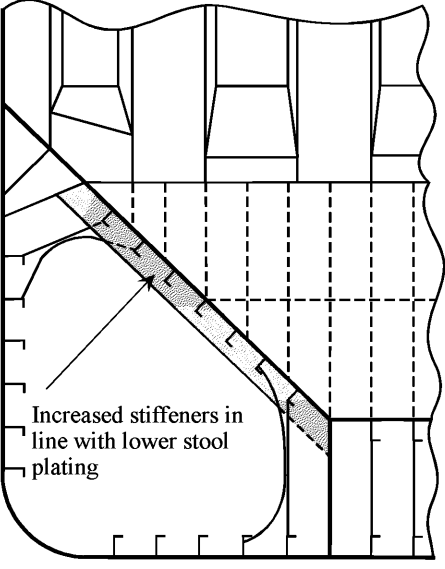
BULK CARRIERS		Guidelines for Surveys, Assessment and Repair of Hull Structure	
Part 1	Cargo hold region	Example No.	
Area 4	Transverse bulkhead and associated structure in cargo hold	6	
Detail of damage		Fractures at the connection of lower stool to hopper	
Sketch of damage		Sketch of repair

<p>Fracture in stool plating</p> <p>Stiffeners in line with lower stool plating</p>

<p>Increased stiffeners in line with lower stool plating</p>	
Notes on possible cause of damage		Notes on repairs	
<ol style="list-style-type: none"> 1. Insufficient strength of the connection 2. Corrosion 		<ol style="list-style-type: none"> 1. Fractured stool plating should be partly cropped and renewed (thicker plate) if considered necessary. 2. If the damage occurred due to insufficient strength, stiffeners in line with stool plating should be increased.

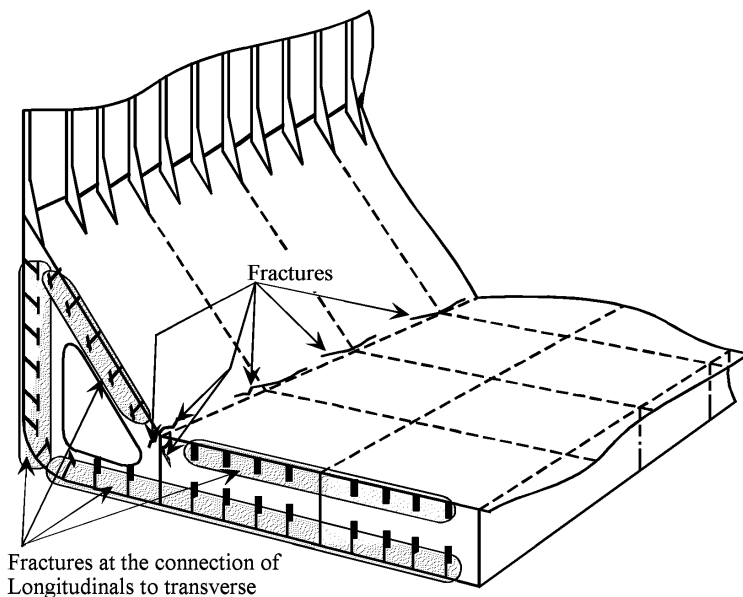
Figure 1 Typical fractures in the connection of hopper sloping plating to inner bottom (tank top) and longitudinals to transverse (or transverse bulkhead)

3.3.2 Fractures may occur in way of the welded or radiused knuckle between the inner bottom and hopper sloping plating if the side girder in the double bottom is not in line with the knuckle and also when the floors below have a large spacing, or when corner scallops are created for ease of fabrication. The local stress variations due to the loading and subsequent deflection may lead to the development of fatigue fractures which can be categorised as follows (See **Figure 1**).

3.3.3 The fractures in way of connection of inner bottom plating/hopper sloping plating to stool may be caused by the cyclic deflection of the inner bottom induced by repeated loading from the sea or due to poor “through-thickness” properties of the inner bottom plating. Scallops in the underlying girders can create stress concentrations which further increase the risk of fractures. These can be categorised as follows (See **Figure 1** and **Examples**).

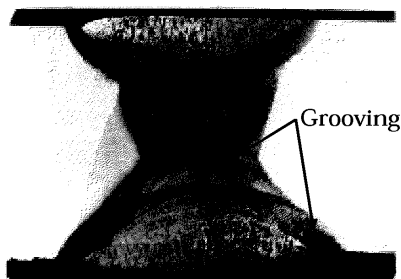
Photograph 2
Section of the grooving shown in Photograph 1

4.1.2 Severe grooving along welding of bottom plating is often found (See **Photographs 1** and **2**). This grooving can be accelerated by poor maintenance of the protective coating and/or sacrificial anodes fitted to the bottom plating.
