ПРОЦЕДУРНЫЕ ТРЕБОВАНИЯ,
УНИФИЦИРОВАННЫЕ ИНТЕРПРЕТАЦИИ
И РЕКОМЕНДАЦИИ
МЕЖДУНАРОДНОЙ АССОЦИАЦИИ
КЛАССИФИКАЦИОННЫХ ОБЩЕСТВ

GENERAL DRY CARGO SHIPS

Guidelines for
Surveys, Assessment and Repair
of Hull Structure

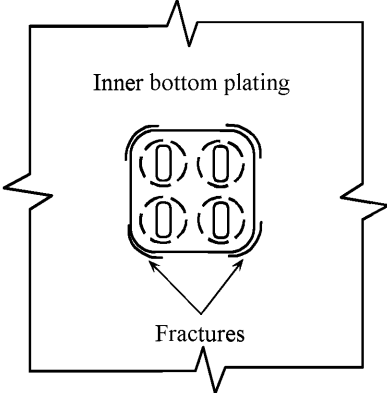
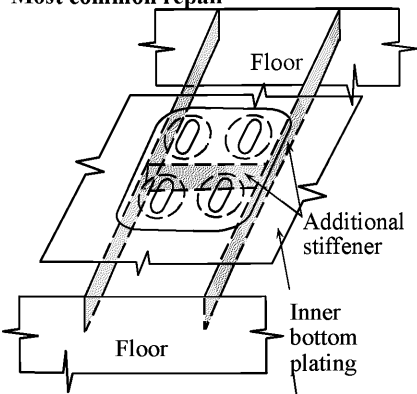
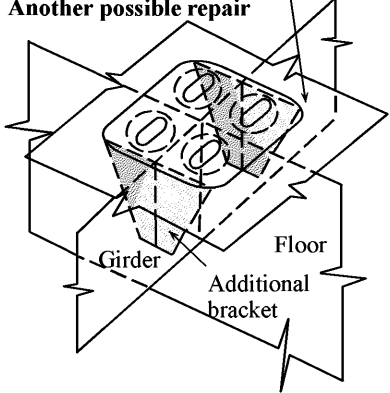
BULK CARRIERS	Guidelines for Surveys, Assessment and Repair of Hull Structure	
Part 1	Cargo hold region	Example No.
Area 5	Double bottom structure including hopper	1
Detail of damage Fractures in inner bottom plating around container bottom pocket		
<p>Sketch of damage</p>

<p>Sketch of repair</p> <p>Most common repair</p>

<p>Another possible repair</p>

<p>Notes on possible cause of damage</p> <ol style="list-style-type: none"> 1. Pocket is not supported correctly by floor, longitudinal and/or stiffener. 	<p>Notes on repairs</p> <ol style="list-style-type: none"> 1. Fractured plating should be cropped and part renewed. 2. Adequate reinforcement should be considered.

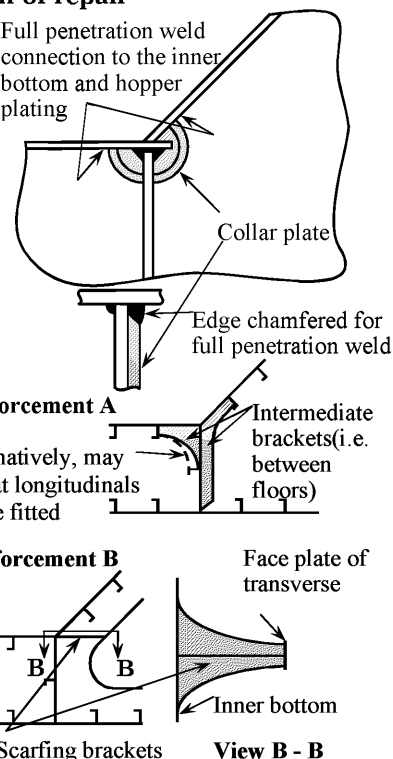
BULK CARRIERS		Guidelines for Surveys, Assessment and Repair of Hull Structure	
Part 1	Cargo hold region	Example No.	
Area 5	Double bottom tank structure including hopper	4	
Detail of damage		Fractures at weld connections of floors in way of hopper/inner bottom interface (welded knuckle)	
<p>Sketch of damage</p>

<p>View A - A Transverse fractures in hopper web plating into possibly extending into the hopper sloping plating</p>

<p>Reinforcement A Alternatively, may stop at longitudinals where fitted</p> <p>Reinforcement B</p> <p>View B - B</p>	
<p>Notes on possible cause of damage</p> <ol style="list-style-type: none"> 1. The damage is partly due to stress concentration at the edges of the weld created by the presence of the deflections in the inner bottom/hopper plating. 		<p>Notes on repairs</p> <ol style="list-style-type: none"> 1. The fracture in the weld and/or plating is veed-out/cropped and renewed as appropriate. 2. The cut-outs are eliminated by introducing suitable collar plates with emphasis on edge preparation and sequence of welding as shown above. 3. Further reinforcements may be incorporated as shown above and depending on the judged cause of damage.

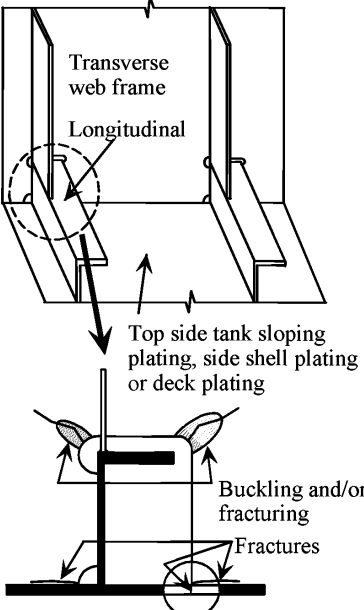
BULK CARRIERS		Guidelines for Surveys, Assessment and Repair of Hull Structure
Part 1	Cargo hold region	Example No.
Area 5	Double bottom tank structure including hopper	6
Detail of damage		Fractures and buckling in way of a cut-out for the passage of a longitudinal through a transverse primary member
Sketch of damage		Sketch of repair

<p>Repair A</p>

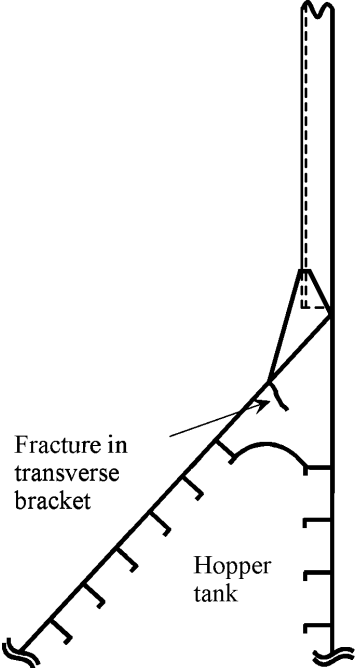
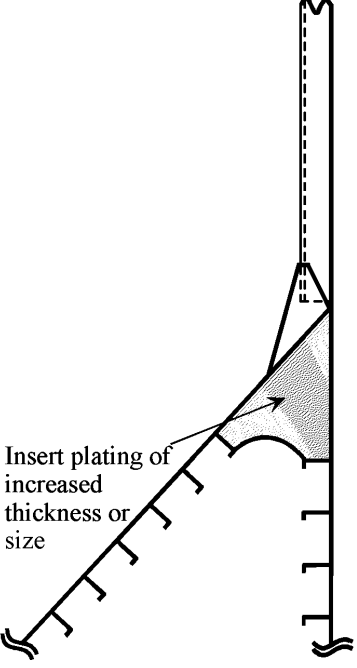
BULK CARRIERS		Guidelines for Surveys, Assessment and Repair of Hull Structure	
Part 1	Cargo hold region	Example No.	
Area 5	Double bottom tank structure including hopper	11	
Detail of damage		Fractures at weld connection of transverse brackets	
Sketch of damage		Sketch of repair

<p>Fracture in transverse bracket</p> <p>Hopper tank</p>

<p>Insert plating of increased thickness or size</p>	
Notes on possible cause of damage		Notes on repairs	
<ol style="list-style-type: none"> 1. General levels of corrosion and presence of stress concentration. 2. Misalignment of the brackets with adjoining structure e.g. frame brackets. 3. High shear stresses due to insufficient bracket. 4. Inadvertent overloading. 		<ol style="list-style-type: none"> 1. If the damage is caused by misalignment with the frame bracket above, the misalignment is to be rectified. 2. Replacement by a bracket of increased thickness or size should be considered.

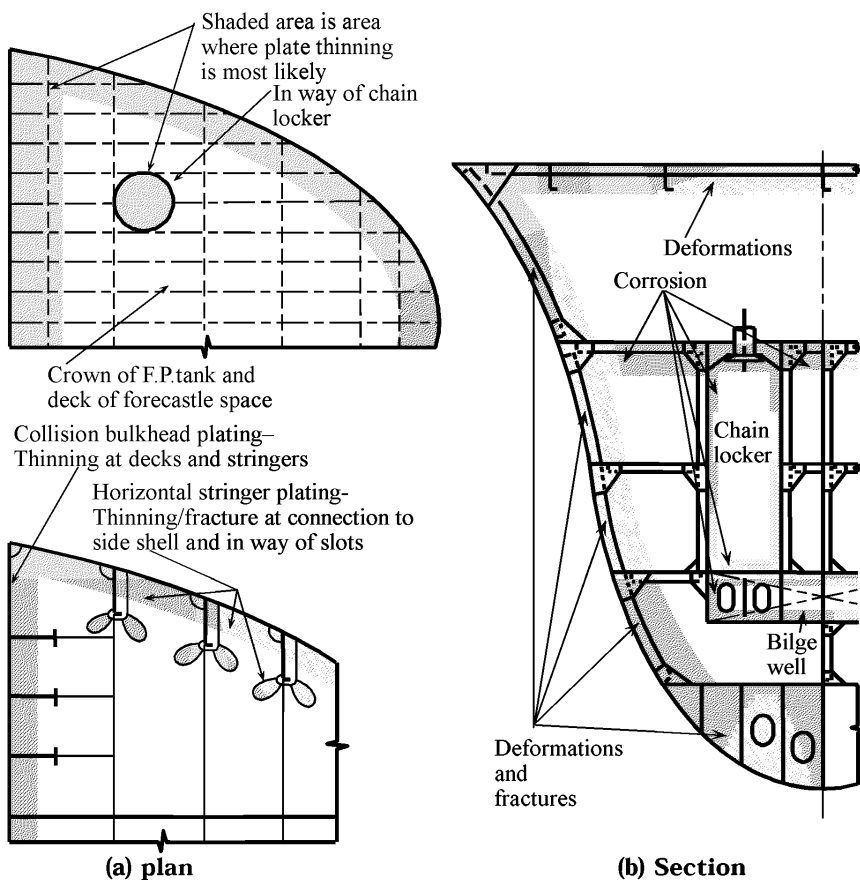
Fig 1 Fore end structure - Potential problem areas

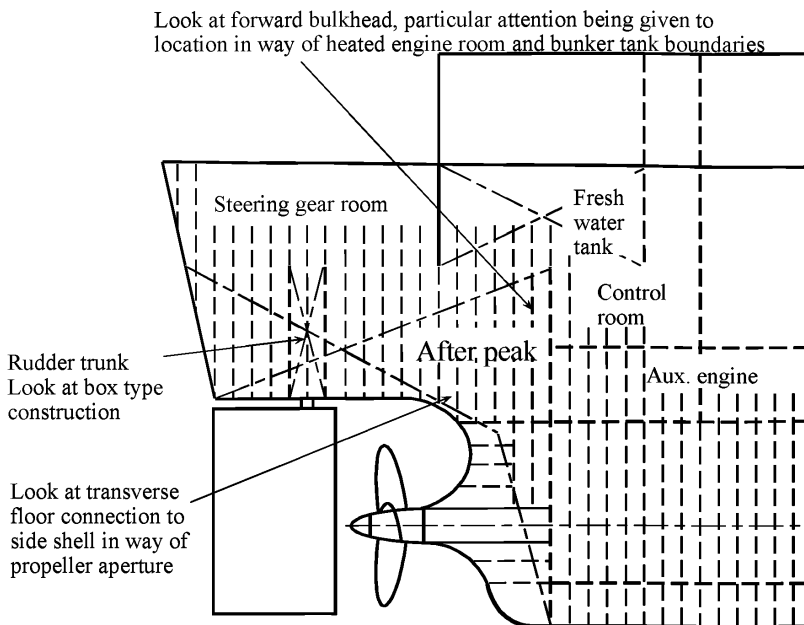
Figure 1 Aft end structure - Potential problem areas

- 2.3.1 Fractures in weld at floor connections and other locations in the aft peak tank and rudder trunk space can normally only be found by close-up inspection.
- 2.3.2 The structure supporting the rudder carrier may fracture and/or deform due to excessive load on the rudder. Bolts connecting the rudder carrier to the steering gear flat may also suffer damage under such load.

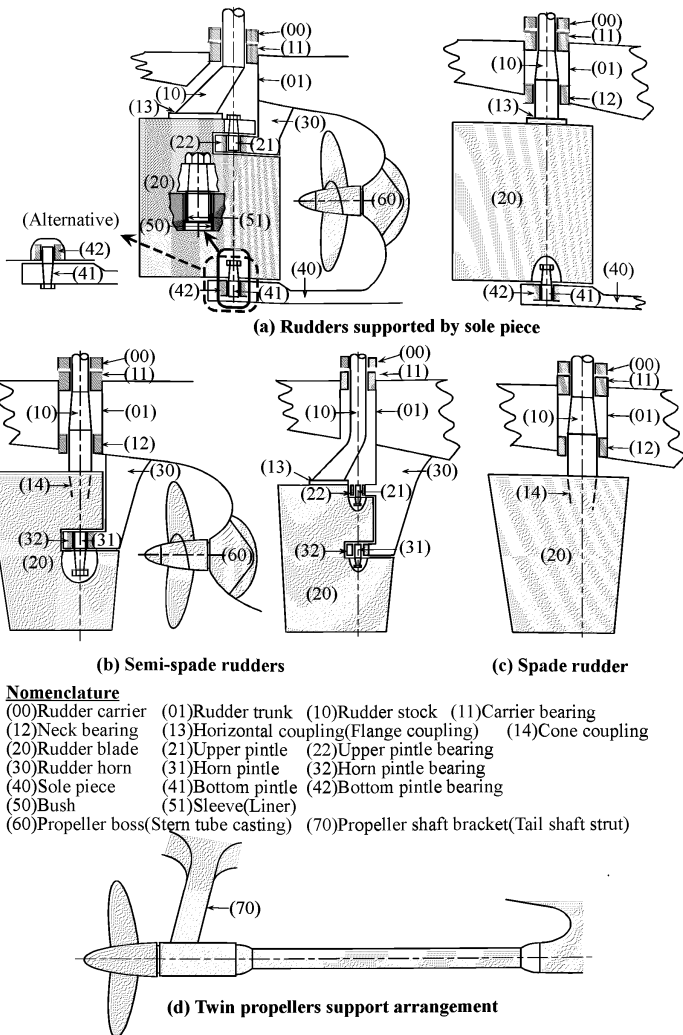
Figure 1 Nomenclature for stern frame, rudder arrangement and propeller shaft support

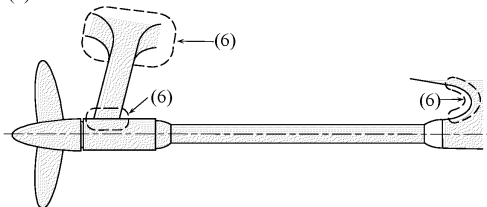
Damage to look for:

- (1) Fractures and loose coupling bolts
- (2) Loose nut
- (3) Wear (excessive bearing clearance)
- (4) Fractures in way of pintle cutout
- (5) Fractures in way of removable access plate
- (6) Fractures
- (7) Erosion

Figure 2 Potential problem areas

- 1.6 Pre-existing manufacturing internal defects in cast pieces may lead to fatigue cracking.
- 1.7 A summary of potential problem areas is shown in **Figure 2**.

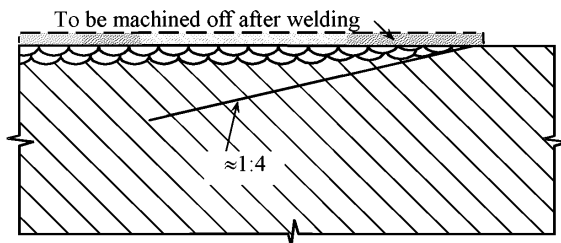
Figure 3 Rudder stock repair by welding

- Removal of the wasted area by machining and/or grinding, non-destructive examination for fractures (magnetic particle inspection preferred)
- Build-up welding by automatic spiral welding (turning device) according to an approved welding procedure (weld process, preheating, welding consumables, etc.)
- Extension of build-up welding over the area of **large bending moments (shafts)** according to the sketch

- Sufficient number of weld layers to compensate removed material, at least one layer in excess (heat treatment of the remaining layer)
- Transition at the end of the build-up welding according to the following sketch

- Post weld heat treatment if required in special cases (never for stainless steel cladding on ordinary steel)
- Final machining, at least two layers of welding material have to remain on the rudder stock (See the above sketch)
- Non-destructive fracture examination

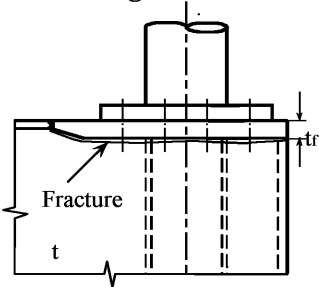
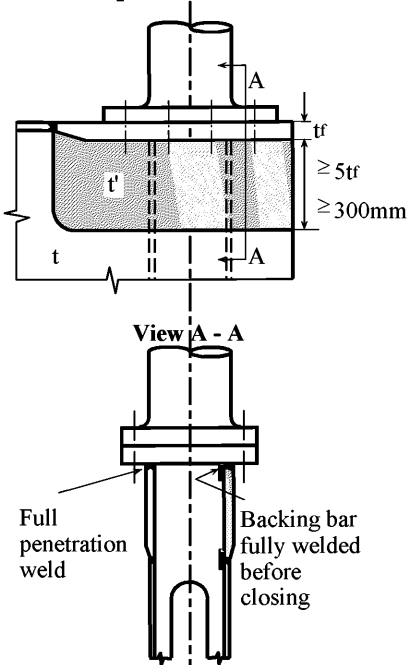
BULK CARRIERS		Guidelines for Surveys, Assessment and Repair of Hull Structure	
Part 2	Fore and aft end regions	Example No. 3	
Area 3	Stern frame, rudder arrangement and propeller shaft support		
Detail of damage		Fractures in connection of palm plate to rudder blade	
Sketch of damage		Sketch of repair

<p>View A - A</p> <p>Full penetration weld</p> <p>Backing bar fully welded before closing</p> <p>$t = \text{plate thickness, mm}$ $tr = \text{actual flange thickness, mm}$ $t = \frac{tr}{3} + 5, \text{ mm, where } tr \leq 50\text{mm}$ $t = 3\sqrt{tr}, \text{ mm, where } tr \geq 50\text{mm}$</p>	
Notes on possible cause of damage		Notes on repairs	
<p>1. Inadequate connection between palm plate and rudder blade plating (insufficient plating thickness and/or insufficient fillet weld).</p>		<p>1. Modification of detail design of the connection by increasing the plate thickness and full penetration welding.</p>

- 3.2.3** Short fatigue fractures starting in the lower and/or upper corners of the pintle recess of semi-spade rudders that do not propagate into vertical or horizontal stiffening structures may be repaired by gouging out and welding. The procedure according to **Example 3** should be preferred.

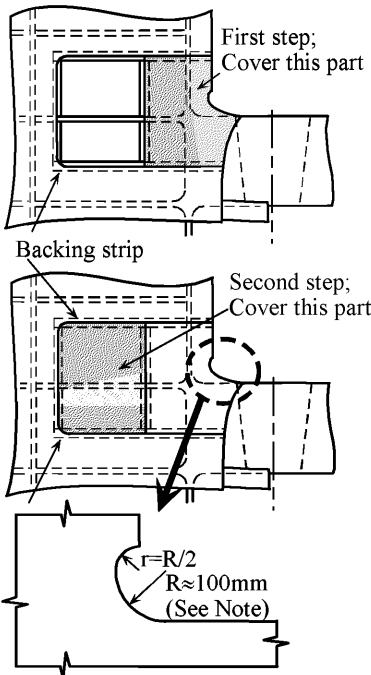
GENERAL CARGO SHIPS		Guidelines for Surveys, Assessment and Repair of Hull Structure
Part 2	Fore and aft end regions	Example No.
Area 3	Stern frame, rudder arrangement and propeller shaft support	5
Detail of damage	Fractures in rudder plating of semi-spade rudder extending beyond the vertical web	
Sketch of damage

Sketch of repair

<p>Note: R should be considered according to local detail</p>
Notes on possible cause of damage 1. Stress concentration due to inadequate local design and/or fabrication notches in way of the butt weld between cast piece and plating.		Notes on repairs 1. Fractured plating is to be cut-out. 2. Internal structures are to be checked. 3. Cut-out is to be closed by an insert plating according to the sketch (welding only from one side is demonstrated). 4. Modification of the radius. 5. In case of a new cast piece, connection with the plating is to be shifted outside the high stress area.

- In case of longer fatigue fractures starting in the lower and/or upper corners of the pintle recess of semi-spade rudders that propagate over a longer distance into the plating, thorough check of the internal structures has to be carried out. The fractured parts of the plating and of the internal structures, if necessary, have to be replaced by insert plates. A proper welding connection between the insert plate and the internal stiffening structure is very important (See **Examples 4 and 5**).

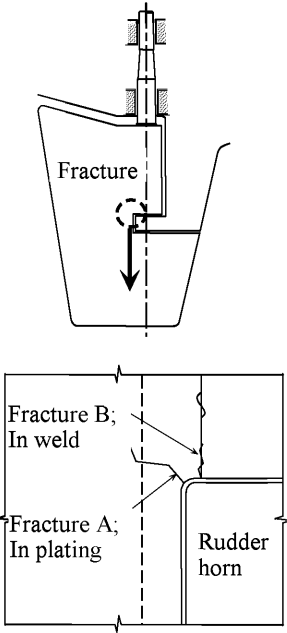
BULK CARRIERS		Guidelines for Surveys, Assessment and Repair of Hull Structure	
Part 2	Fore and aft end regions	Example No.	
Area 3	Stern frame, rudder arrangement and propeller shaft support	6	
Detail of damage	Fractures in rudder plating of semi-spade rudder in way of pintle cutout		
<p>Sketch of damage</p>

<p>The sketch shows a semi-spade rudder with a fracture in the plating. A detail view shows 'Fracture B; In weld' and 'Fracture A; In plating' near the 'Rudder horn'.</p>		<p>Sketch of repair</p>

<p>The repair sketch shows two steps: 'Second step; Cover this part' and 'First step; Cover this part'. It includes radii $R=350\text{mm}$ and $R=100\text{mm}$, and a reference to 'See Detail A'. A note states: 'Note: 1.R should be considered according to local detail. 2.New contour should be ground smooth'. 'View B - B' shows 'Rudder plating', 'Backing strip', and areas 'To be ground' and 'To be cut'.</p>

<p>Notes on possible cause of damage</p> <ol style="list-style-type: none"> 1. Inadequate design for stress concentration in way of pintle bearing (Fracture A). 2. Imperfection in welding seam (Fracture B). 		<p>Notes on repairs</p> <ol style="list-style-type: none"> 1. Fractured part to be cropped off. 2. Repair by two insert plates of modified, stress releasing contour. For the vertical seam no backing strip is used 100mm off contour, welding from both sides, to be ground after welding. 3. Variant (See Detail A): Repair as mentioned under 2 with the use of backing strip for the complete vertical seam. After welding backing strip partly removed by grinding.

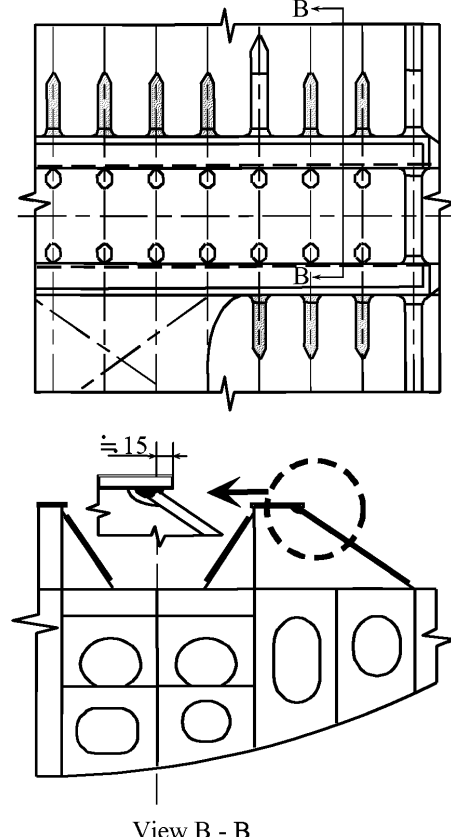
BULK CARRIERS		Guidelines for Surveys, Assessment and Repair of Hull Structure	
Part 3	Machinery and accommodation spaces	Example No.	
Area 1	Engine room structure	1	
Detail of damage		Fractures in brackets at main engine foundation	
Sketch of damage		Sketch of repair

Notes on possible cause of damage		Notes on repairs	
<ol style="list-style-type: none"> 1. Vibration of main engine. 2. Insufficient strength of brackets at main engine foundation. 3. Insufficient pre-load bolts. 		<ol style="list-style-type: none"> 1. Fractures are to be veed-out and rewelded. 2. New modified brackets at main engine foundation. 3. Or insert pieces and additional flanges to increase section modulus of the brackets.

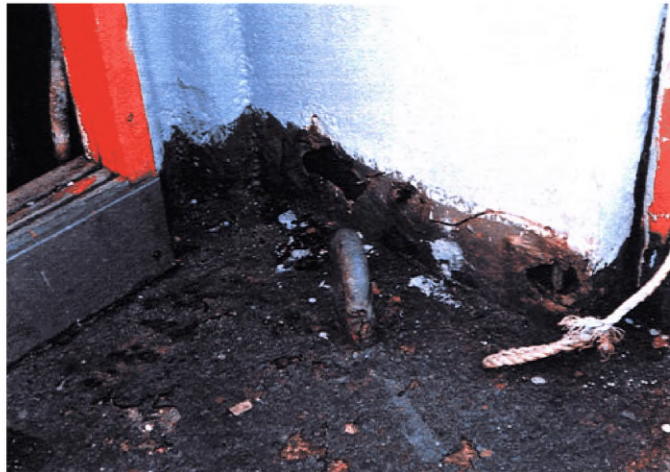
Photograph 1 Corroded accommodation house side structure

Severe corrosion may be found in exposed deck plating and deck house side structure adjacent to the deck plating where water is liable to accumulate (See **Photograph 1**). Corrosion may also be found in accommodation bulkheads around cutout for fittings, such as doors, side scuttles, ventilators, etc., where proper maintenance of the area is relatively difficult. Deterioration of the bulkheads including fittings may impair the integrity of weathertightness.

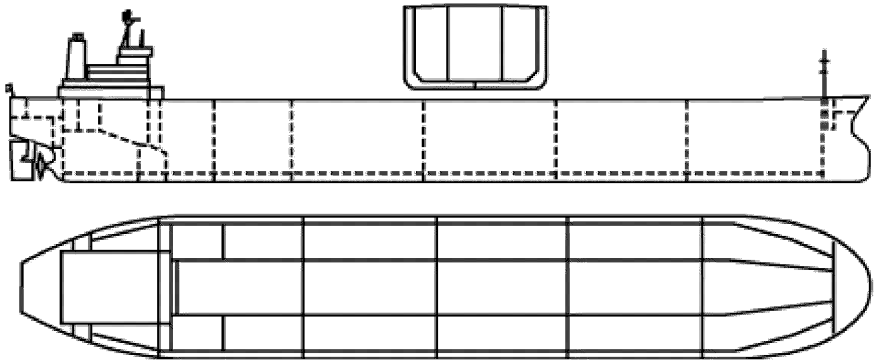
Figure 1 General view of a typical double hull oil tanker (150,000 DWT and greater)

This manual gives guidelines for a double hull oil tanker which is constructed primarily for the carriage of oil in bulk and which has the cargo tanks protected by a double hull which extends for the entire length of the cargo area, consisting of double sides and double bottom spaces for the carriage of water ballast or void spaces. **Figures 1 & 2** show the general views of typical double hull oil tankers with two longitudinal bulkheads or one centreline longitudinal bulkhead respectively.

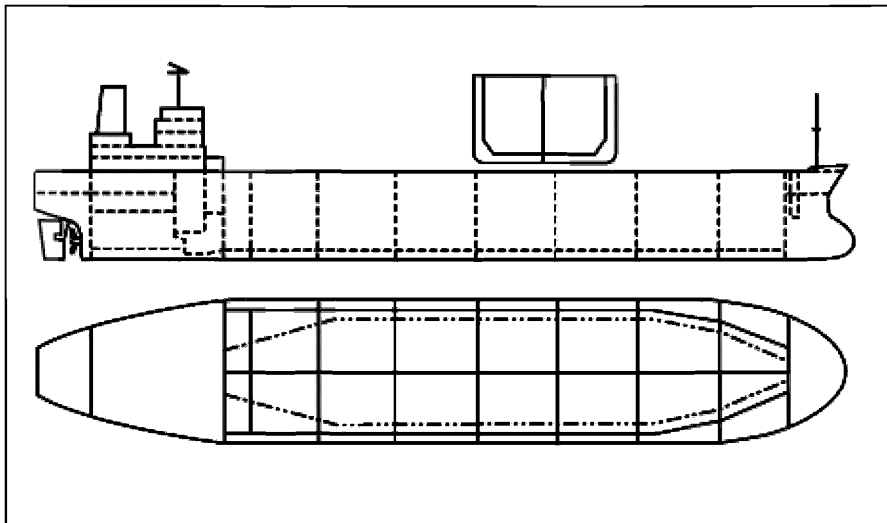
Figure 2 General view of a typical double hull oil tanker (150,000 DWT or less)

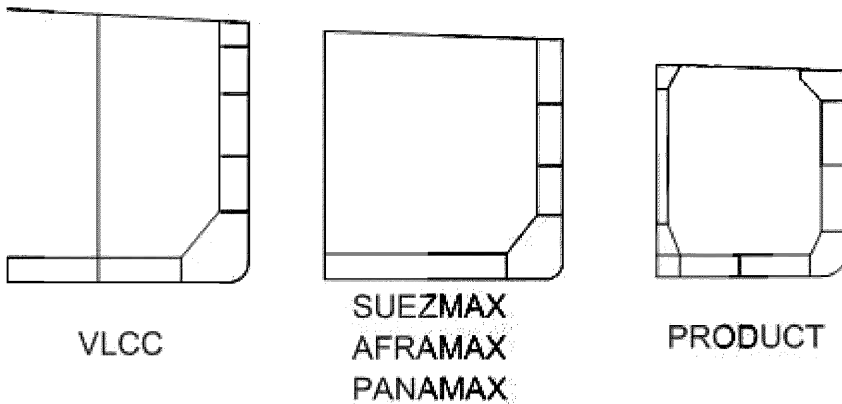
Figure 3 Categories of Bulkhead Configurations

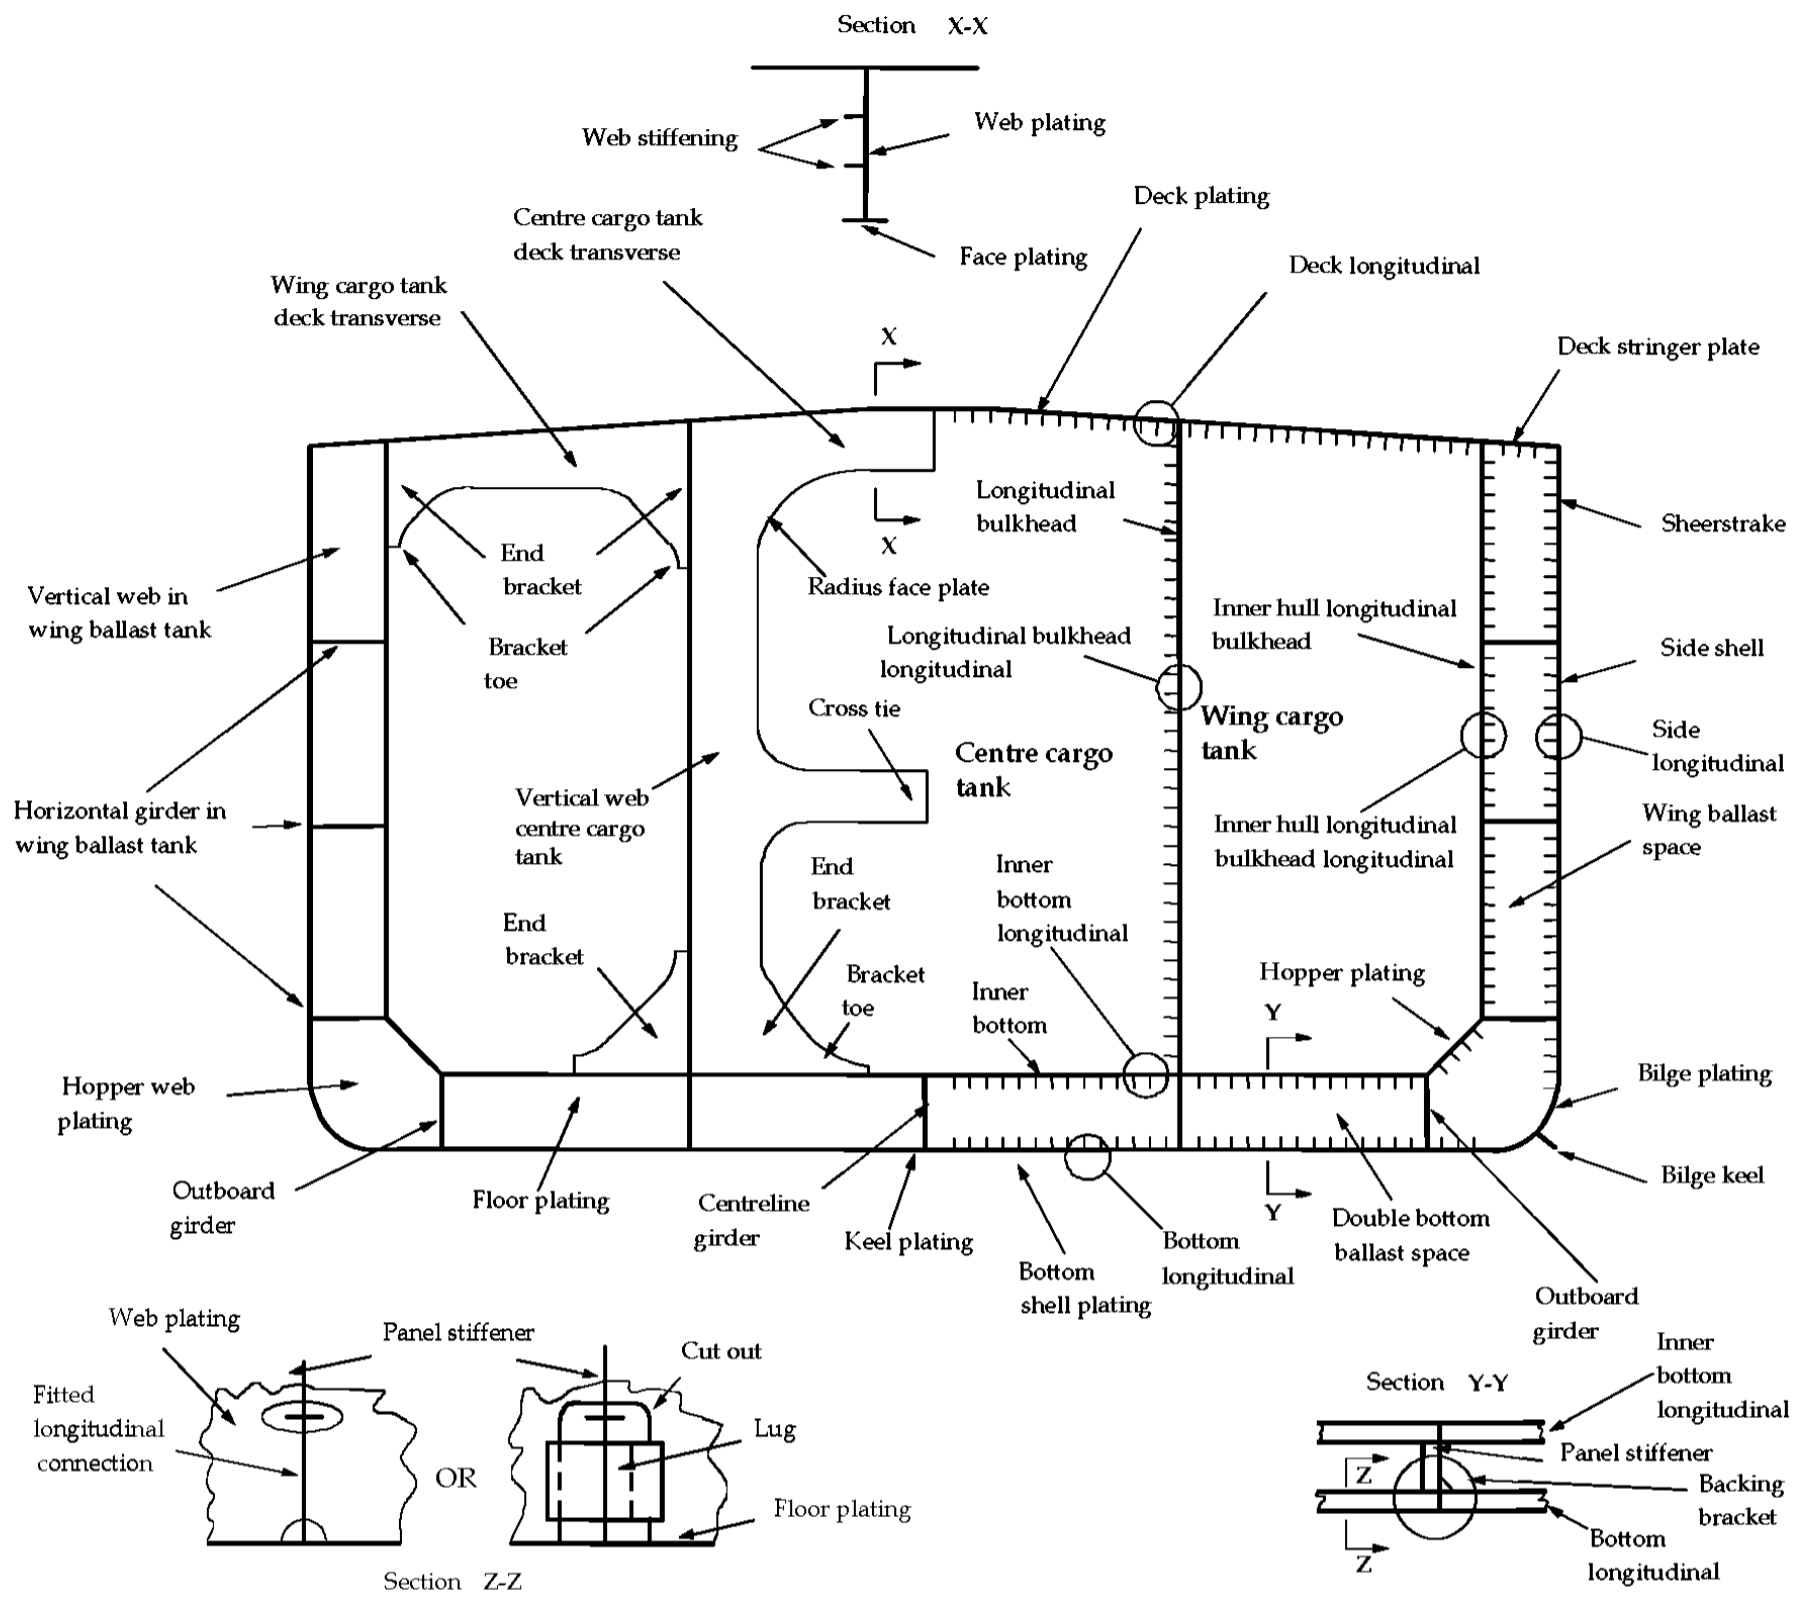
Figure 4 Typical midship section of a double hull oil tanker with two longitudinal bulkheads including nomenclature

Figures 4 to 6 show the typical nomenclature used for the midship section and transverse bulkhead.

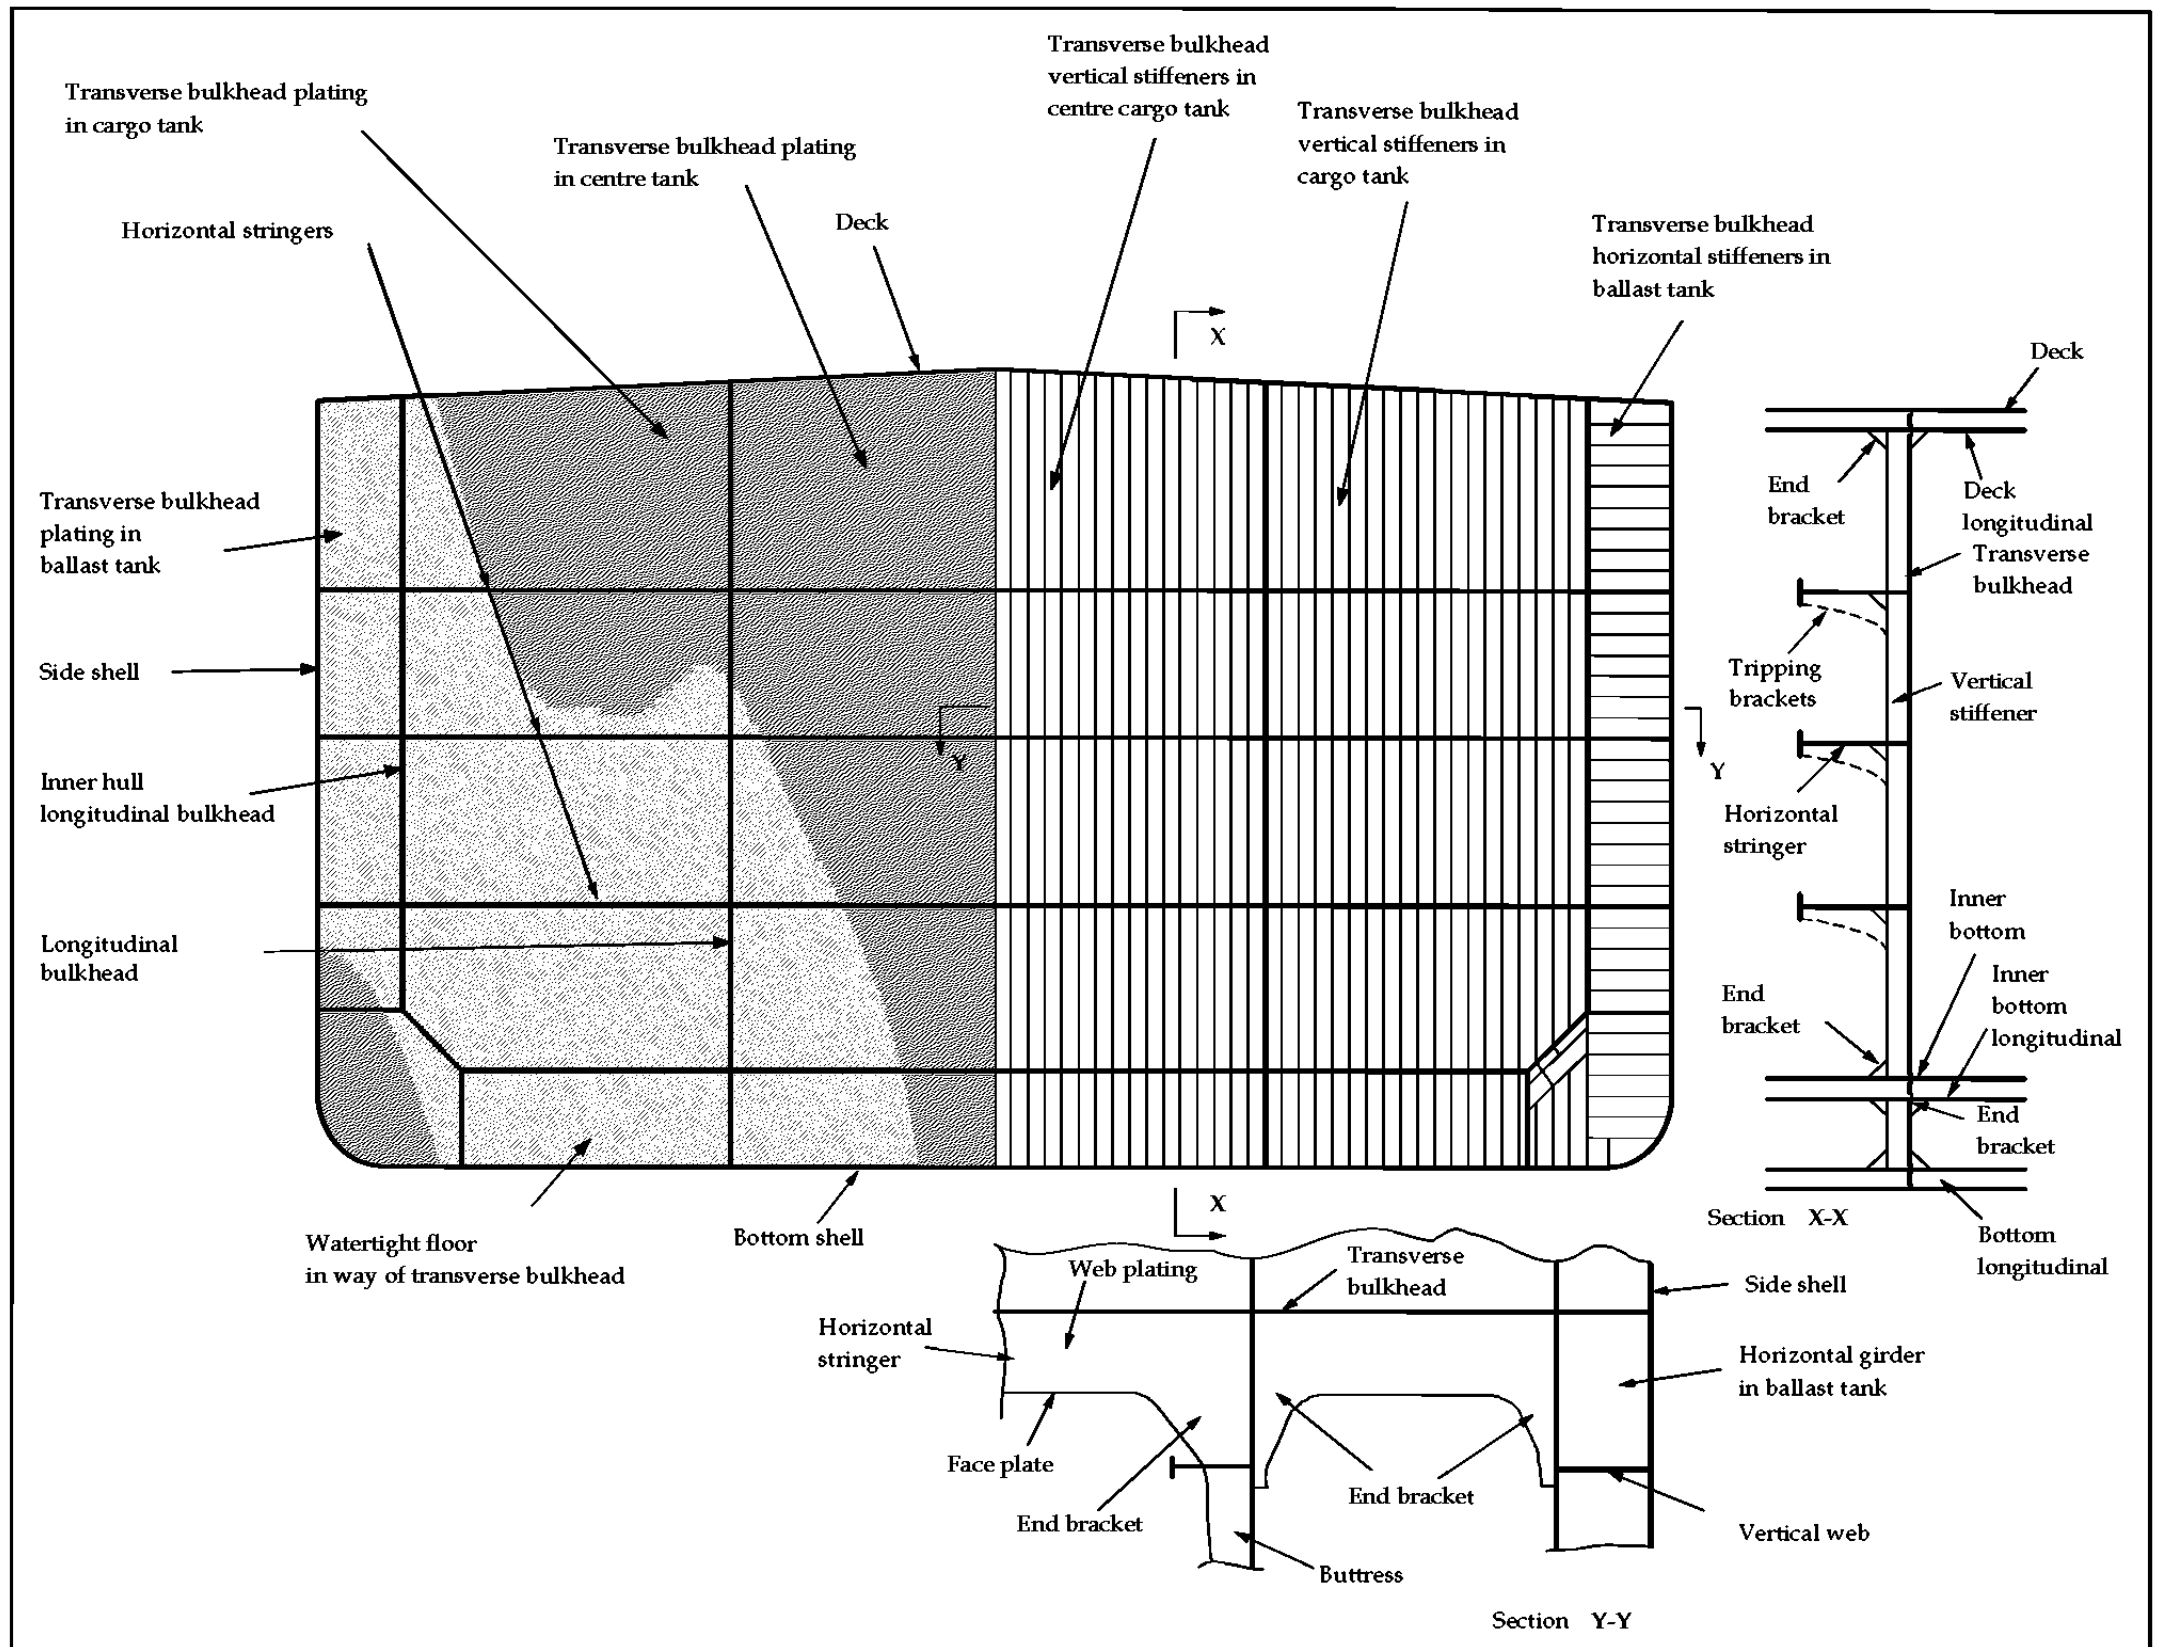
Figure 5 Double Hull Tanker – Typical Transverse Bulkhead

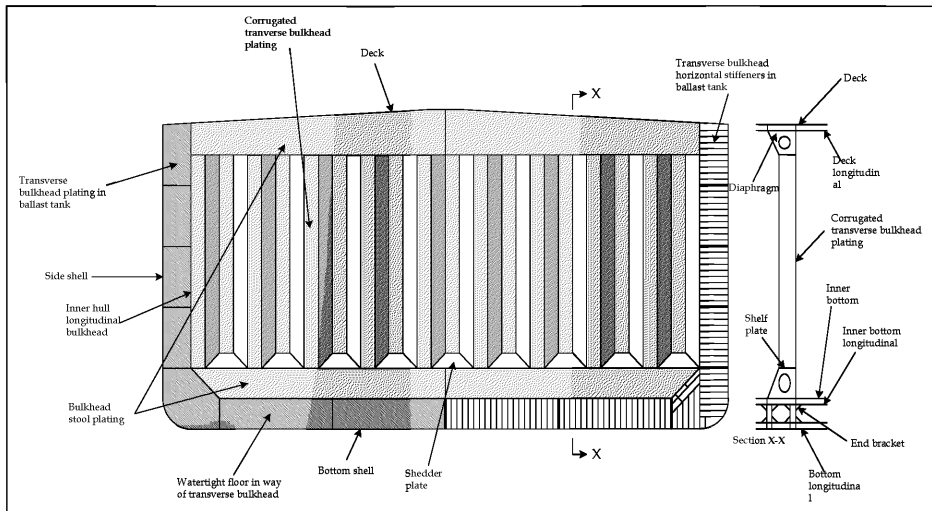
Figure 6 Corrugated Transverse Bulkhead Nomenclature

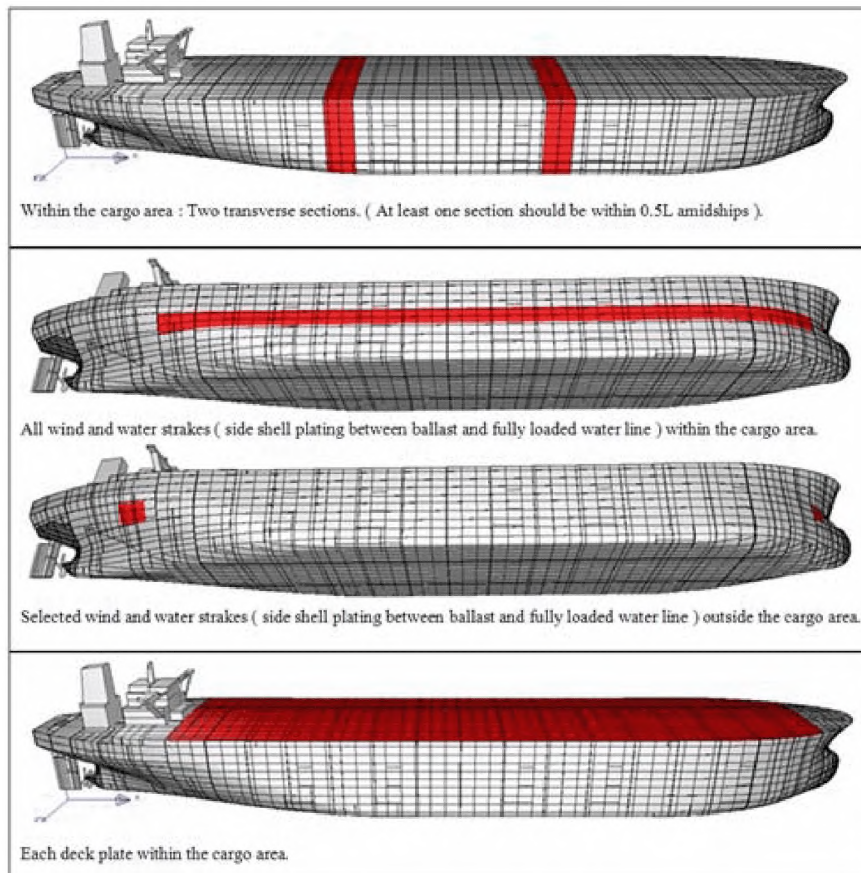
Figure 7 Example of Transverse Sections of Shell Plating and Main Deck Thickness Measurement Requirements for an oil tanker 15 years of age.

2.4.2 The Special Survey concentrates on close-up surveys in association with thickness measurements and is aimed at detecting fractures, buckling, corrosion and other types of structural deterioration. See Figure 7.

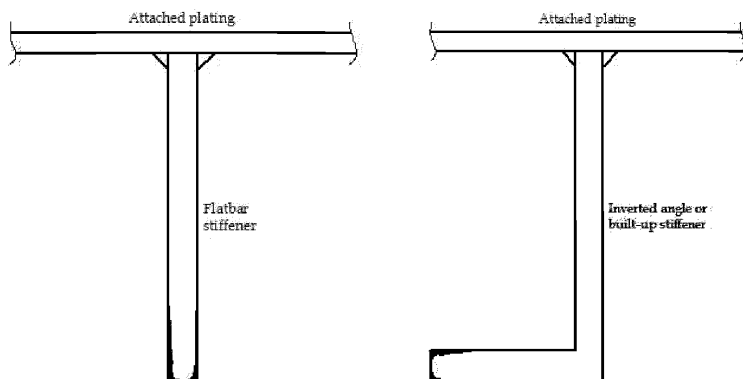
Figure 9 Edge Corrosion

Edge corrosion is defined as local corrosion at the free edges of plates, stiffeners, primary support members and around openings. An example of edge corrosion is shown in Figure 9.

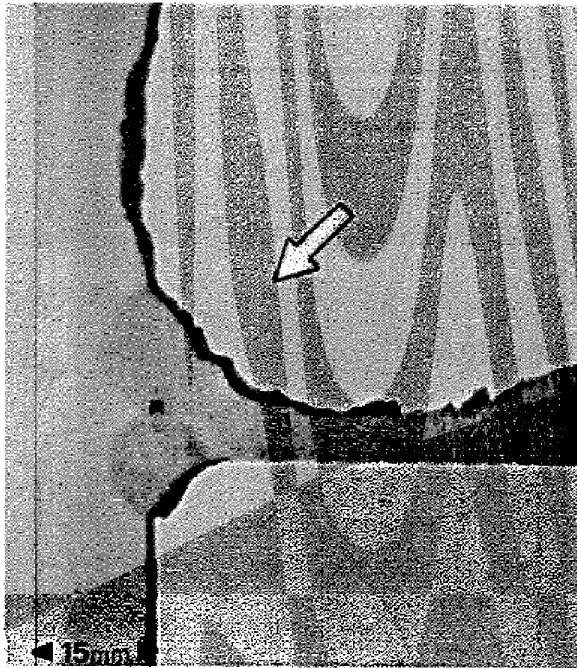
Figure 10 Detail of Necking Effect

- Necking occurs at the junction of the longitudinal bulkhead plating and longitudinals. The deflection of the bulkhead plating and longitudinals due to reverse, cyclic loading from cargo oil and water ballast plus the accumulated mixtures of water, mud and scale at their junctures accelerates the corrosion rate. As the steel thins and weakens, the flexing consequently increases and hence corrosion accelerates (see Figure 10). The similar necking effect could also occur in the transverse bulkhead plating and stiffeners, or in the inner bottom plating and longitudinals inside the double bottom space. In the coated water ballast tanks, the plating is the principally affected area due to local corrosion in way of coating failure.

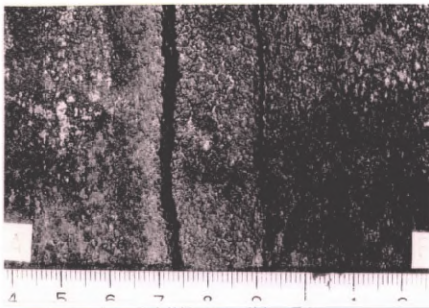
Photograph 1
Grooving corrosion of welding of bottom plating

4.1.2 Severe grooving along welding of bottom plating is often found (See **Photographs 1** and **2**). This grooving can be accelerated by poor maintenance of the protective coating and/or sacrificial anodes fitted to the bottom plating.

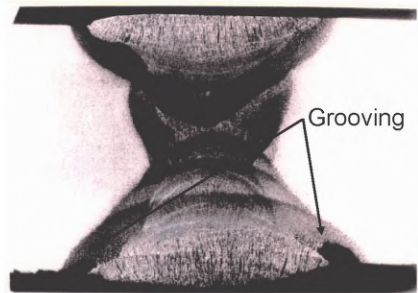
Photograph 2
Section of the grooving shown in Photograph 1

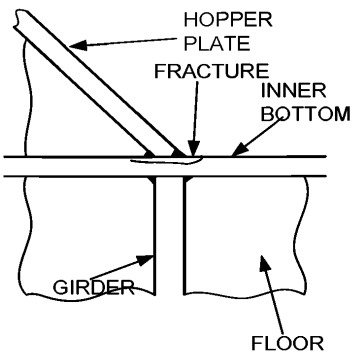
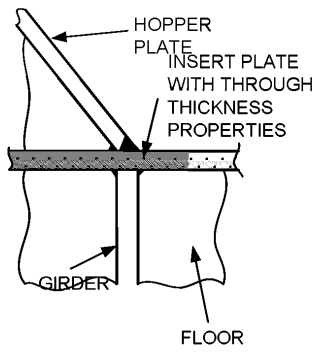
OIL Tankers		Guidelines for Surveys, Assessment and Repair of Hull Structure	
Group 1	Cargo area	Example No.	
	Hopper and double bottom ballast tank	2	
Detail of damage		Fracture at connection of bilge hopper plate and inner bottom	
<p>Sketch of damage</p>

<p>Sketch of repair</p>

<p>Notes: Plate midlines intersect</p>	
<p>Factors which may have caused damage</p> <p>1. Stress concentration at the knuckle.</p>		<p>Notes on repairs</p> <p>See Sketch.</p>

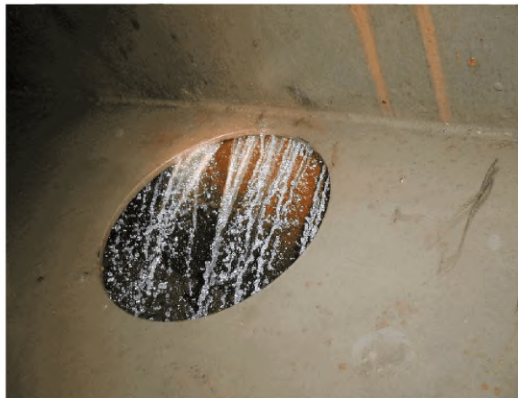
Photograph 1 Side shell fracture in way of horizontal stringer weld

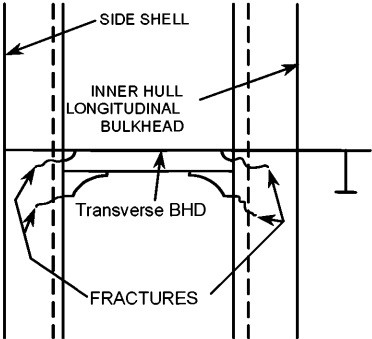
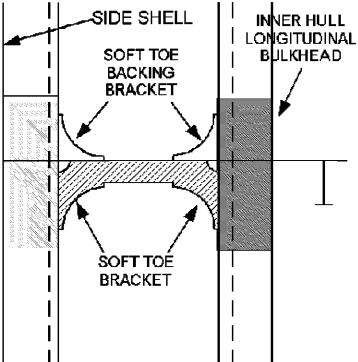
OIL Tankers		Guidelines for Surveys, Assessment and Repair of Hull Structure	
Group 2	Cargo area	Example No.	
	Wing ballast tank	1	
Detail of damage	Crack in way of connection of longitudinals to transverse bulkhead		
<p>Sketch of damage</p>

<p>Sketch of repair</p>

<p>Factors which may have caused damage</p> <ol style="list-style-type: none"> 1. Asymmetrical connection of bracket without backing bracket. 2. Relative deflection of adjoining transverse web against transverse bulkhead. 3. Additional biaxial bending stresses due to asymmetry of the angle bar longitudinal instead of symmetric T section. 4. Dynamic load in the vicinity of the water line. 5. Large upstand at bracket toe. 	<p>Notes on repairs</p> <p>See Sketch.</p>

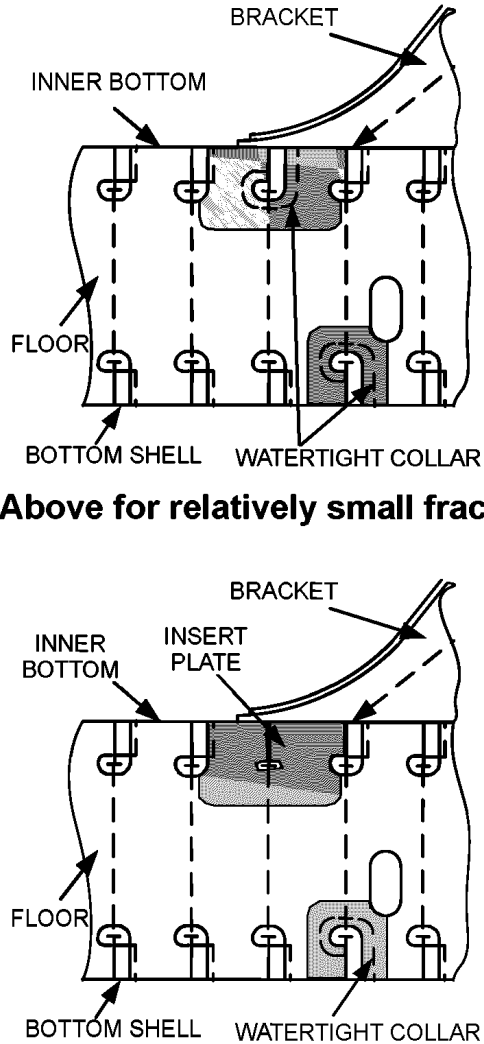
OIL Tankers		Guidelines for Surveys, Assessment and Repair of Hull Structure	
Group 3	Cargo area	Example No.	
	Bottom ballast tank	6	
Detail of damage		Cut-outs on floors	
<p>Sketch of damage</p>

<p>Sketch of repair</p>

<p>Above for relatively small fractures.</p> <p>Above method for larger fractures.</p>	
<p>Factors which may have caused damage</p> <ol style="list-style-type: none"> 1. High stress in the vicinity of the transverse web frame bracket toe. 2. Lack of material between manhole and cut-out for bottom longitudinals. 		<p>Notes on repairs</p> <ol style="list-style-type: none"> 1. Top sketch: Gouge and reweld fractures then fit WT collars. 2. Bottom sketch: As an alternative to rewelding and fitting collar, crop and insert.

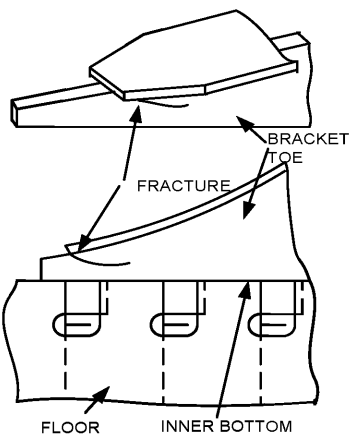
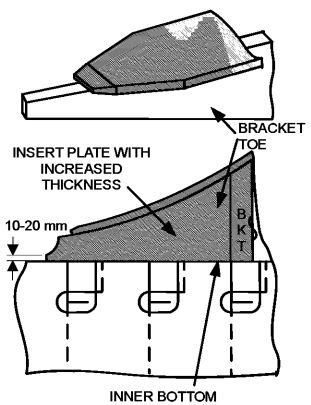
OIL Tankers		Guidelines for Surveys, Assessment and Repair of Hull Structure
Group 4	Cargo area	Example No.
	Web Frame in cargo tank	1
Detail of damage		Fracture at toe of web frame bracket connection to inner bottom.
Sketch of damage		Sketch of repair

<p>Modify Face Taper</p> <ol style="list-style-type: none"> 1. Breadth taper 20 degrees. 2. Breadth at toe as small as practical. 3. Thickness taper 1 in 3 to 10mm.

Factors which may have caused damage		Notes on repairs
<ol style="list-style-type: none"> 1. Inadequate tapering of the toe end. 2. Insufficient tapering of flange. 3. Lateral flexing of the bracket. 		<p>See Sketch.</p>

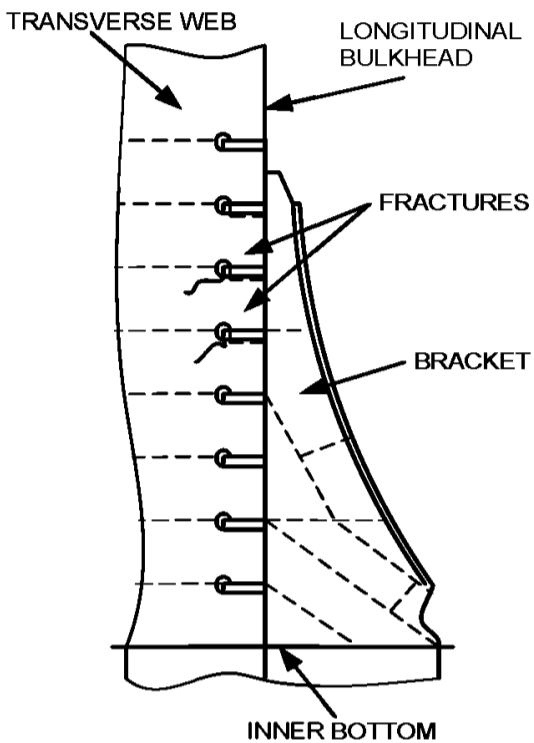
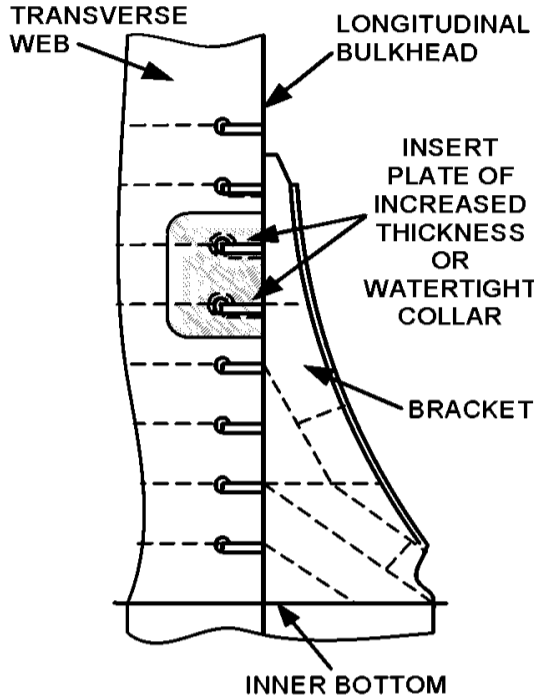
OIL Tankers		Guidelines for Surveys, Assessment and Repair of Hull Structure	
Group 4	Cargo area	Example No.	
	Web Frame in cargo tank	4	
Detail of damage		Cut-outs around transverse bracket end.	
<p>Sketch of damage</p>

<p>Sketch of repair</p>

<p>Factors which may have caused damage</p> <ol style="list-style-type: none"> 1. High stresses at toe of bottom transverse end bracket. 2. Sharp corner at cut-out. 		<p>Notes on repairs</p> <p>See Sketch.</p>

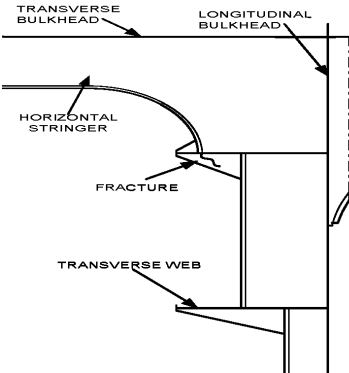
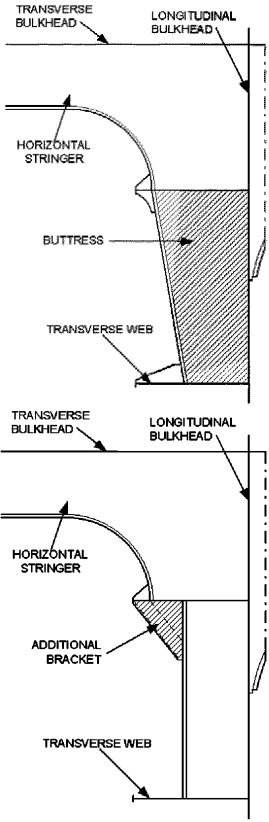
OIL Tankers		Guidelines for Surveys, Assessment and Repair of Hull Structure
Group 5	Cargo area	Example No.
	Transverse Bulkhead in cargo tank	1
Detail of damage	Fracture in way of connection of transverse bulkhead stringer to transverse web frames and longitudinal bulkhead stringer	
Sketch of damage	Sketch of repair

Factors which may have caused damage	Notes on repairs	
<ol style="list-style-type: none"> 1. Stress concentration due to discontinuous structure. 2. High shear stress in the horizontal stringer. 	<p>See Sketch.</p>
