ПРОЦЕДУРНЫЕ ТРЕБОВАНИЯ,
УНИФИЦИРОВАННЫЕ ИНТЕРПРЕТАЦИИ
И РЕКОМЕНДАЦИИ
МЕЖДУНАРОДНОЙ АССОЦИАЦИИ
КЛАССИФИКАЦИОННЫХ ОБЩЕСТВ

GENERAL DRY CARGO SHIPS

Guidelines for
Surveys, Assessment and Repair
of Hull Structure

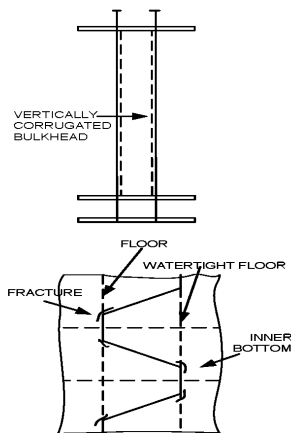
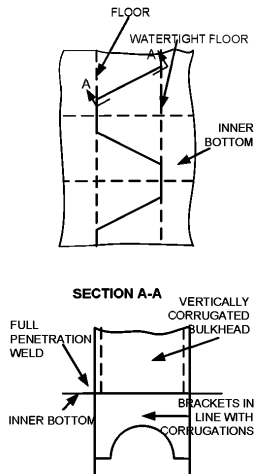
OIL Tankers		Guidelines for Surveys, Assessment and Repair of Hull Structure	
Group 5	Cargo area	Example No.	
		6	
Detail of damage	Vertically corrugated bulkhead without stool, connection to deck and inner bottom		
Sketch of damage	Sketch of repair

<p>The sketch shows a vertical section of a bulkhead. The top part is labeled 'FLOOR' and 'WATERTIGHT FLOOR'. The bottom part is labeled 'INNER BOTTOM'. A dashed line indicates a 'FRACTURE' in the bulkhead web. The bulkhead is labeled 'VERTICALLY CORRUGATED BULKHEAD'.</p>

<p>The sketch shows a section A-A of the bulkhead. The top part is labeled 'FLOOR' and 'WATERTIGHT FLOOR'. The bottom part is labeled 'INNER BOTTOM'. A 'FULL PENETRATION WELD' is shown connecting the bulkhead to the floor. The bulkhead is labeled 'VERTICALLY CORRUGATED BULKHEAD'. 'BRACKETS IN LINE WITH CORRUGATIONS' are shown at the bottom of the bulkhead.</p>		
Factors which may have caused damage	Notes on repairs

<ol style="list-style-type: none"> 1. Stress concentration due to unsupported corrugation web. 2. High through thickness stress, lamellar tearing. 3. Weld details and dimensions. 4. Misalignment between face of corrugation and floor underneath. 5. Cut-outs and scallops or air holes increasing the stress in the floor. 6. Insufficient through thickness properties of inner bottom plate. 	<p>See Sketch.</p>

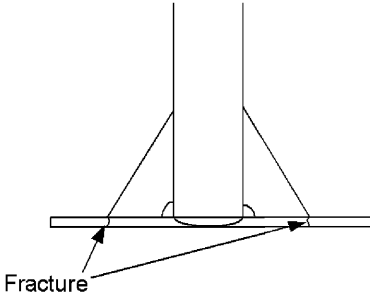
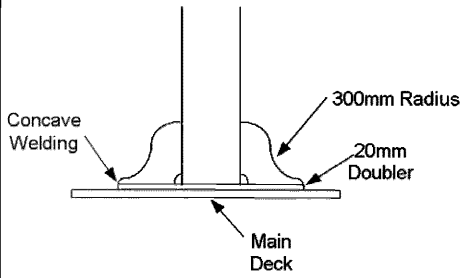
OIL Tankers		Guidelines for Surveys, Assessment and Repair of Hull Structure	
Group 6	Deck Structure		Example No.
			5
Detail of damage		Fractured deck plating in way of deck pipe support stanchions (midships)	
Sketch of damage		Sketch of repair

Factors which may have caused damage		Notes on repairs	
<p>1. Stanchions experience more severe relative displacements from hull girder bending.</p>		<p>See Sketch.</p>

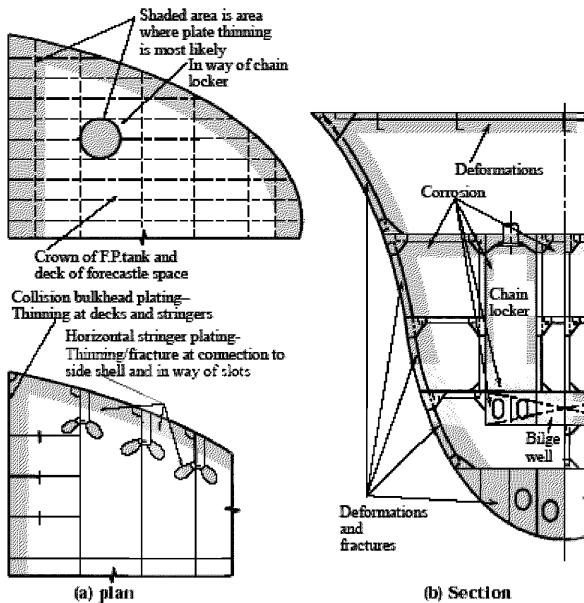
Fig 1 Fore end structure - Potential problem areas

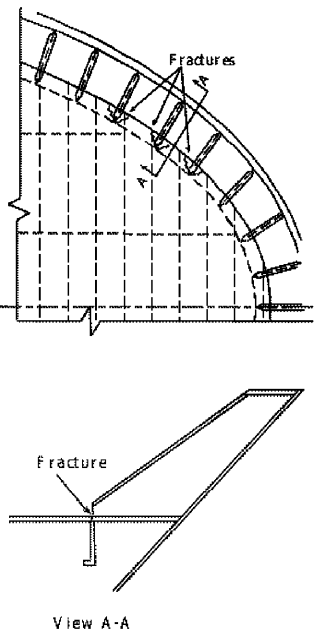
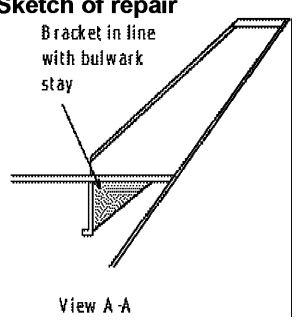
OIL Tankers		Guidelines for Surveys, Assessment and Repair of Hull Structure
Group 7	Fore region	Example No.
Area 1	Forecastle	1
Detail of damage		Fracture in forecastle deck plating at bulwark
<p>Sketch of damage</p>

<p>Sketch of repair</p>

<p>Factors which may have caused damage</p> <ol style="list-style-type: none"> 1. Bow Flare effect in heavy weather. 2. Stress concentration due to poor design. 		<p>Notes on repairs</p> <ol style="list-style-type: none"> 1. Fractured deck plating should be cropped and renewed. 2. Bracket in line with the bulwark stay to be fitted to reduce stress concentration.

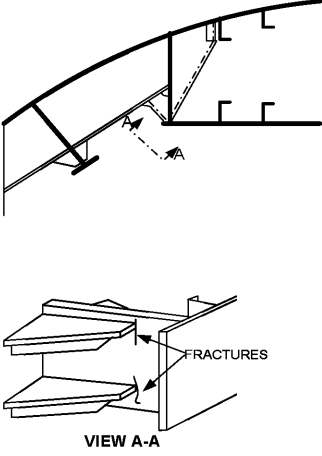
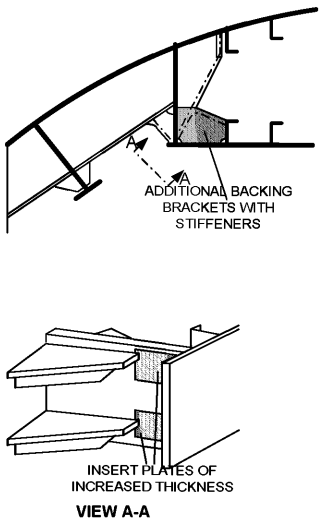
OIL Tankers		Guidelines for Surveys, Assessment and Repair of Hull Structure
Group 7	Fore region	Example No.
Area 1	Forepeak ballast tank	4
Detail of damage	Fractured vertical web at the longitudinal stiffener ending in way of the parabolic bow structure.	
Sketch of damage	Sketch of repair

<p>VIEW A-A</p>

<p>VIEW A-A</p>	
Factors which may have caused damage <ol style="list-style-type: none"> 1. Stress concentrations at bracket ending due to inadequate support at bracket toes in way of connection to web frame members. 2. Localised thinning in way of coating failure at bracket endings due to flexing of the structure. 3. Dynamic seaway loadings at bow causing flexing at bracket endings. 	Notes on repairs See Sketch.

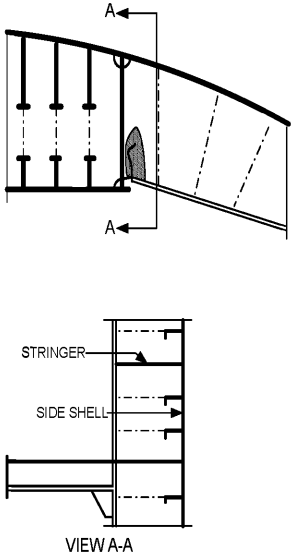
OIL Tankers		Guidelines for Surveys, Assessment and Repair of Hull Structure
Group 7	Fore region	Example No.
Area 1	Forepeak ballast tank	5
Detail of damage	Fractured stringer end connection in way of the parabolic bow structure	
<p>Sketch of damage</p>

<p>Factors which may have caused damage</p> <ol style="list-style-type: none"> 1. High stress concentration of stringer to stiff girder/deep web intersection due to discontinuity of faceplate. 2. Localised thinning in way of coating failure at stringer connection due to flexing of the structure. 3. Dynamic seaway loadings at bow causing flexing in way of detail. 		<p>Notes on repairs</p> <p>See Sketch.</p>

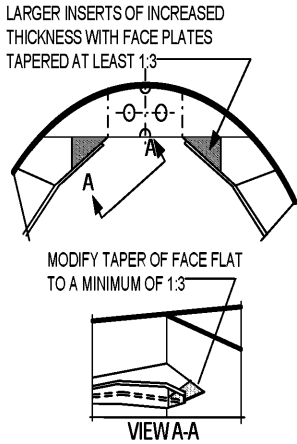
OIL Tankers		Guidelines for Surveys, Assessment and Repair of Hull Structure	
Group 7	Fore region	Example No.	
Area 1	Forepeak ballast tank	6	
Detail of damage		Fracture at end of longitudinal at bow structure.	
Sketch of damage		Sketch of repair

<p>A cross-sectional sketch of the forepeak ballast tank structure. It shows a curved shell plating at the top. Below it, two side longitudinal members are shown. Arrows point to the junctions between the shell plating and the side longitudinals, labeled 'FRACTURES'. The side longitudinals are labeled 'SIDE LONGITUDINALS'. The top shell plating is labeled 'SHELL PLATING'.</p>

Factors which may have caused damage		Notes on repairs	
<ol style="list-style-type: none"> 1. Inadequate brackets forming the longitudinal endings at bow structure. 2. Localised thinning in way of coating failure at longitudinal endings due to flexing of the structure. 3. Dynamic seaway loadings at bow causing flexing at longitudinal endings. 		<p>See Sketch.</p>

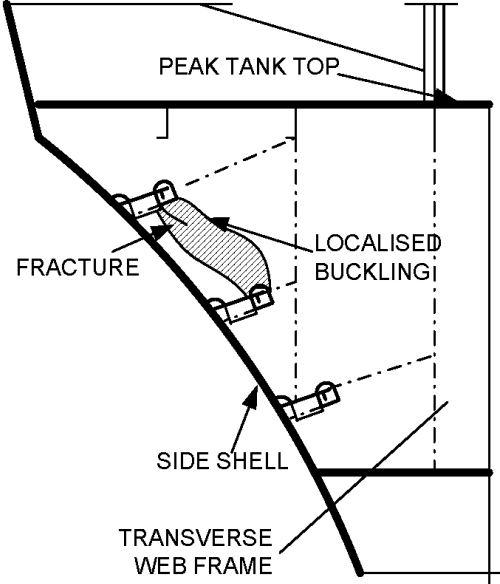
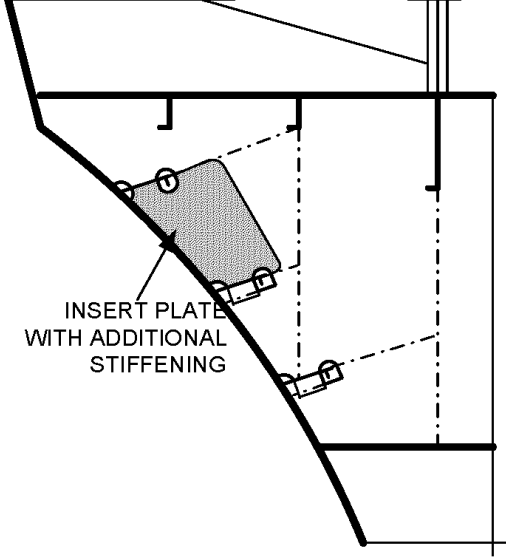
OIL Tankers		Guidelines for Surveys, Assessment and Repair of Hull Structure	
Group 7	Fore region		Example No.
Area 1	Forepeak ballast tank		7
Detail of damage		Fracture and buckle of bow transverse web frame in way of longitudinal cut-outs.	
Sketch of damage		Sketch of repair

Factors which may have caused damage 1. Localised thinning in way of coating failure at cut-outs and sharp edges due to working of the structure. 2. Dynamic seaway loadings in way of bow flare.		Notes on repairs See Sketch.

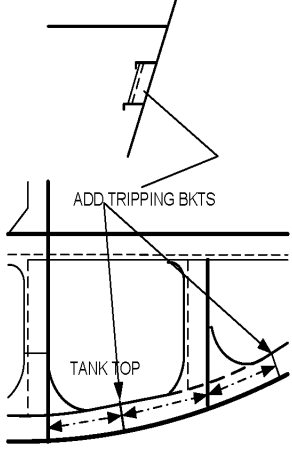
<p>The sketch shows the same cross-section as the damage sketch, but with repairs. A horizontal line at the top is labeled 'ADD. TRIPPING BKTS' with arrows pointing to small rectangular brackets added to the structure. Below it, a horizontal line is labeled 'TANK TOP' with arrows pointing to the top surface of the tank.</p>

Factors which may have caused damage		Notes on repairs	
<ol style="list-style-type: none"> 1. Bow impact load. 2. Low buckling resistance. 		<p>See Sketch.</p>

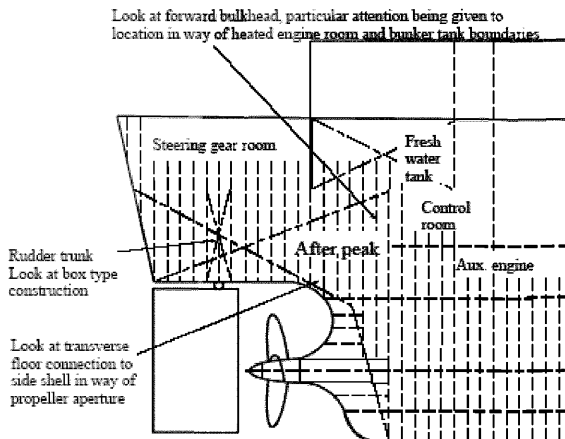
Figure 1 Aft end structure - Potential problem areas

2.1.1 Wastage (and possible subsequent fractures) is more likely to be initiated at in the locations as indicated in **Figure 1**. A close-up survey should be carried out with selection of representative thickness measurements to determine the extent of corrosion. Particular attention should be given to bunker tank boundaries and spaces adjacent to heated engine room.

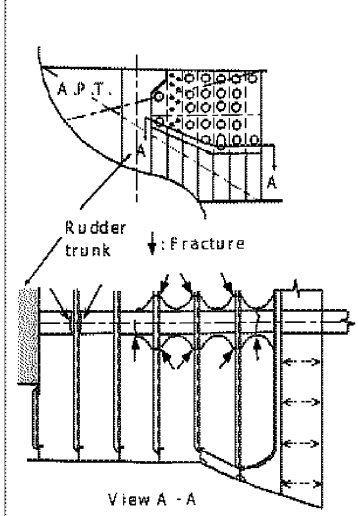
OIL Tankers		Guidelines for Surveys, Assessment and Repair of Hull Structure	
Group 7	Aft region	Example No.	
Area 2	Aft peak ballast tank	10	
Detail of damage		Fractures at the connection of floors and girders/side brackets	
<p>Sketch of damage</p>

<p>Newly provided strut</p>	
<p>Factors which may have caused damage</p> <ol style="list-style-type: none"> 1. Vibration. 		<p>Notes on repairs</p> <ol style="list-style-type: none"> 1. The fractured plating should be cropped and renewed. 2. Natural frequency of the panel should be changed, e.g. reinforcement by additional strut.

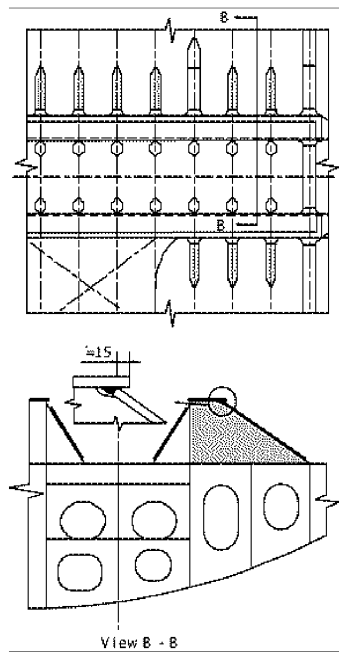
OIL Tankers		Guidelines for Surveys, Assessment and Repair of Hull Structure	
Group 8	Machinery and accommodation spaces	Example No.	
Area 1	Engine room	1	
Detail of damage		Fractures in brackets at main engine foundation	
Sketch of damage		Sketch of repair

Factors which may have caused damage		Notes on repairs	
<ol style="list-style-type: none"> 1. Vibration of main engine. 2. Insufficient strength of brackets at main engine foundation. 3. Insufficient pre-load of the bolts. 		<ol style="list-style-type: none"> 1. Fractures may be veed-out and rewelded. 2. New modified brackets at main engine foundation. 3. Or insert pieces and additional flanges to increase section modulus of the brackets.

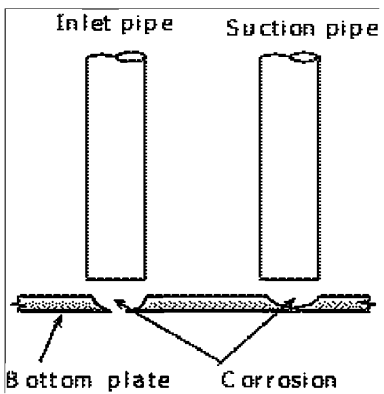
OIL Tankers		Guidelines for Surveys, Assessment and Repair of Hull Structure	
Group 8	Machinery and accommodation spaces		Example No.
Area 1	Engine room		3
Detail of damage	Corrosion in bottom plating under inlet/suction/pipe in way of bilge tank in engine room		
Sketch of damage		Sketch of repair

<p>The sketch shows two vertical pipes, labeled 'Inlet pipe' and 'Suction pipe', resting on a horizontal 'Bottom plate'. The area of the bottom plate directly beneath the pipes is shaded with a cross-hatch pattern and labeled 'Corrosion'. An arrow points from the 'Bottom plate' label to the uncorroded area of the plate.</p>

<ol style="list-style-type: none"> 1. Heavy corrosion of bottom plating under the inlet/suction pipe. 		<ol style="list-style-type: none"> 1. Corroded bottom plate is to be cropped and part renewed. Thicker plate is preferable. 2. Replacement of pipe end by enlarged conical opening (similar to suction head in ballast tank) is preferable.

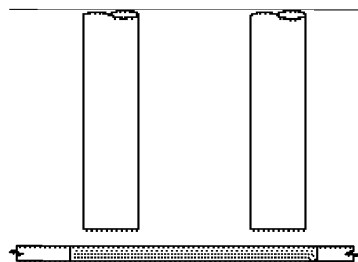
<p>The sketch shows the same two vertical pipes on a thicker bottom plate. The area under the suction pipe is now a conical opening, similar to a suction head. The rest of the bottom plate is shown with a cross-hatch pattern.</p>	
Factors which may have caused damage		Notes on repairs

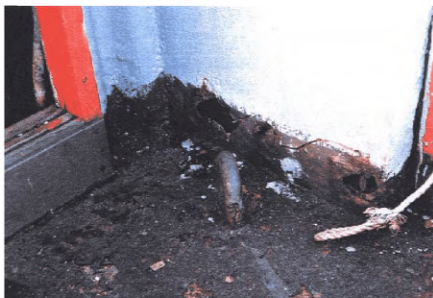
Photograph 1 Corroded accommodation house side structure

Severe corrosion may be found in exposed deck plating and deck house side structure adjacent to the deck plating where water is liable to accumulate (See **Photograph 1**). Corrosion may also be found in accommodation bulkheads around cut-out for fittings, such as doors, side scuttles, ventilators, etc., where proper maintenance of the area is relatively difficult. Deterioration of the bulkheads including fittings may impair the integrity of weathertightness.

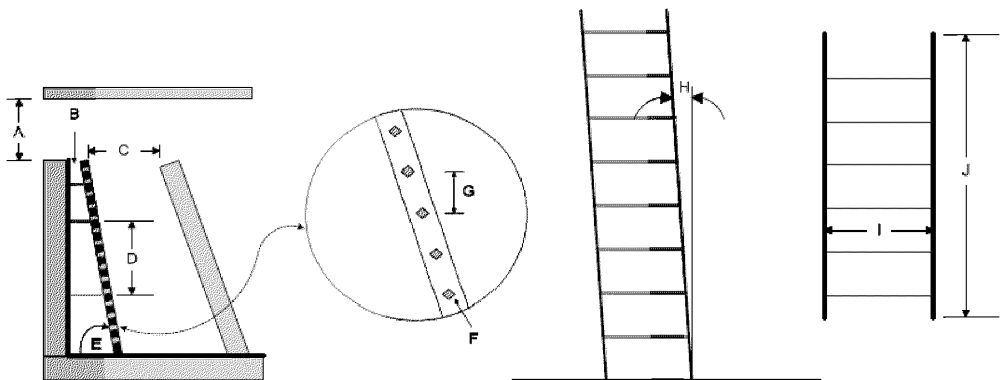
Figure 2 Vertical Ladders (General Criteria)

<i>Dimension</i>		<i>Recommendation</i>
A	Overhead Clearance	2130 mm (84.0 in.)
B	Ladder distance (gap accommodating toe space) from surface (at 90 degrees)	≥ 175 mm (7.0 in.) ≤ 200 mm (8.0 in.)
C	Horizontal Clearance (from ladder face and obstacles)	≥ 750 mm (29.5 in.) or ≥ 600 mm (23.5 in.) (in way of openings)
D	Distance between ladder attachments / securing devices	≤ 2.5 m (8.0 ft)
E	Ladder angle of inclination from the horizontal	80 to 90 degrees
F	Rung Design – (Can be round or square bar; where square bar is fitted, orientation should be edge up)	Square bar 25 mm (1.0 in.) x 25 mm (1.0 in.) Round bar 25 mm (1.0 in.) diameter
G	Distance between ladder rungs (rungs evenly spaced throughout the full run of the ladder)	≥ 275 mm (11.0 in.) ≤ 300 mm (12.0 in.)
H	Skew angle	≤ 2 degrees
I	Stringer separation	400 to 450 mm (16.0 to 18.0 in.)
J	Ladder height: Ladders over 6 m (19.7 ft) require intermediate/linking platforms)	≤ 6.0 m (19.5 ft)

In addition to the recommendations for Vertical Ladders presented in Section 4.6 Access & Egress Design, the following recommended dimensions relating to the design of Ladders are presented in Figure 2 to Figure 5.

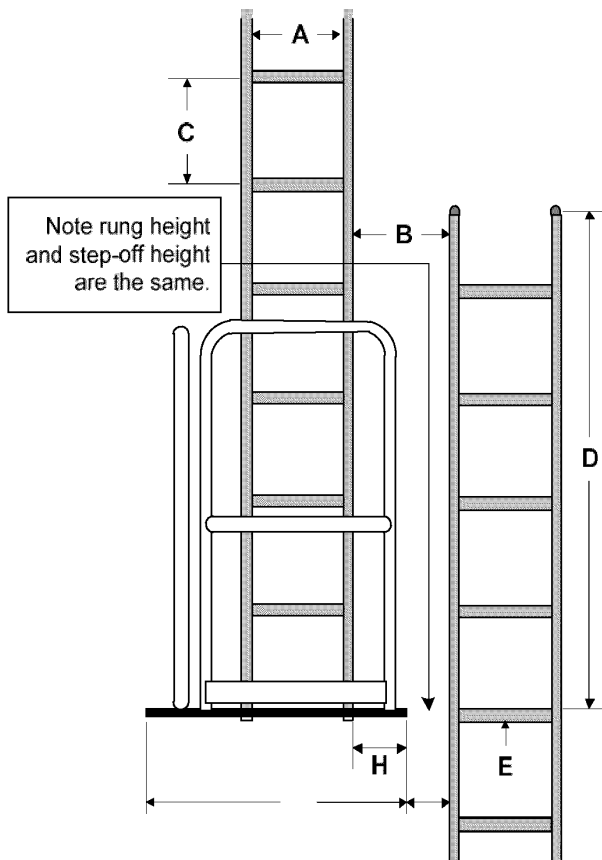
Figure 3 Staggered Vertical Ladders

<i>Dimension</i>		<i>Recommendation</i>
A	Stringer separation	400 to 450 mm (16.0 to 18.0 in.)
B	Horizontal separation between two vertical ladders, stringer to stringer	≥ 225 mm (9 in.) ≤ 450 mm (18 in.)
C	Distance between ladder rungs (rungs evenly spaced throughout the full run of the ladder)	≥ 275 mm (11.0 in.) ≤ 300 mm (12.0 in.)
D	Stringer height above landing or intermediate platform	≥ 1350 mm (53.0 in.)
E	Rung design – (Can be round or square bar; where square bar is fitted, orientation should be edge up)	Square bar 22 mm (0.9 in.) x 22 mm (0.9 in.) Round bar 25 mm (1.0 in.) diameter
F	Horizontal separation between ladder and platform	≥ 150 mm (6.0 in.) ≤ 300 mm (12.0 in.)
G	Landing or intermediate platform width	≥ 925 mm (36.5 in.)
H	Platform ladder to Platform ledge	≥ 75 mm (3.0 in.) ≤ 150 mm (6.0 in.)

*Note: Left side guardrail of platform omitted for clarity.

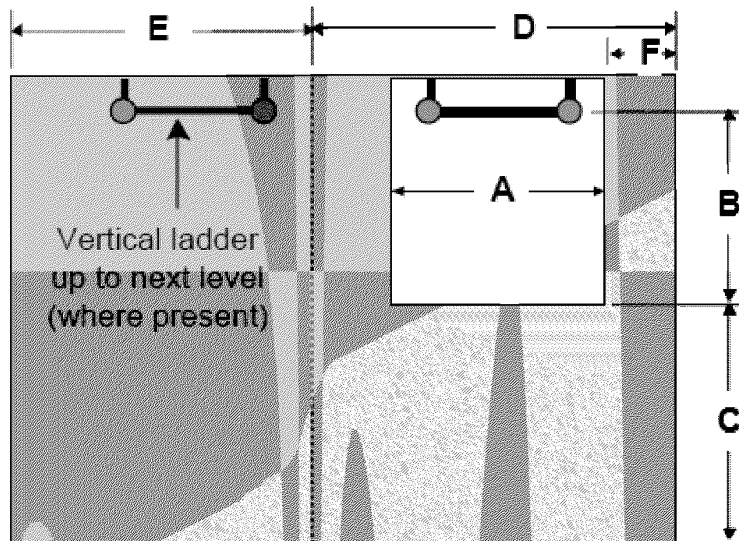
Figure 5 Vertical Ladders to Landings (Ladder through Platform)*

<i>Dimension</i>	<i>Recommendation</i>
A	Vertical ladder opening	≥ 750 mm (29.5 in.)
B	Distance from front of vertical ladder to back of platform opening	≥ 750 mm (29.5 in.)
C	Minimum clear standing area in front of ladder opening – Depth	≥ 750 mm (29.5 in.)
D	Minimum clear standing area in front of ladder opening – Width	≥ 925 mm (36.5 in.)
E	Additional platform width for intermediate landing (where present)	≥ 925 mm (36.5 in.)
F	Horizontal separation between ladder and platform	≥ 150 mm (6.0 in.) and ≤ 300 mm (12.0 in.)

*Notes: Top view. Guardrails/Handrails not shown.

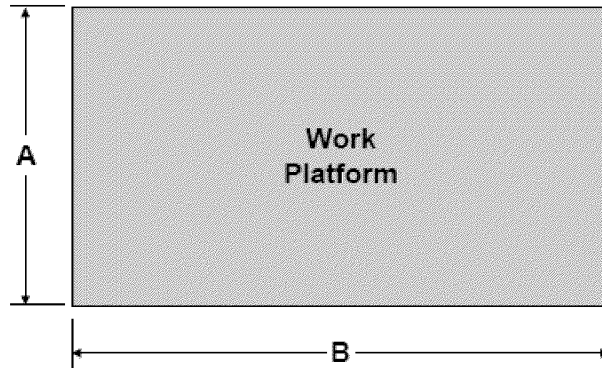
Figure 6 Work Platform Dimensions

<i>Dimension</i>		<i>Recommendation</i>
A	Work platform width	≥ 750 mm (29.5 in.)
	Work platform width (if used for standing only)	≥ 380 mm (15.0 in.)
B	Work platform length	≥ 925 mm (37.0 in.)
	Work platform length (if used for standing only)	≥ 450 mm (18.0 in.)

In addition to the recommendations for Work Platforms presented in Section 4.6 Access & Egress Design, the following recommended dimensions relating to the design of Work Platforms are presented in Figure 6 'Work Platform Dimensions'.

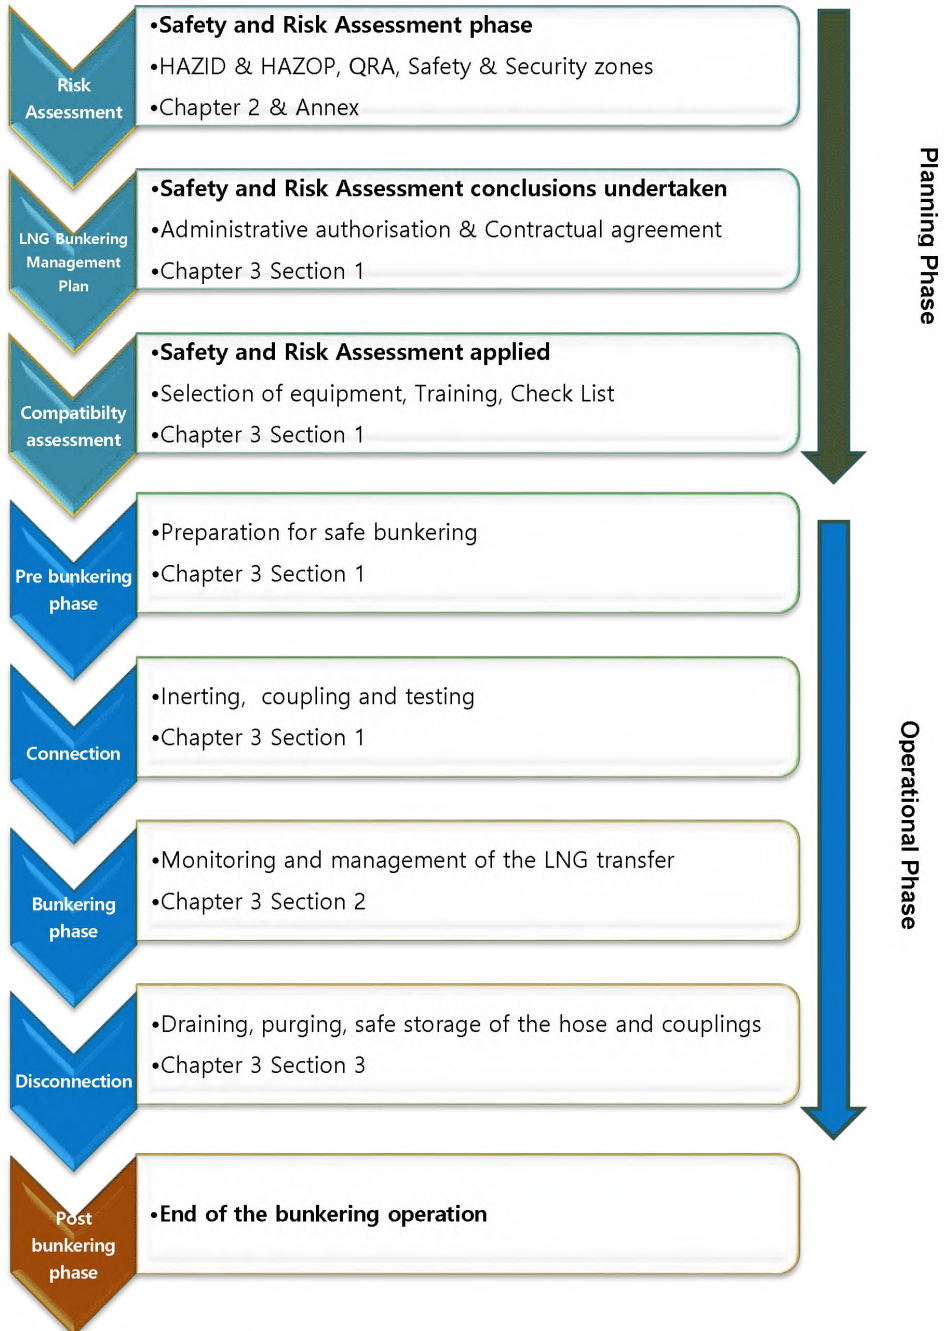
Figure 1: Bunkering process

The sequence for a bunkering operation carried out between two parties for the first time is described in the following diagram; the references identify the applicable sections of the guideline.

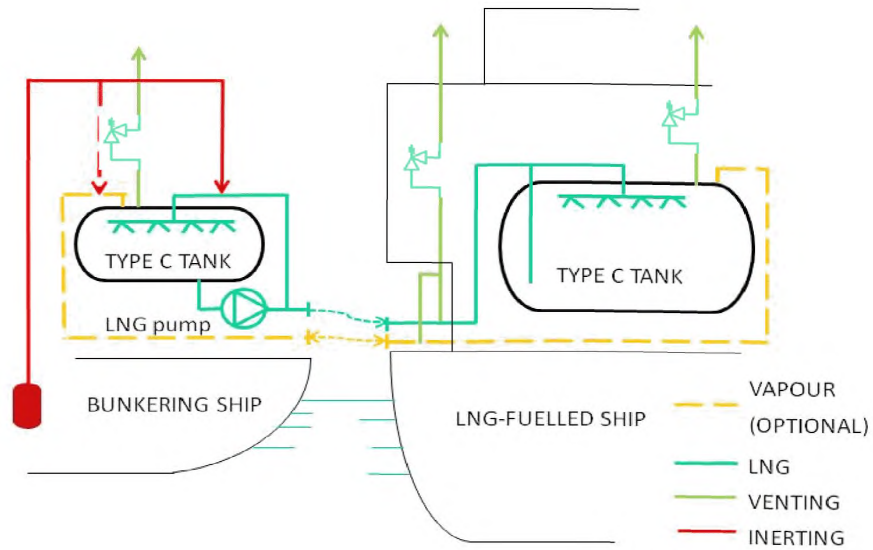
Figure 3: Ship-to-ship bunkering - typical arrangement of bunkering ship and LNG fuelled ship with type C tank

Bunkering facility				
		Type C tank			Atmospheric tank	
		Bunker ship	Tank truck	Shore-based facility	Bunker ship	Shore-based facility
Receiving ship	Type C tank	Fig.3	Fig.6	(*)	(*)	Fig.7
	Atmospheric tank	Fig.4	(*)	(*)	Fig.5	(*)

Note: For small scale bunker supply using Type C tanks, the LNG supply pressure may be generated by pump (as shown in the figures below) or by a Pressure Built Up unit.

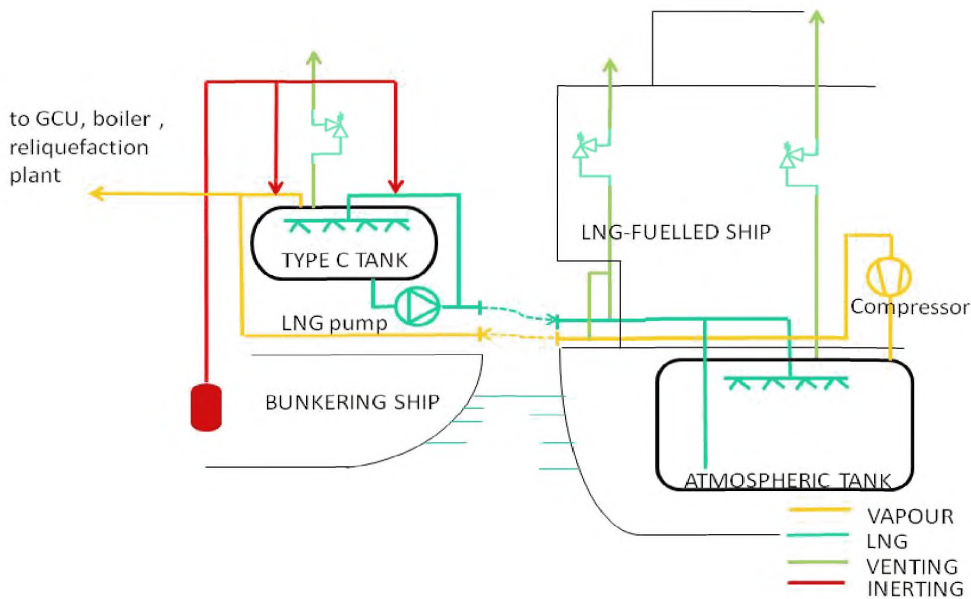
Figure 4: Ship-to-ship bunkering - typical arrangement of bunkering ship with type C tank and LNG fuelled ship with atmospheric tank

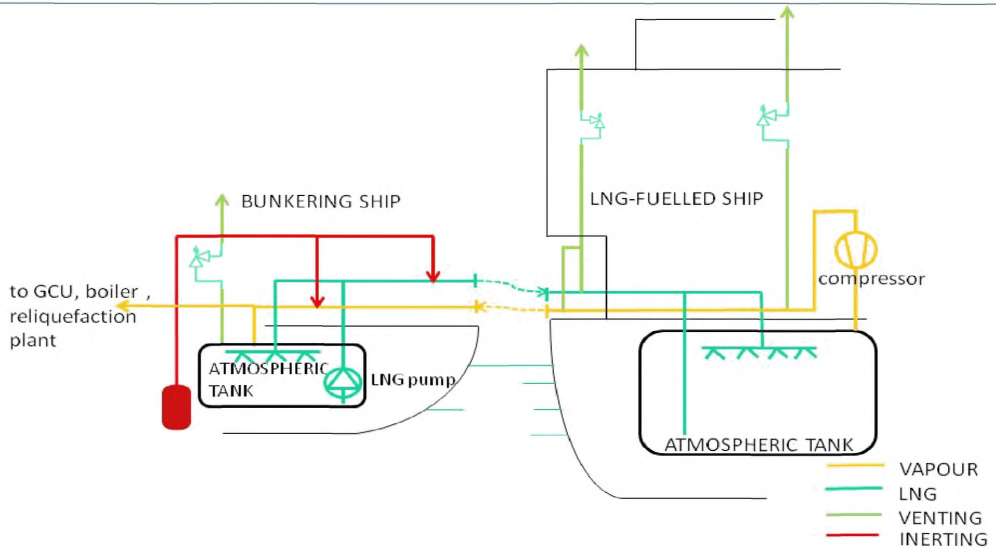
Figure 5: Ship-to-ship bunkering - typical arrangement of bunkering ship and LNG fuelled ship with atmospheric tank

* Compressor is optional, only necessary if free flow is not possible. Normally there is no need for a compressor if the bunker ship uses atmospheric tanks or uses type C tanks operated at very low pressure (using discharge pump and not PBU). It is only required in cases where there is likely to be large quantities of flash gas generated during bunkering and the pressure gradient between the bunker ship and receiving ship does not allow free flow of vapour.

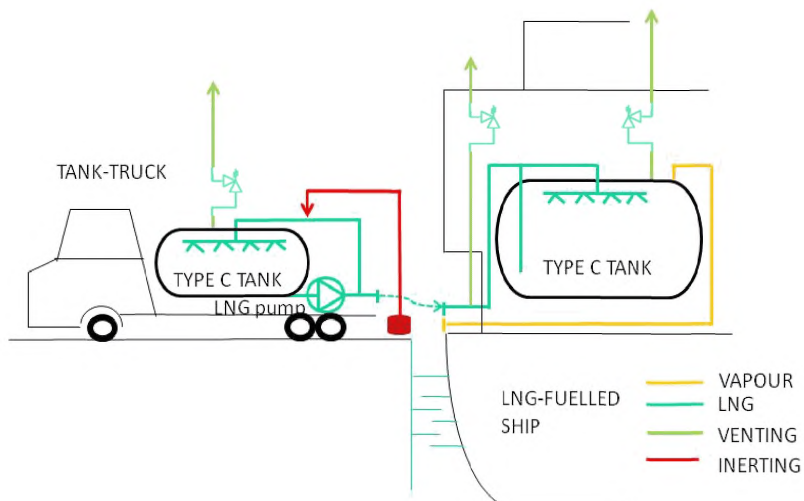
Figure 6: Truck-to-ship bunkering - typical arrangement of LNG fuelled ship with type C tank

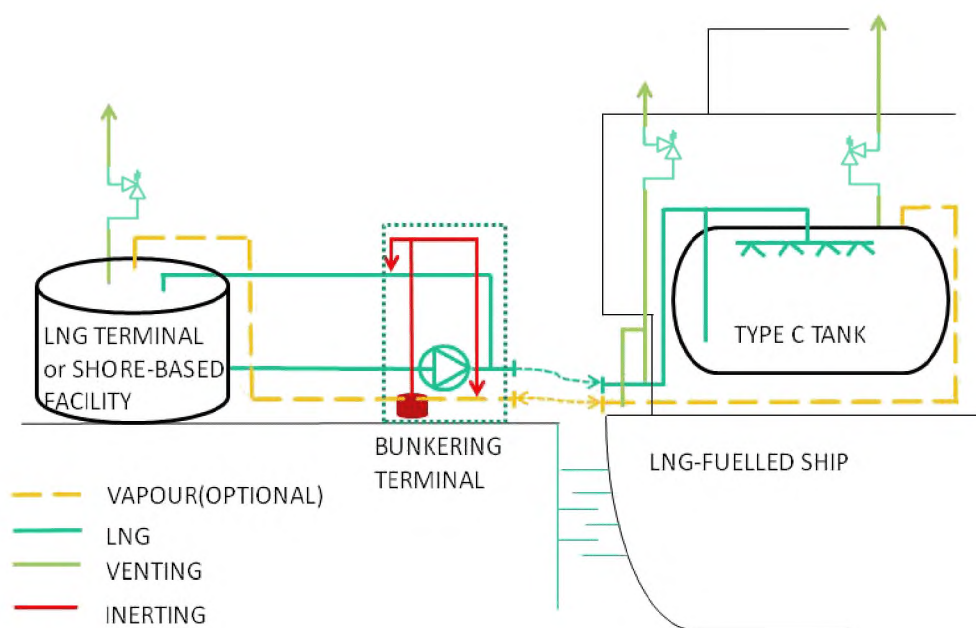
Figure 7: Terminal to ship bunkering - typical arrangement of LNG fuelled ship with type C tank

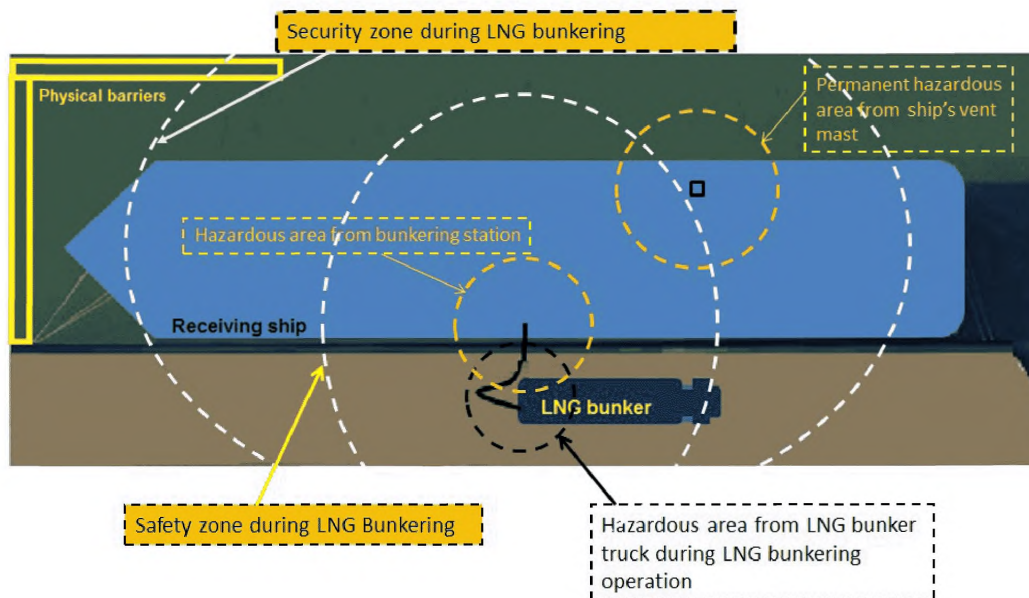
A safety zone and a security zone should be established around the bunkering operation in accordance with ISO/TS 18683. These zones are in addition to the established practice of setting hazardous area classification zones that will be required around areas with potential for explosive atmospheres such as the bunkering connections. A pictorial example of these zones is illustrated below.

Both the safety and security zones should be enforced and monitored at all times during bunkering, at all other times these zones are not enforced.

The purpose of the safety zone is to set an area within which only essential personnel are allowed and potential ignition sources are controlled. Essential personnel are those required to monitor and control the bunkering operation. Similarly, the purpose of the security zone is to set an area within which ship/port traffic is monitored and controlled.

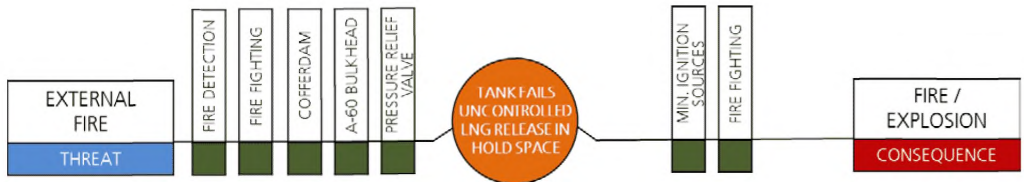
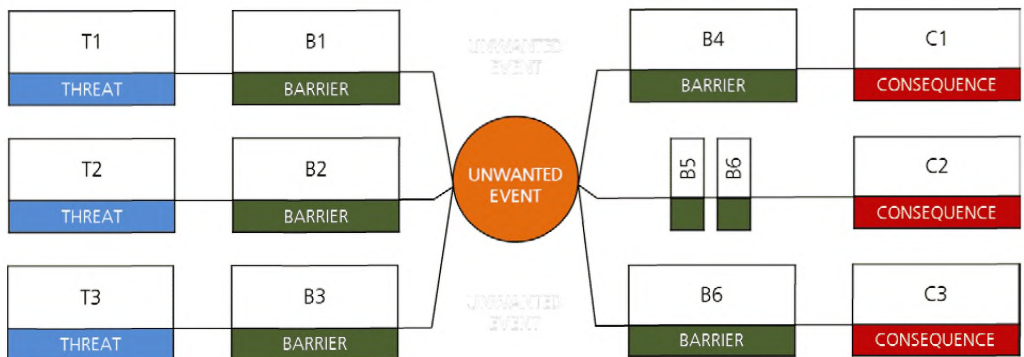
- Threat** – A cause that can potentially lead to the unwanted event.
- Barrier** – A mitigation measure that can potentially prevent the unwanted event or its consequences.
- Unwanted Event** – A situation to be avoided e.g. a release of fuel or a loss of ship propulsion.
- Consequence** – An outcome of a threat and an unwanted event not being mitigated by the barriers.

In respect of ‘mitigation measures’ (i.e. barriers) those prior to the unwanted event are often referred to as preventative barriers or prevention measures.
